CITY OF
PITTSBURGH
FACILITY ANALYSIS REPORT

Firehouse 17 (B128)
7601 Hamilton Avenue
Pittsburgh, Pennsylvania 15208

May 21, 2010

RE: Visual Survey - Firehouse #17

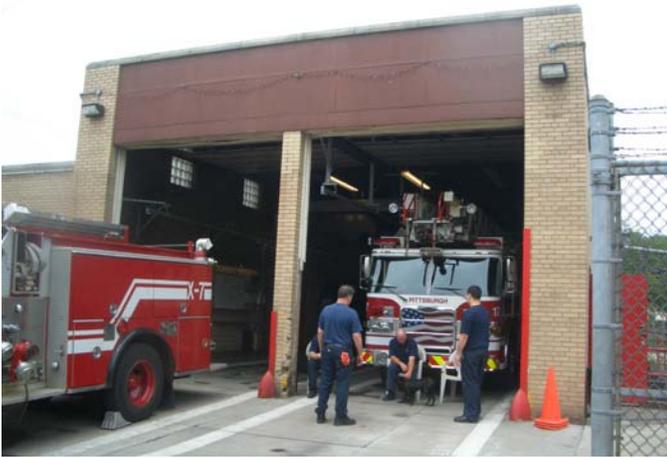
R-1 Right front of building

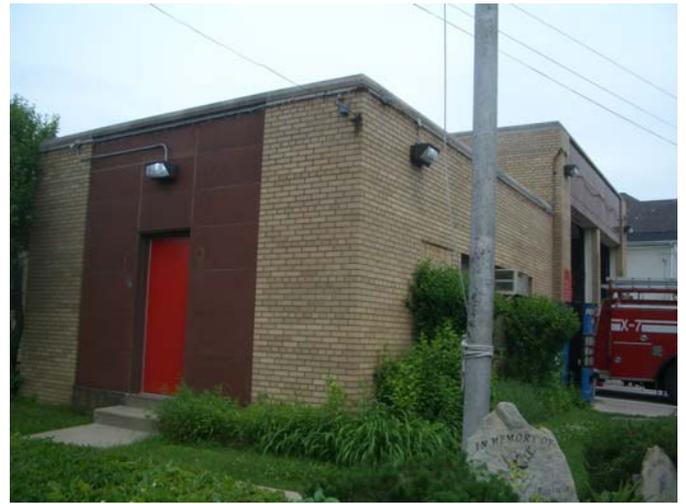
R-4 Left side of building (front)

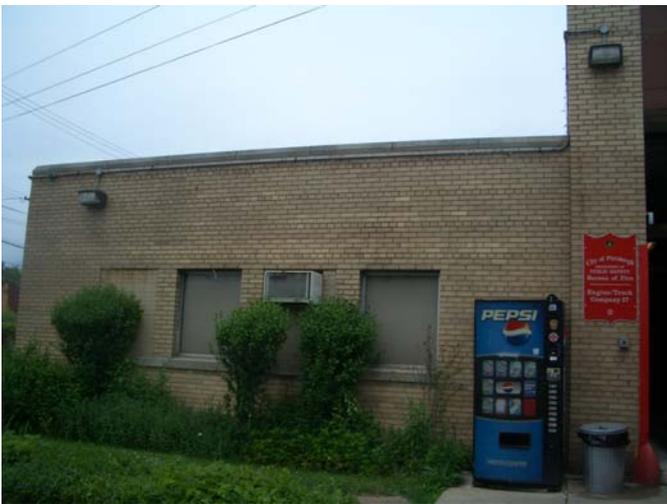
R-2 Left front of building

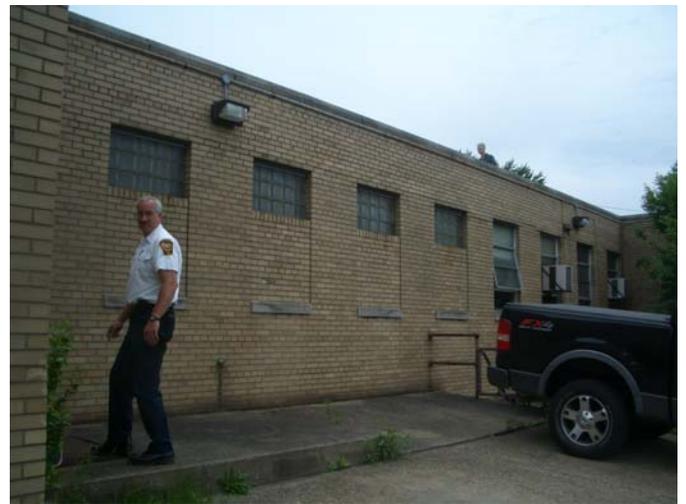
R-5 Left side of building (middle)

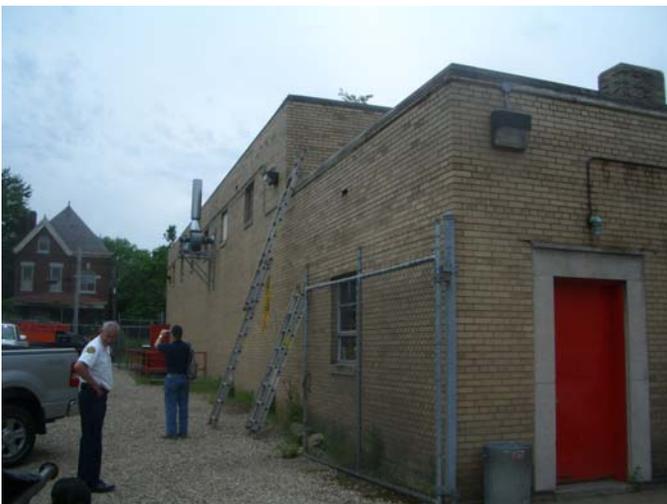
R-3 Right side of building

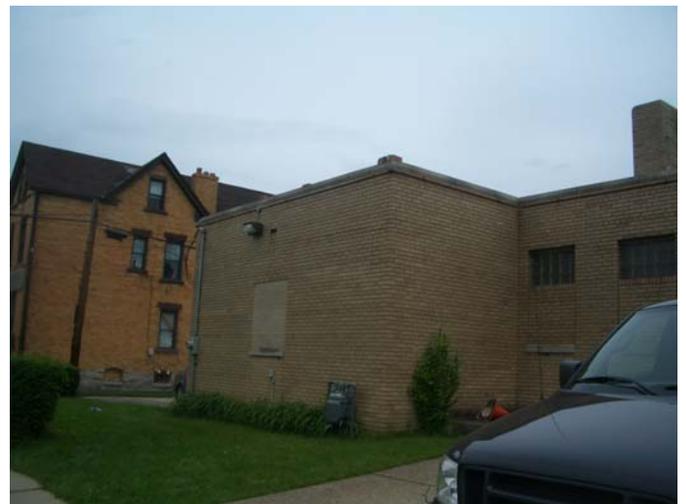
R-6 Left side of building (rear)

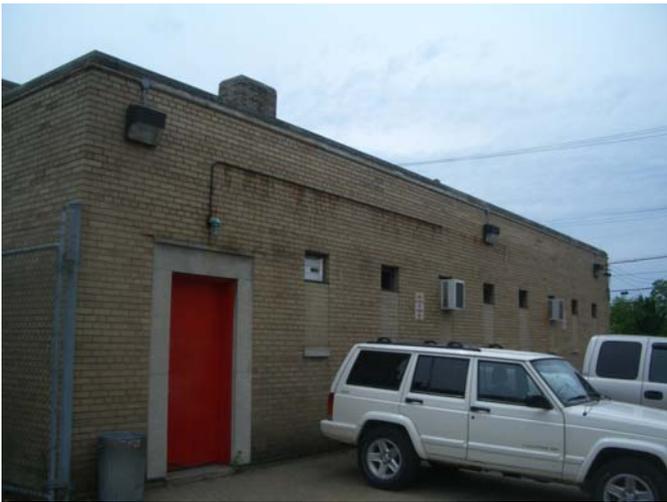
R-7 Rear of Building

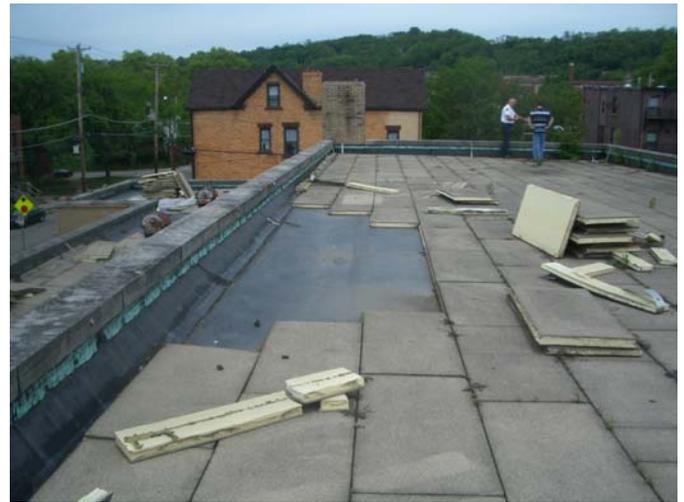
3.2 Condition: The insulation is in poor condition. The insulation has been displaced to repair the roof and not replaced. Ultraviolet rays have deteriorated and aged the insulation.

5.2 Condition: The membrane flashing system is in poor condition. The flashing is loose from the wall and bridged (stretched). Numerous patches and repairs were observed. Most are loose and open. The flashings have been repaired numerous times.

R-10 Truck bay roof, bridged flashing and displaced insulation

1 year: Replace roofing and flashing system, re- point and seal the coping joints - Estimated cost: \$70,000 (5,050 SF x \$12/SF)

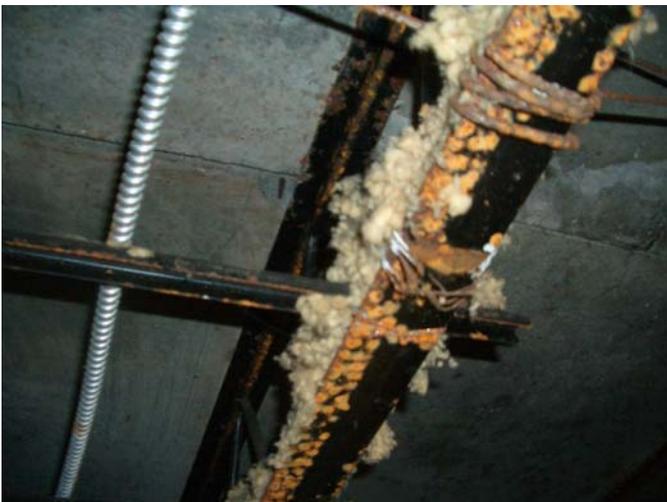
The roof decking appears to be in good condition. We did not observe any signs that would suggest a serious problem with the decking system at this time.

R-8 Underside of roof typical, concrete deck with bar joist

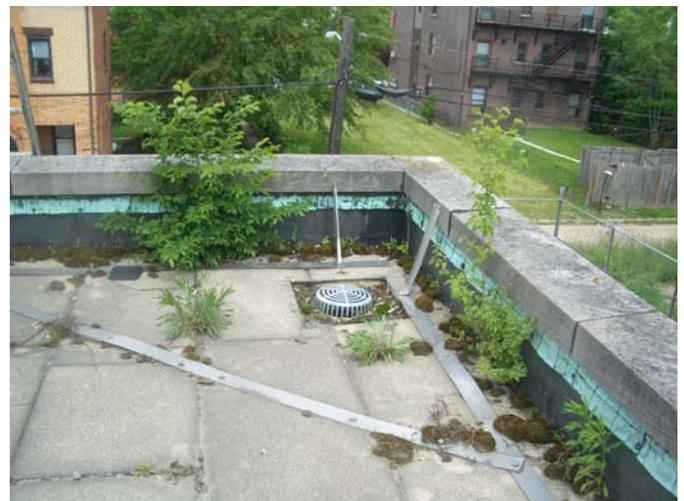
8.2 Condition: The drainage system appears to be operating properly. Some drains are clogged with debris.

R-11 Truck bay roof, vegetation, debris at clogged roof drain

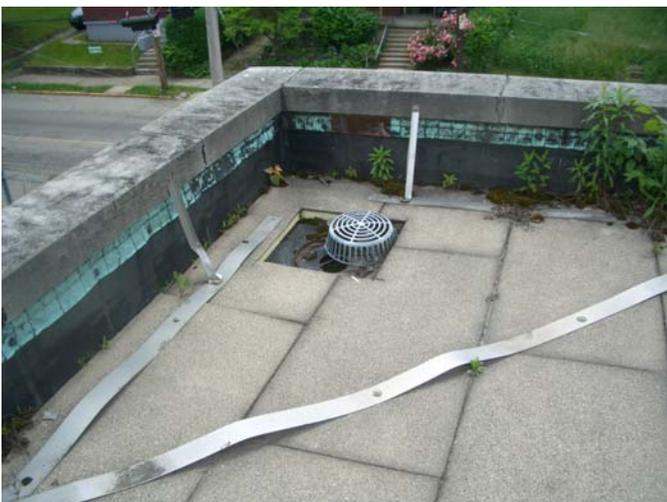
R-9 Truck bay roof, vegetation, IRMA insulation

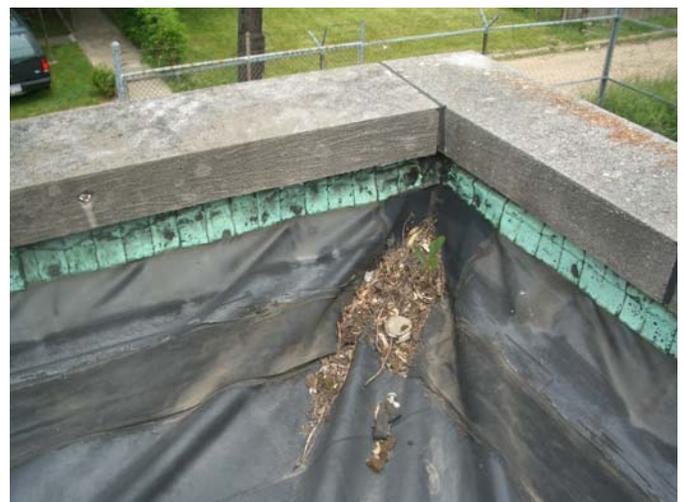
4.2 Condition: The roof membrane appeared in poor condition. Numerous patches and repairs were observed. Most patches and repairs are loose and deteriorated. Debris was observed on the roof. Trees and vegetation are growing on the roof.

R-12 Low Roof, bridged membrane, shrinking membrane and debris

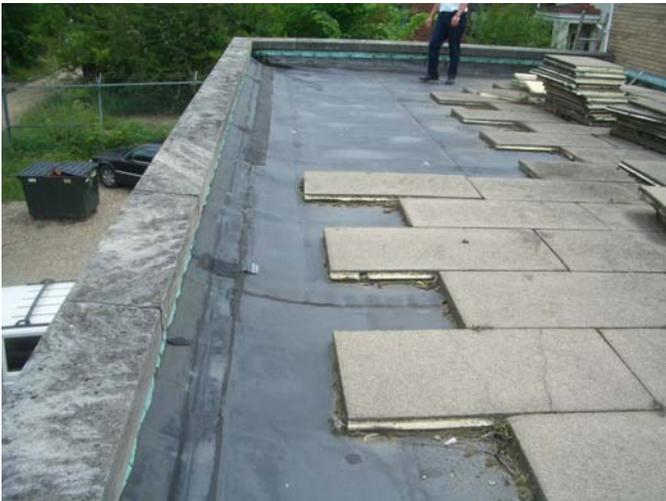
R-14 Low roof, bridged flashing at wall and displaced insulation

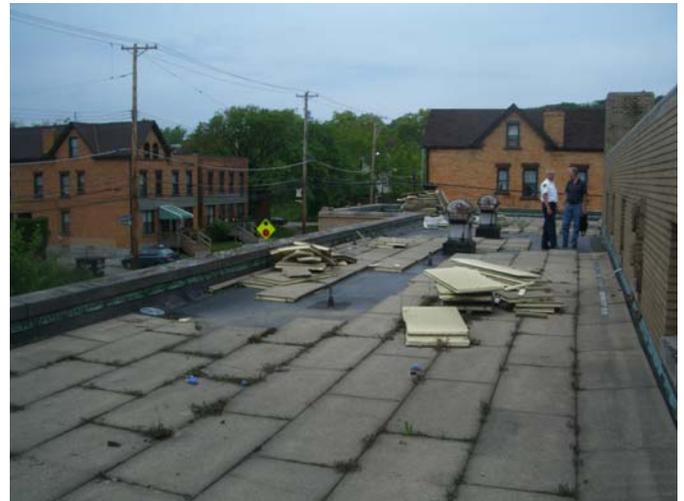
R-17 Low roof, displaced insulation vegetation

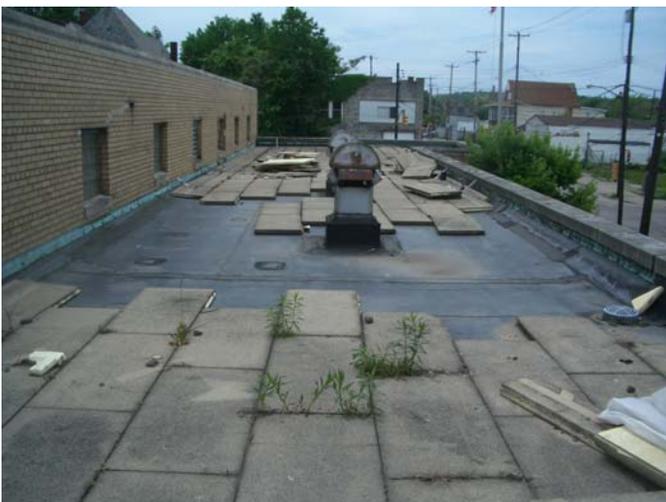
R-15 Low roof, displaced insulation, vegetation
