CITY OF
PITTSBURGH
FACILITY ANALYSIS REPORT

Firehouse #27 (B136)
90 Virginia Avenue
Pittsburgh, Pennsylvania 15205

July 7, 2010

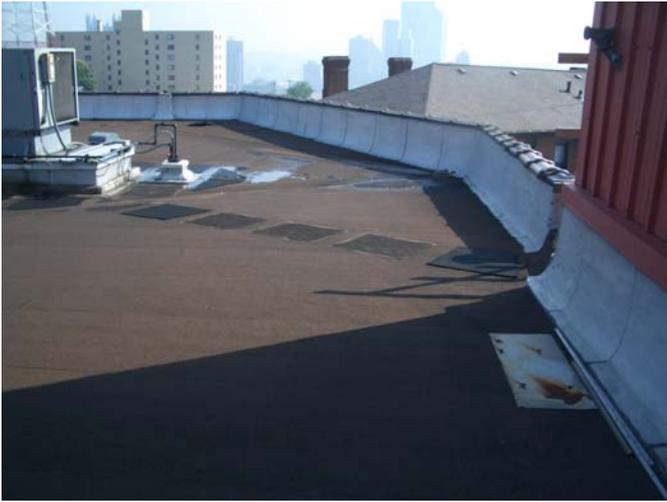
R-1 east wall looking north

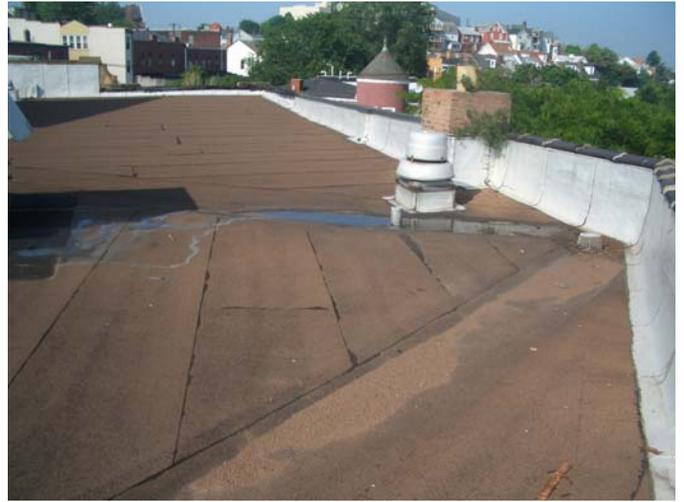
R-4 west wall looking south

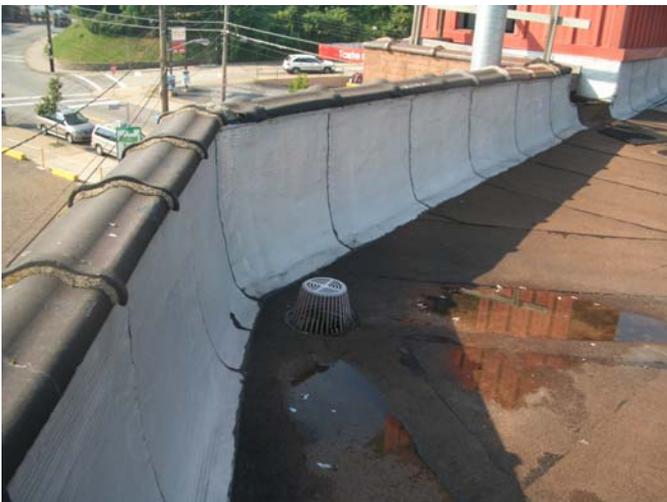
R-2 east wall looking south

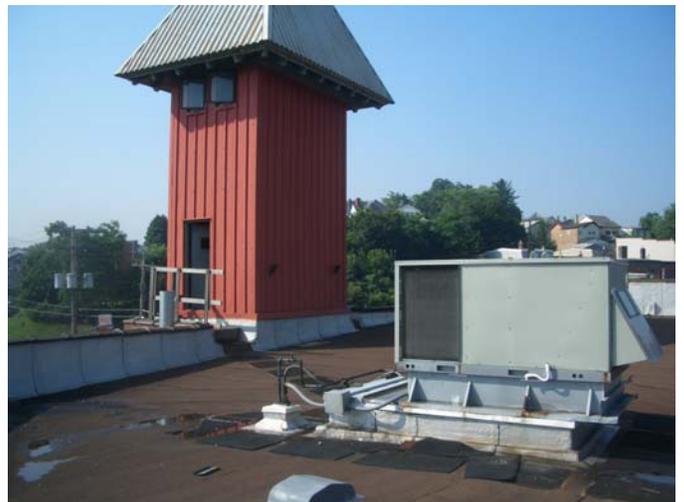
R-5 east wall, and hose tower

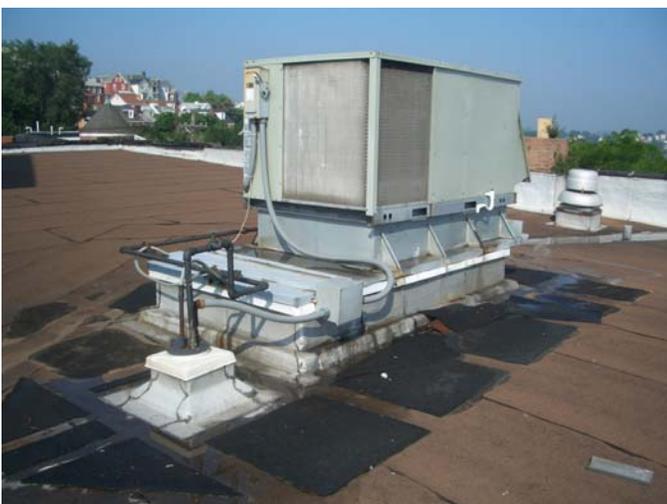
R-3 HVAC unit

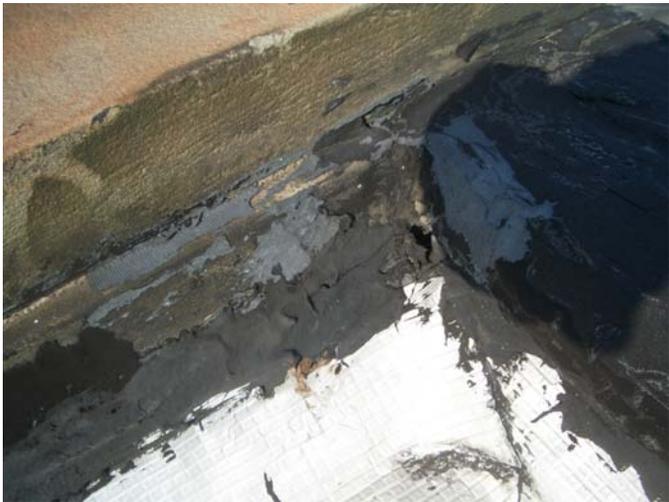
5.2 Condition: The flashing systems are in fair condition. A few repairs were observed. The flashing is loose from the wall, SW side and open at the top (metal term bar is loose).

R-11 Open flashing at SW corner

The roof membrane and flashing systems are in fair condition. Repairs to the flat roof should be limited to leak chasing. Repairs to the wall flashings should be done as soon as possible.

1 year: Repair wall flashings - Estimated Cost: \$800.00. Replace the walkway system - Estimated cost: \$800.00. Paint Metal roof panels - Estimated cost: \$12,000 (610 SF x \$20/SF). Maintain a pro-active maintenance program. Inspect the roof systems and walls on a regular schedule - minimum twice a year (late spring and late fall). Estimated cost: none (perform in-house).

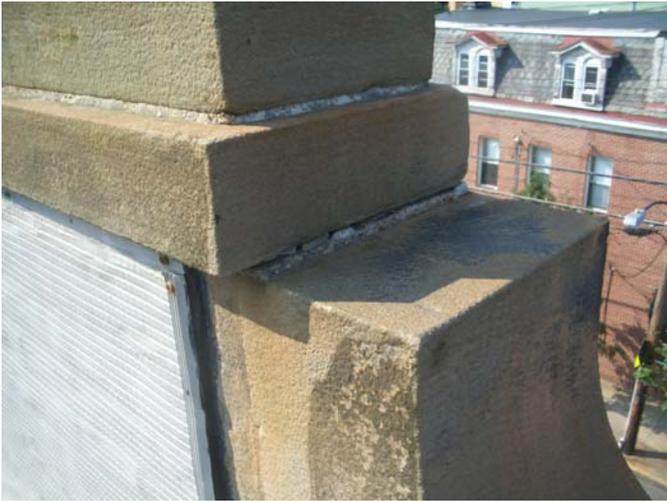
6.2 Condition: The stone coping is in fair condition. The caulking at the butt joints is aged. The cement in the coping bed joint is aged, deteriorated and falling out. The terra cotta tile coping is in fair condition. A few mortar joints are cracked and open. The metal coping is in good condition.

R-13 Open mortar joint on stone coping

The stone and tile coping systems are in fair condition. The mortar joints should be repaired. The roof top penetrations are in fair condition.

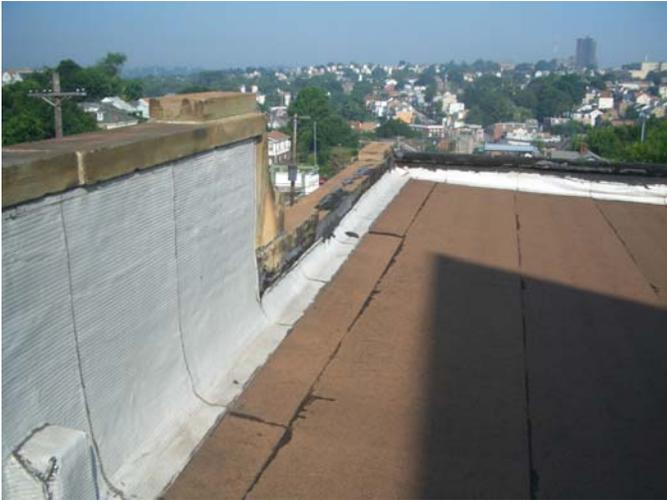
R-14 South (front) wall looking west

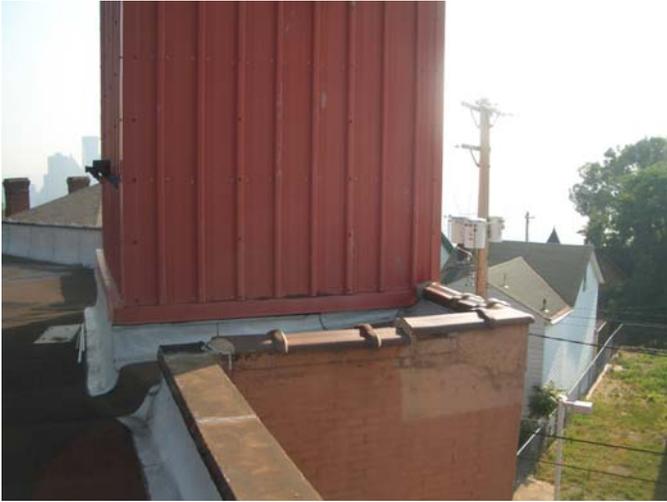
R-15 SE corner looking north

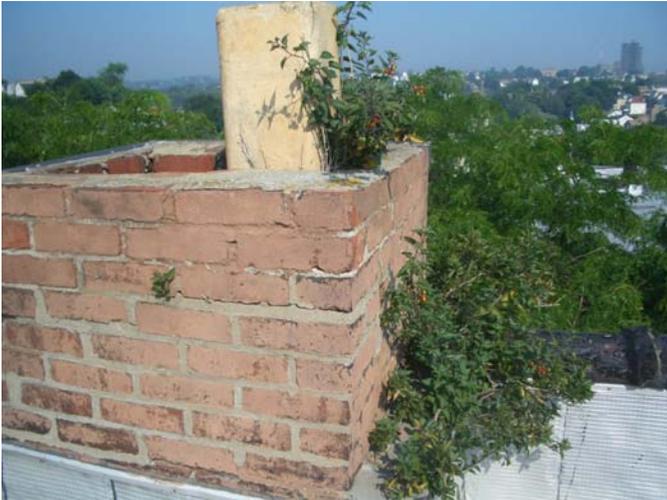
7.2 Condition: The penetrations are in fair condition. The chimney is in poor condition - some brick joints are cracked, the cement capping is cracked and loose, and plants are growing out of the chimney.

R-20 Plants growing in chimney

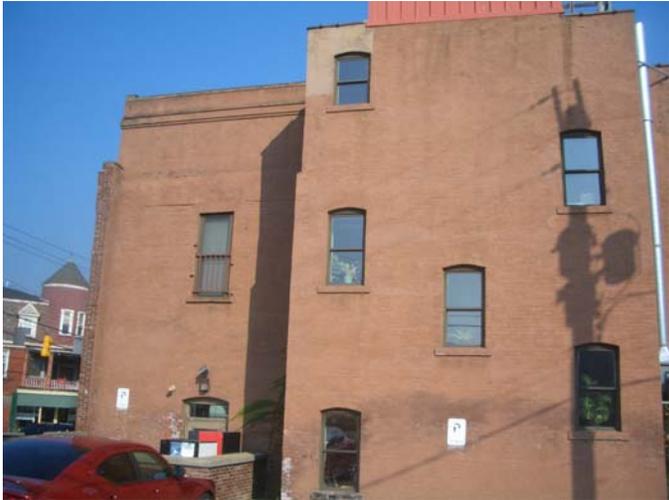
W-1 East wall

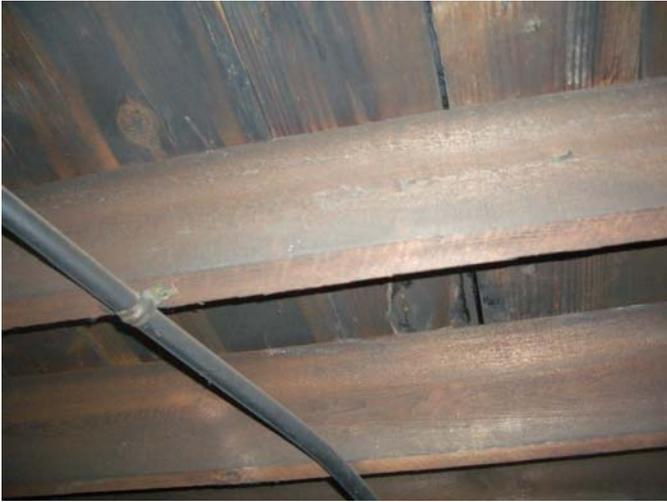
R-21 Wood deck and rafters

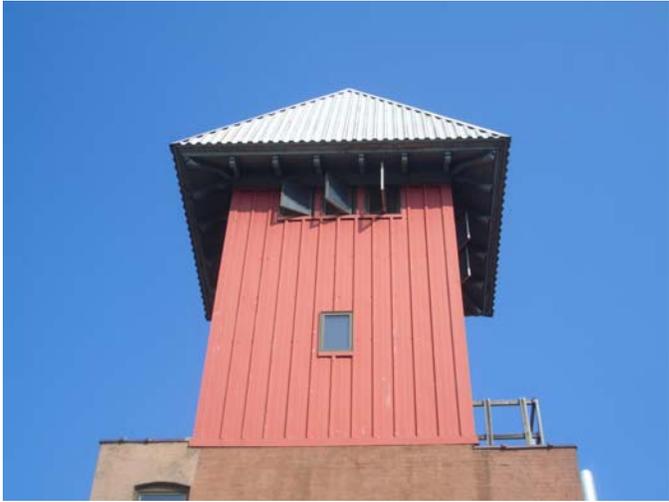
W-2 East side of Hose Tower

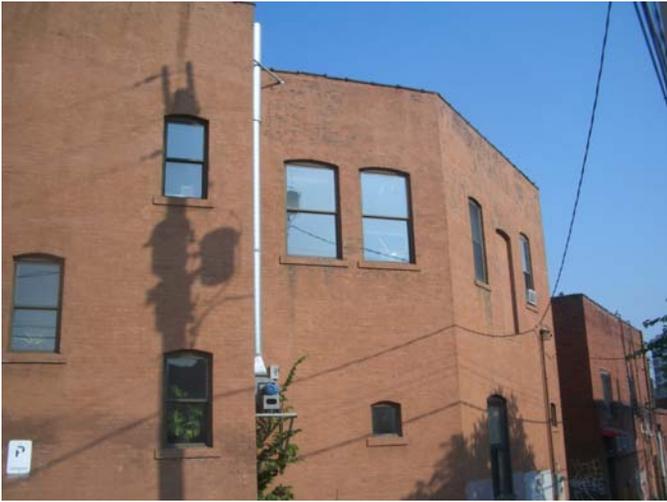
W-3 NE corner from east

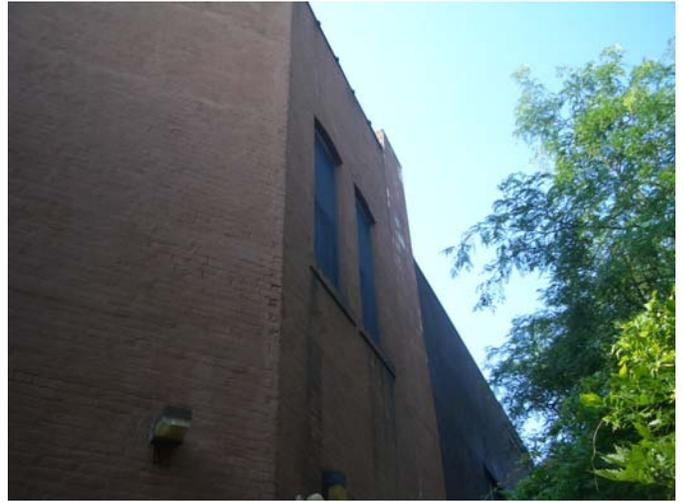
W-6 NW corner from north

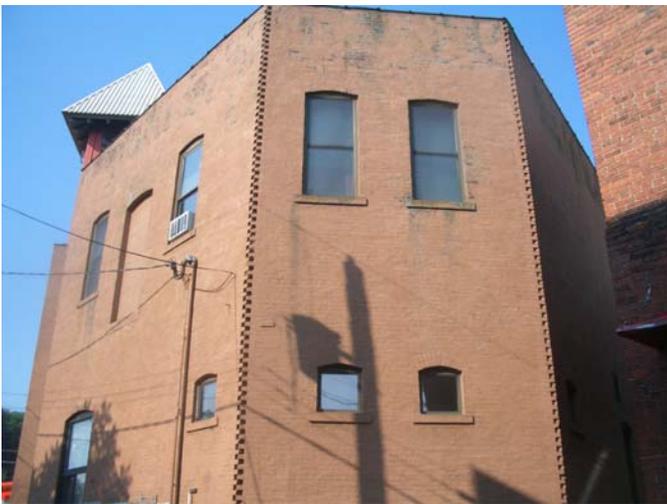
W-4 NE corner from north

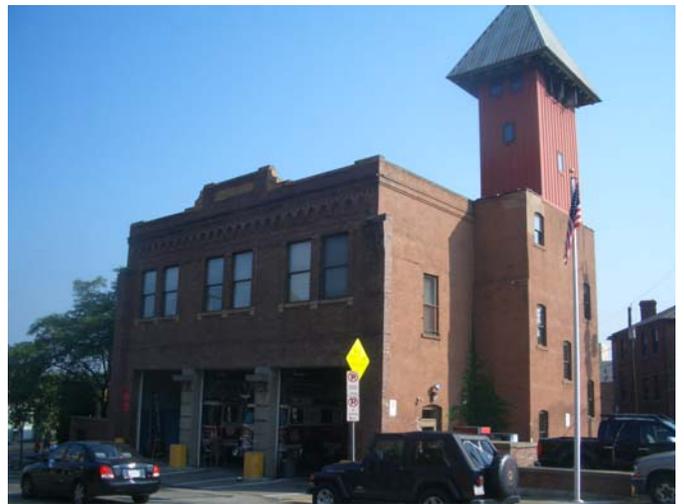
W-7 Front of building

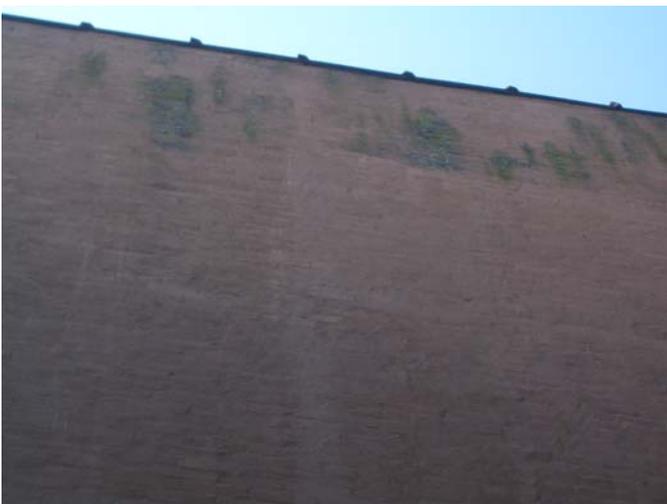
1.2 Condition: The building walls appear to be in fair condition. Some areas of cracked brick, deteriorated mortar and open/cracked masonry joints were observed. The painted surface is aging. Moss is growing on the north walls. The paint is peeling on the wood soffit under the metal roof on the hose tower (bare wood exposed). The paint is faded and peeling is a few areas on the metal panels installed on the Hose Tower.

W-5 North wall with moss growing

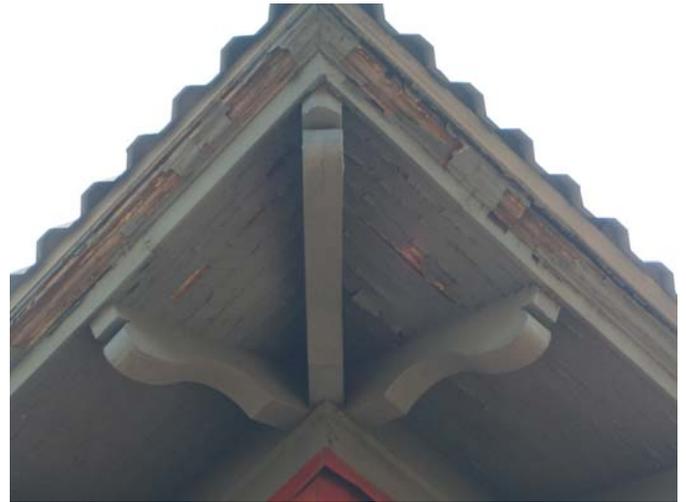
W-12 Peeling paint on eaves of Hose Tower roof

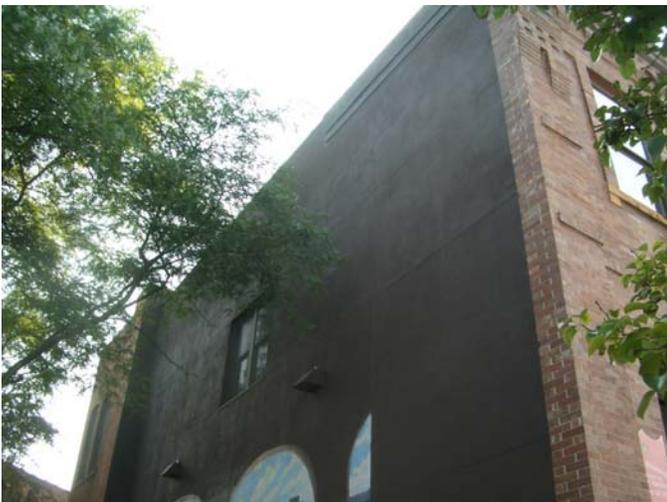
W-10 West wall

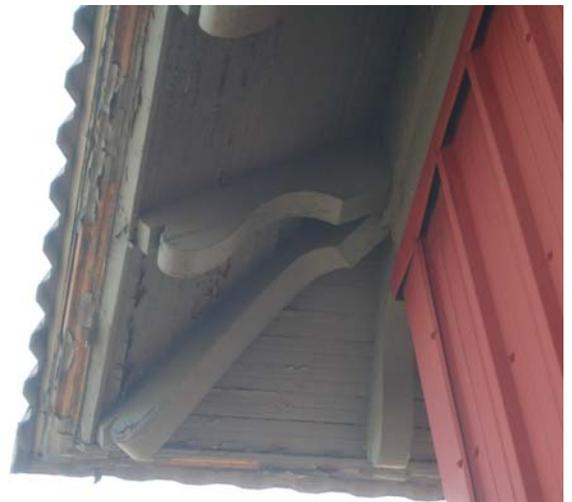
W-13 Peeling paint on eaves of Hose Tower roof

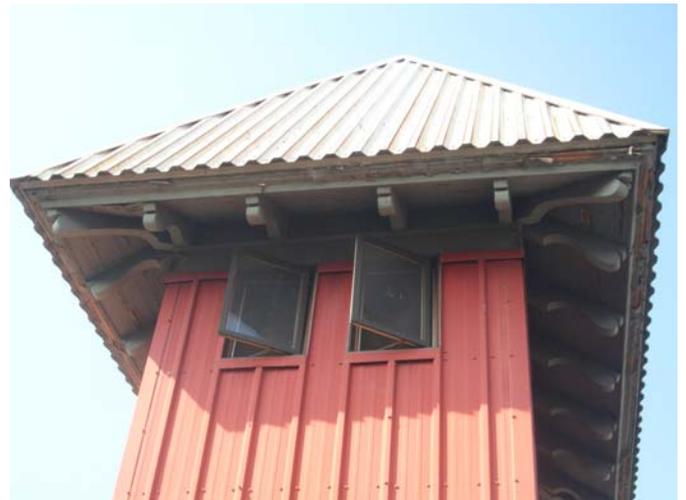
W-14 South side of Hose Tower

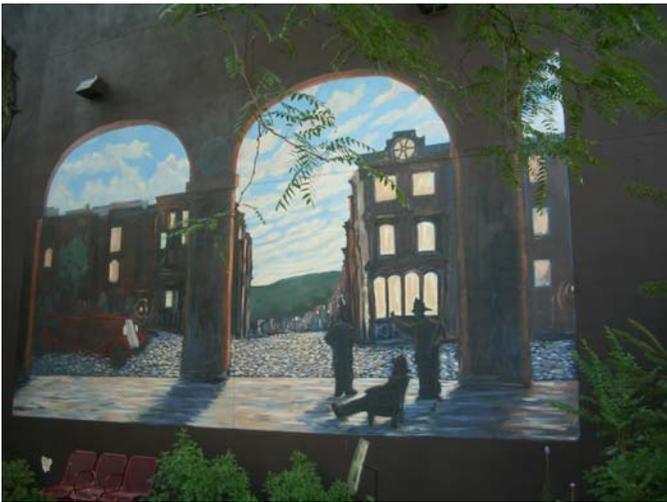
W-15 Mural on West wall in park

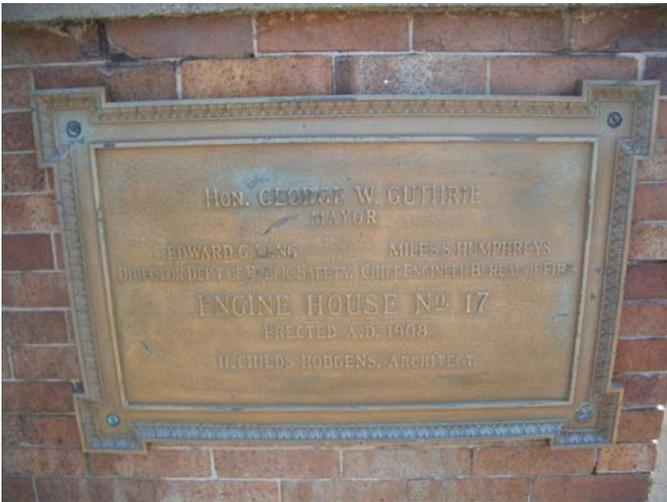
W-16 Bronze construction plaque
