CITY OF
PITTSBURGH
FACILITY ANALYSIS REPORT

Firehouse # 29 (B225)
2100 Noblestown Avenue
Pittsburgh, Pennsylvania 15205

July 2, 2010

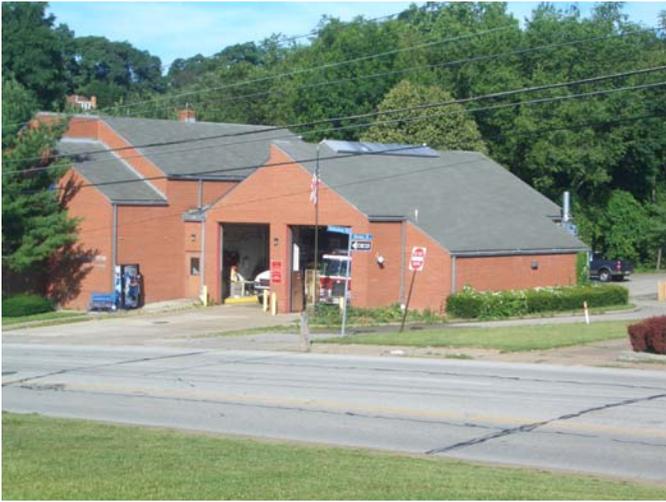
R-1 Overview of front and east roof areas

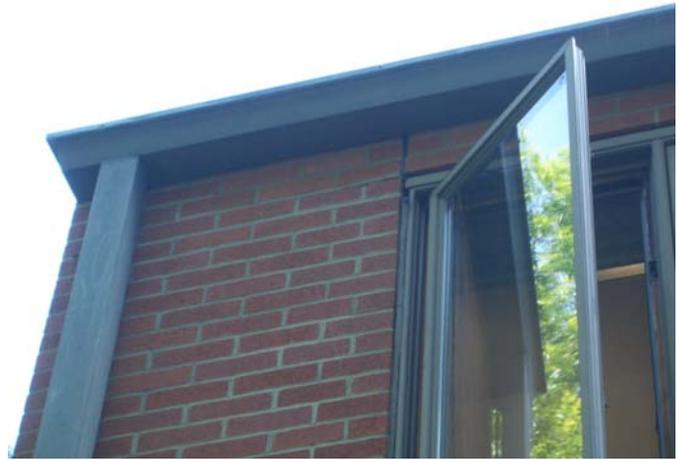
1.2 Condition: The building walls appear to be in good condition. Some areas of cracked and open caulking was observed at the windows.

R-4 Gutter and downspout system, caulking at window is open NW corner

10.1 The caulking and sealants appear to be original construction and are aged, cracked and open. The brick walls are in good condition. The caulking and sealants should be replaced and the skylight should be repaired to maintain water tight integrity.

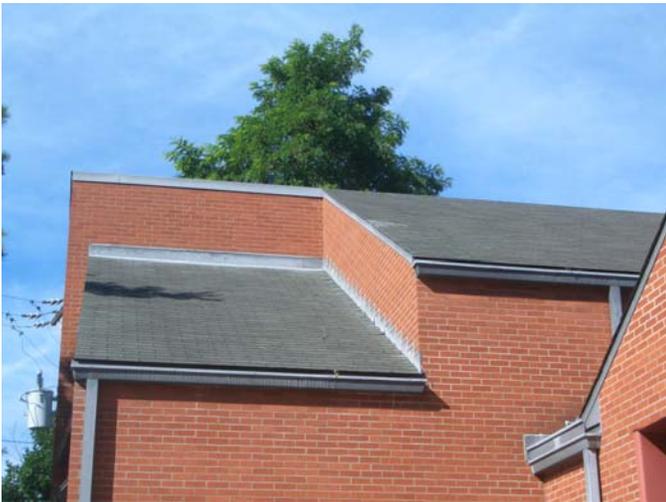
R-2 Counter, step, fascia and gutter systems

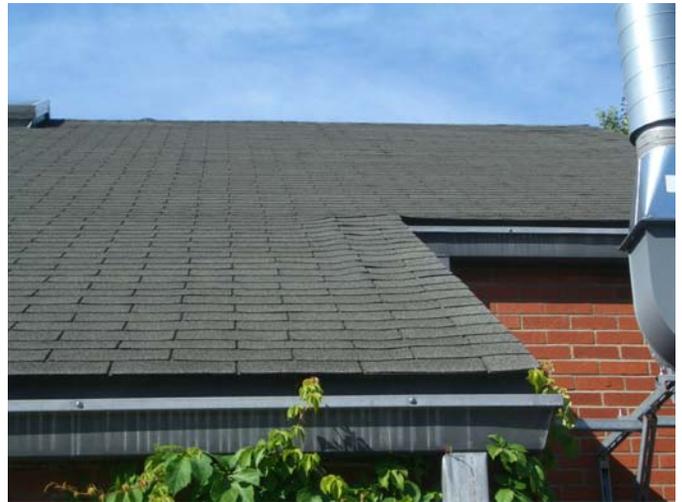
R-5 East side, shingle corners lifting at the rake

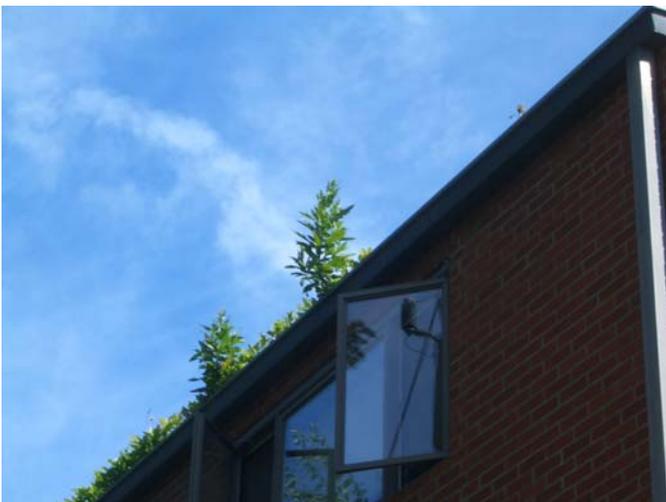
8.2 Condition: The drainage system appears to be operating properly in most areas. Some gutters contain debris. The gutter on the south west corner (left front) is full of plant growth and is a cause of reported leaks in the windows below.

R-3 Plants growing in gutter on SW corner (left front)

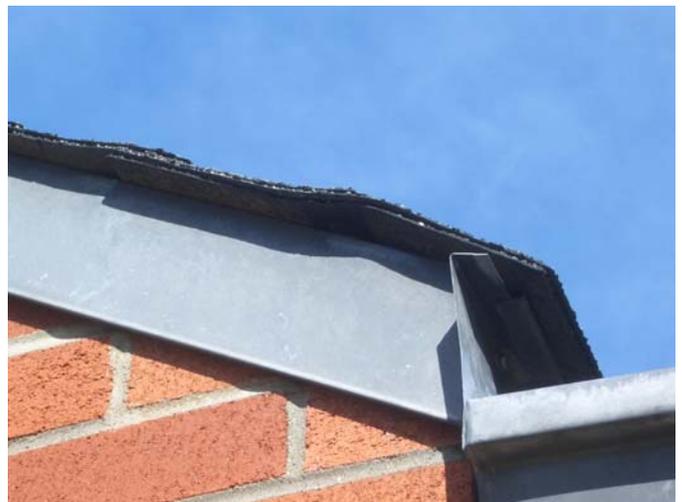
R-6 Shingle installation at eave showing starter course with inverted shingle

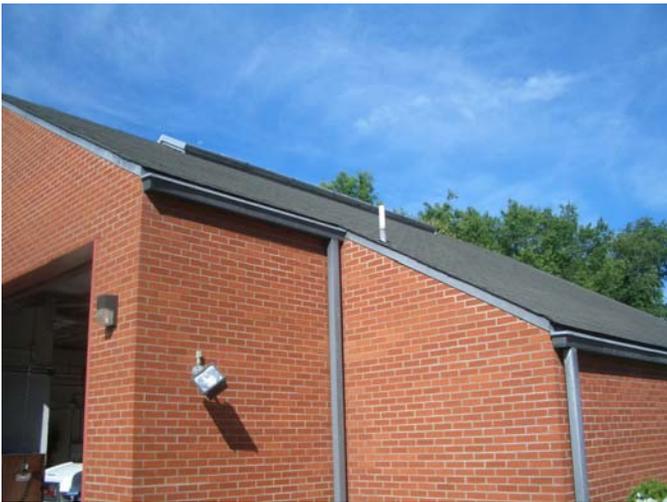
R-7 East side, gutter and downspouts

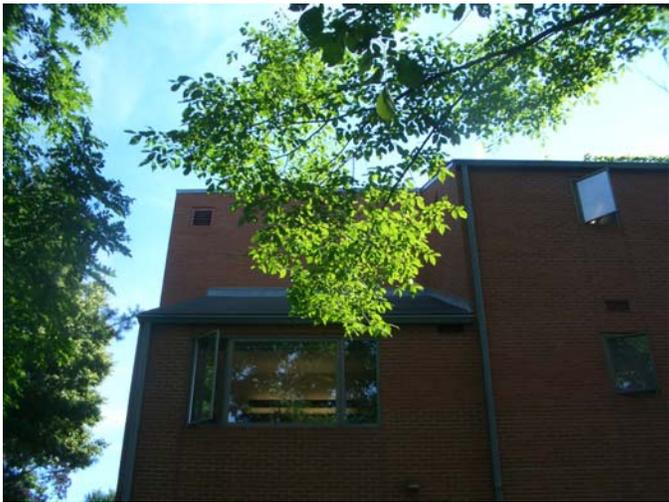
R-10 NW corner, elevation changes

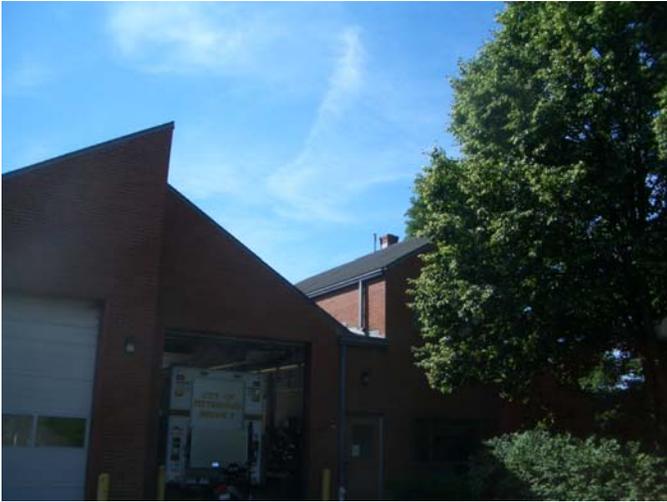
R-8 North side (rear), elevation changes

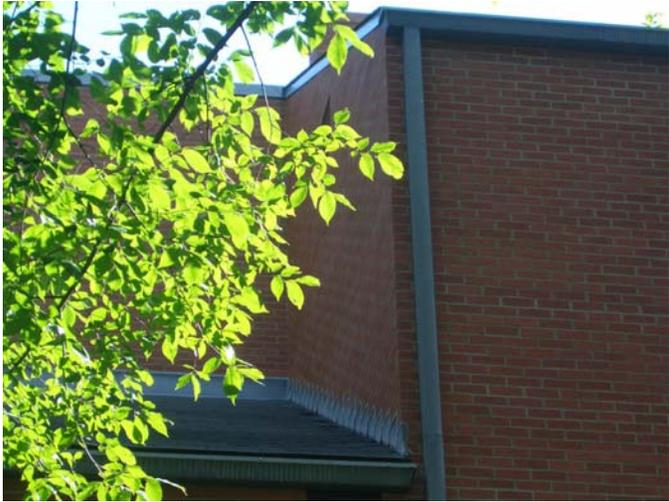
R-11 NW corner, counter and step flashing on lower area

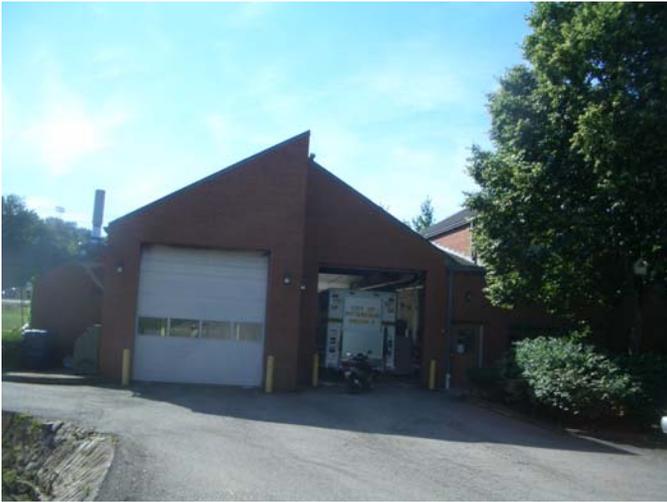
R-9 North side (rear), elevation changes

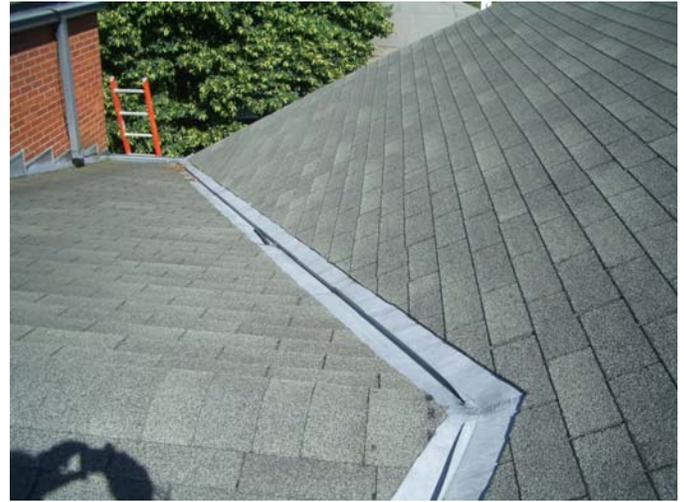
R-16 Valley flashing

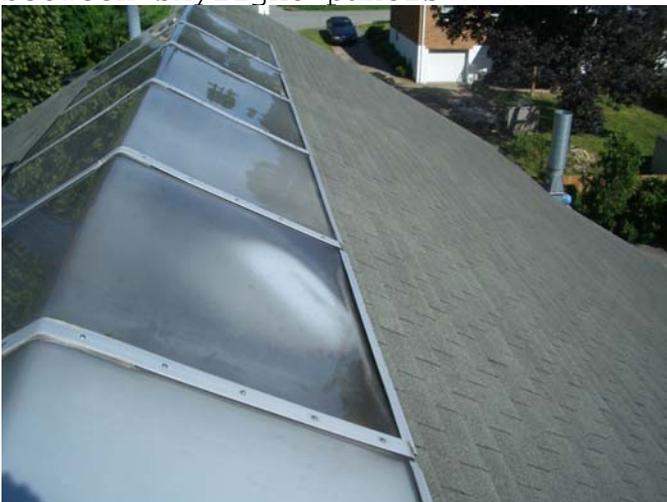
7.2 Condition: The pipe penetrations are in good condition. The skylight is in poor condition - the metal edge trim is loose and the foam seals are falling out.

R-14 Dirty and deflected panels in skylight (east side) of truck bay

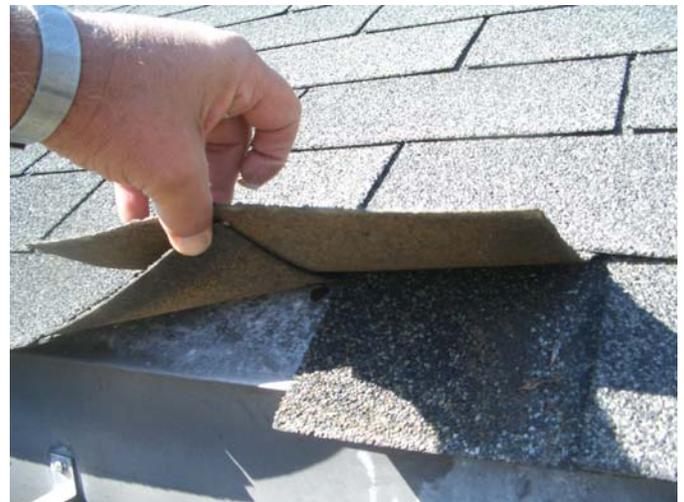
R-17 Shingle installation at eave showing inverted shingle used as starter

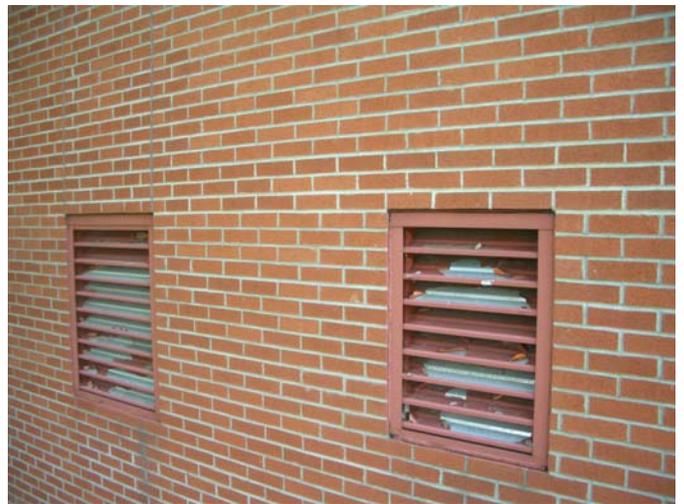
W-3 Paint peeling at louvers on west wall
