CITY OF
PITTSBURGH
FACILITY ANALYSIS REPORT

Firehouse #32 (B140)
900 Spring Garden Avenue
Pittsburgh, Pennsylvania 15212

July 9, 2010

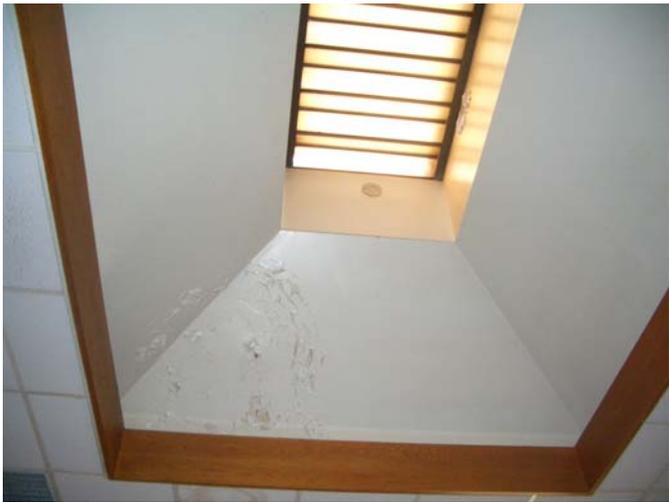
R-4 Underside of skylight, peeling paint and stains from leaks

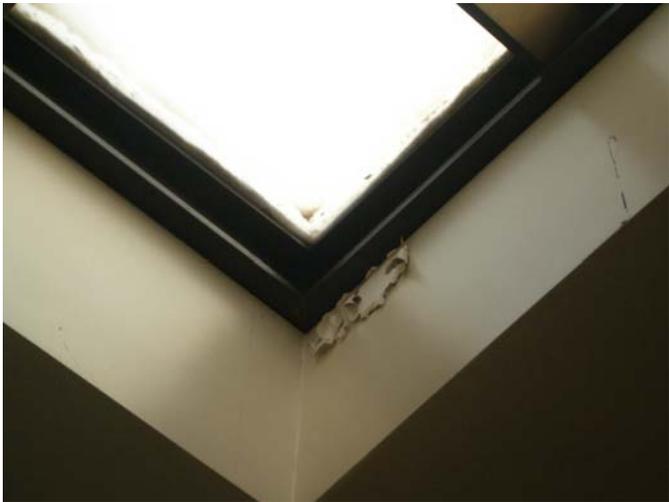
R-5 Underside of skylight, peeling paint from leaks

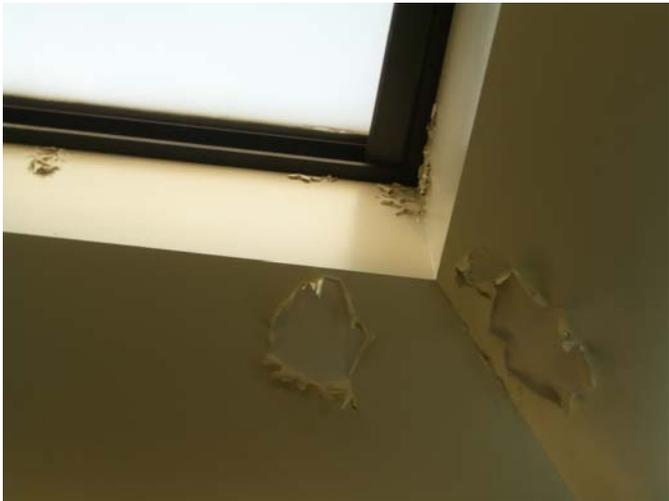
R-6 Underside of skylight, peeling paint from leaks

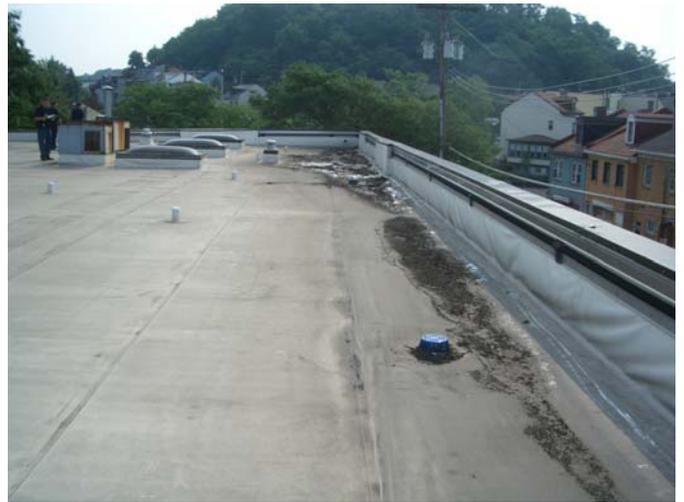
8.2 Condition: The drainage system appears to be operating properly. Debris on the roof clogs the drain strainers causing ponding water.

R-10 South wall from the SW corner
Debris at low points

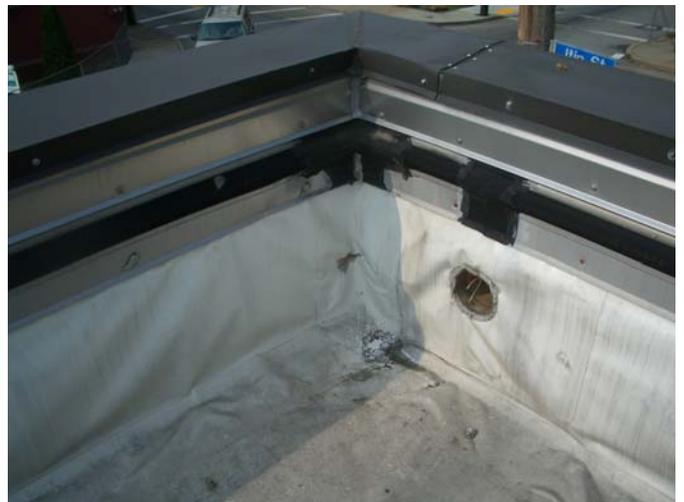
R-11 Overflow drain in SW corner of
parapet wall

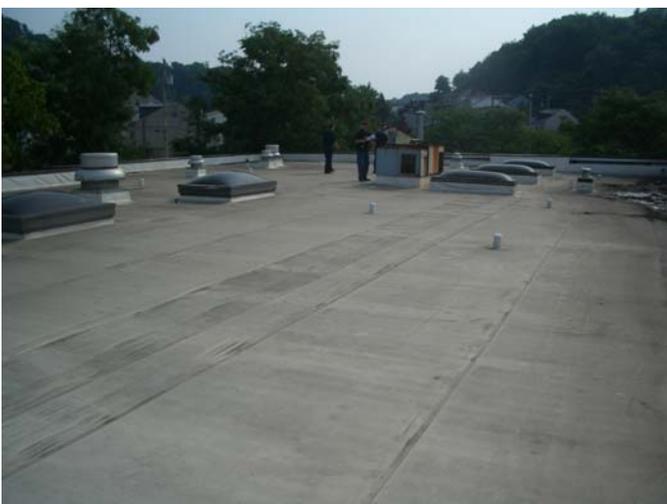
R-9 Looking west from SW corner

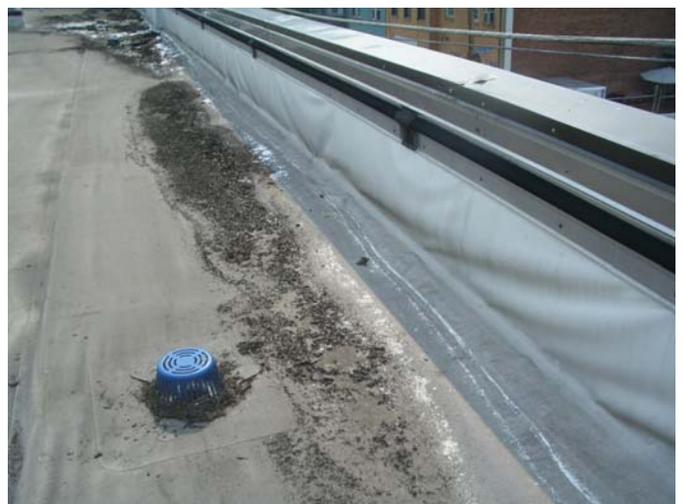
R-12 Roof drain with debris
clogging the strainer

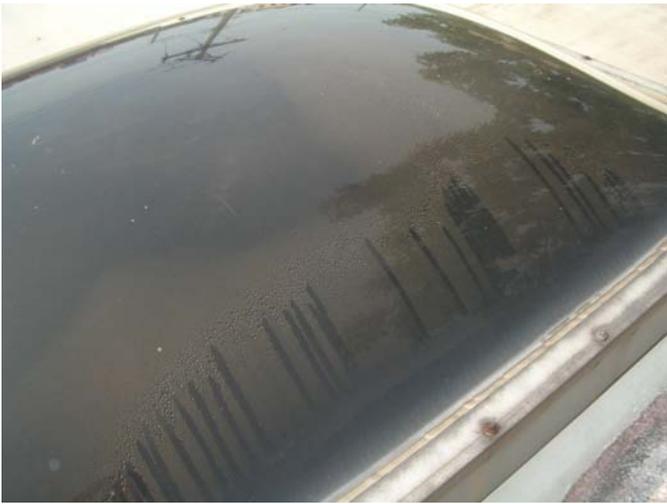
R-13 Condensation in skylight

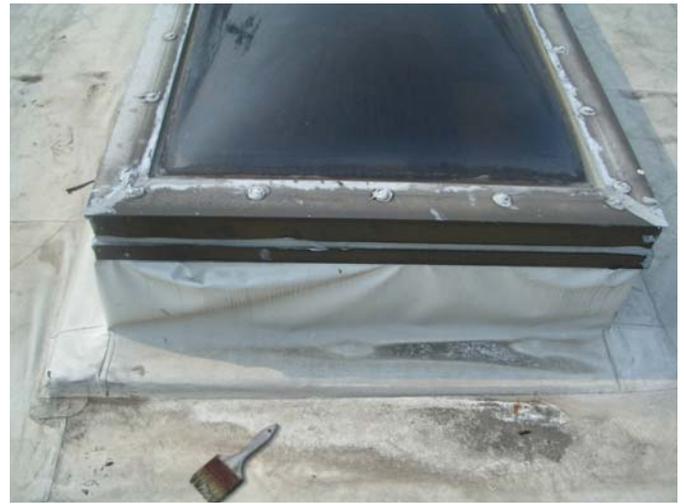
R-16 Skylight with caulking and typical curb flashing

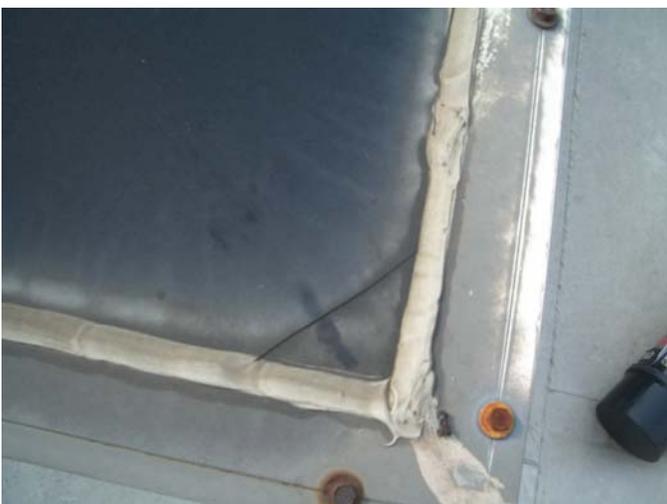
R-14 Caulking on top of skylight instead of opening built in drains

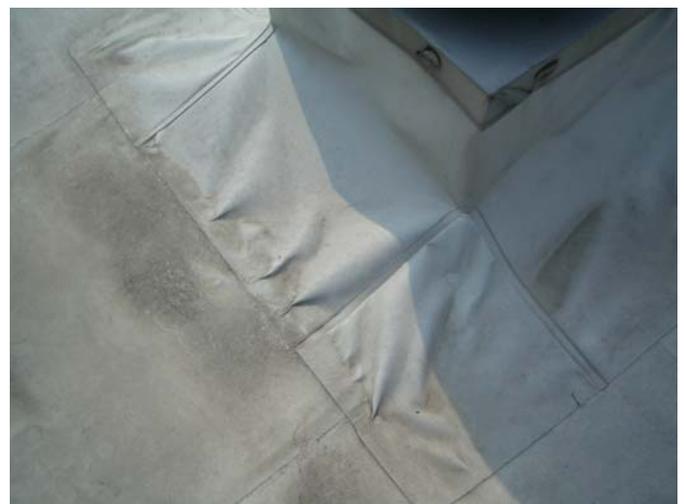
R-18 Typical flashing installation

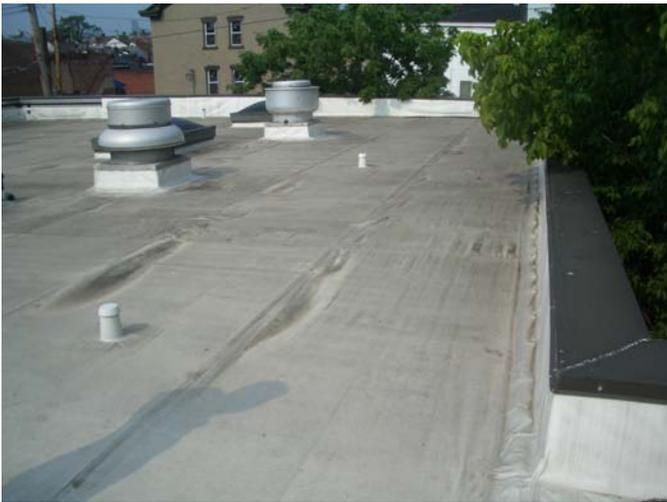
R-19 North wall from NE corner

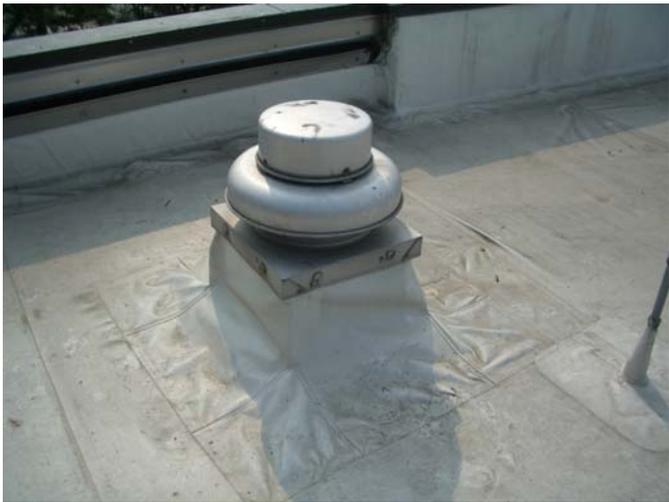
R-22 Wrinkled flashing at exhaust fan, typical

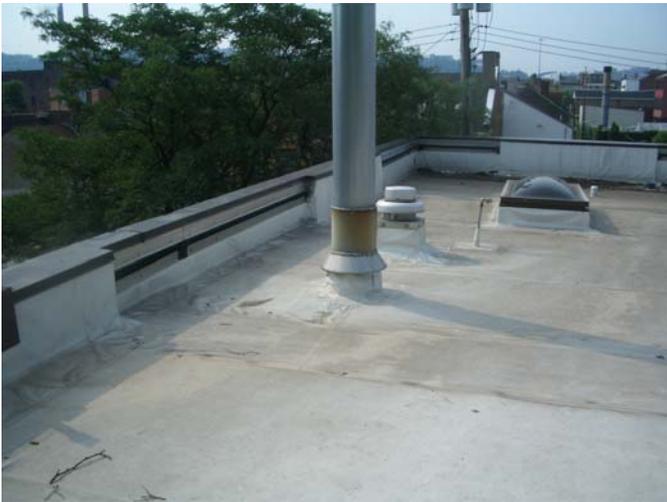
R-20 East wall from NE corner

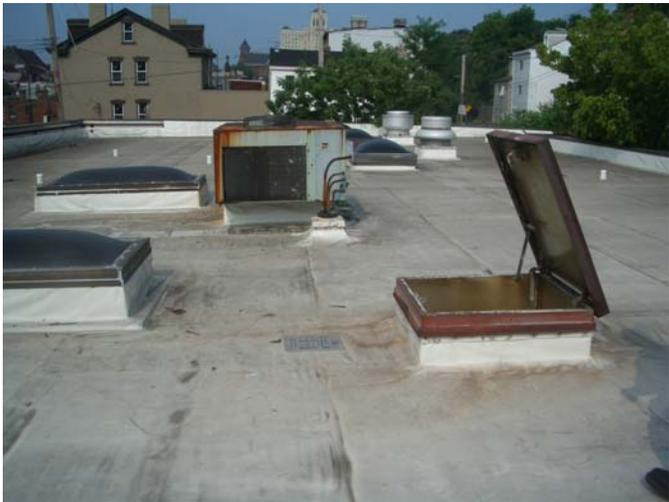
R-23 Middle of roof from east wall, HVAC unit not level, installed with slope of roof

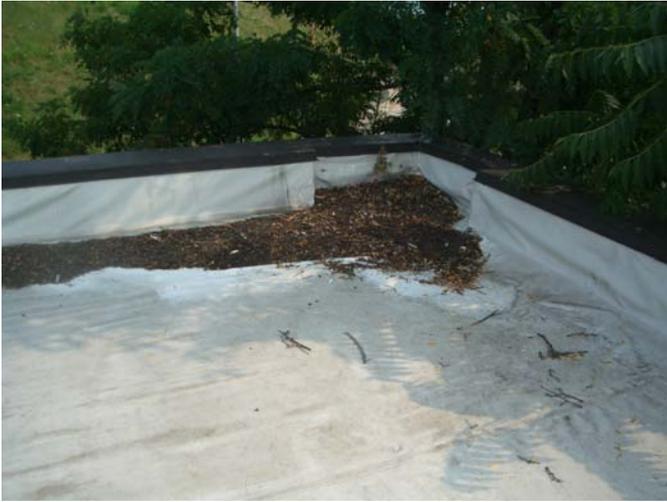
R-21 Debris in NE corner

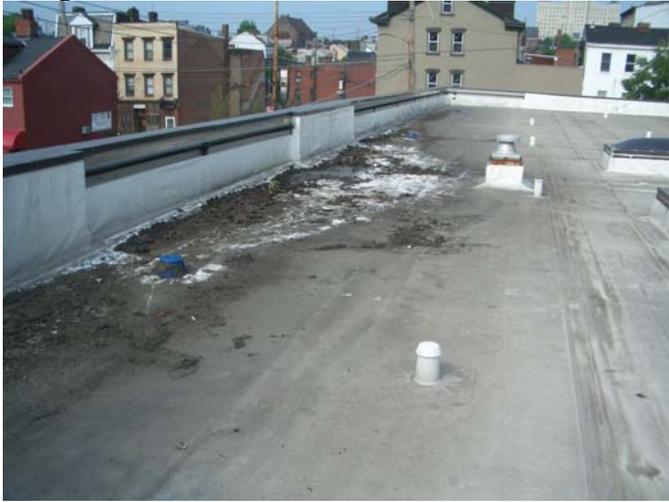
R-24 Debris along south wall

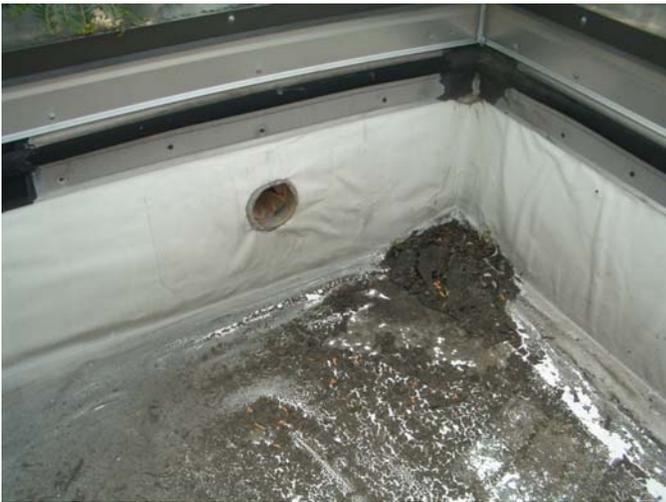
R-25 Debris in SE corner, overflow scupper

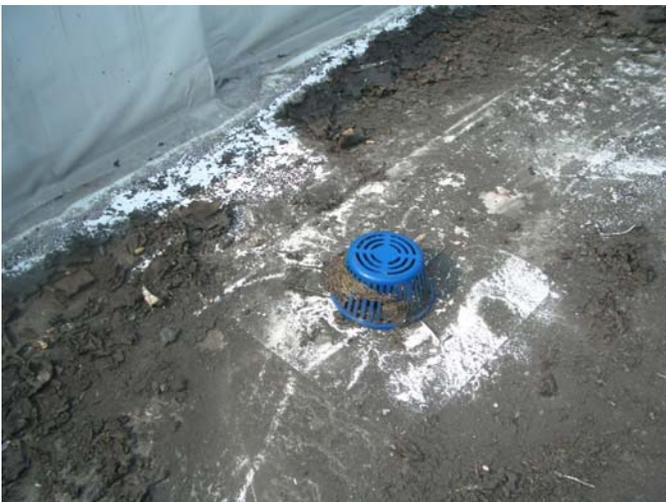
R-26 Debris at roof drain

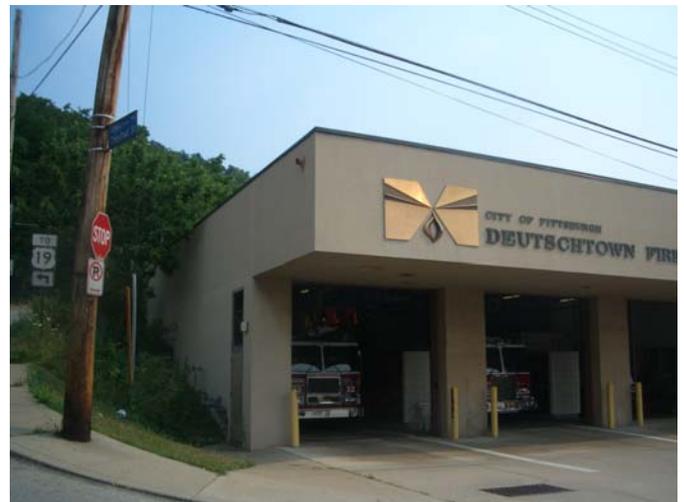
W-1 SW corner of building

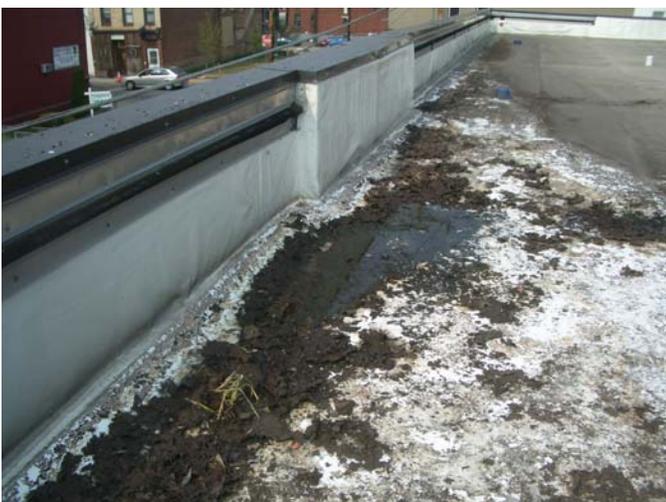
R-27 Debris at south wall with ponding water

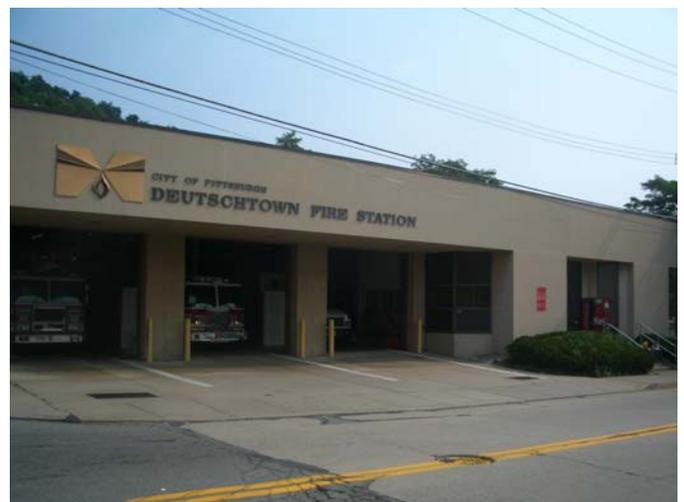
W-2 Front of building

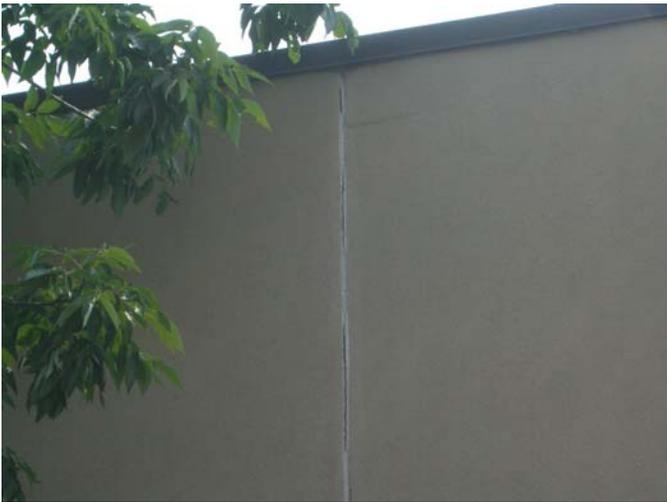
W-3 Cracked caulking on EIFS joint on west wall

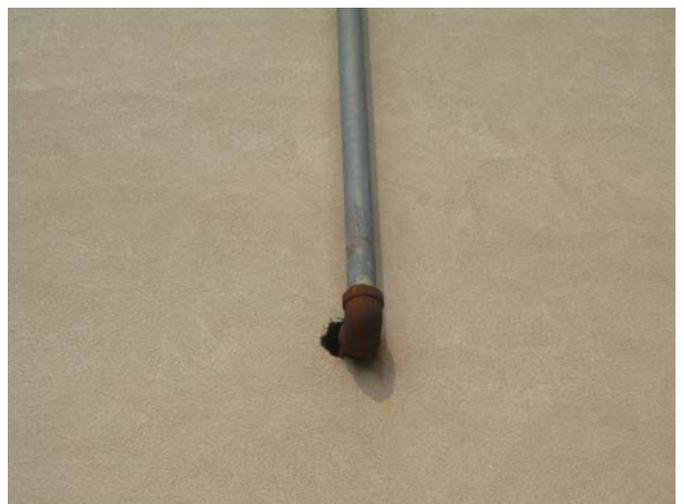
W-8 Pipe penetration not sealed on east wall
