CITY OF
PITTSBURGH
FACILITY ANALYSIS REPORT

Firehouse #37 (B144)
1124 West North Avenue
Pittsburgh, Pennsylvania 15233

June 30, 2010

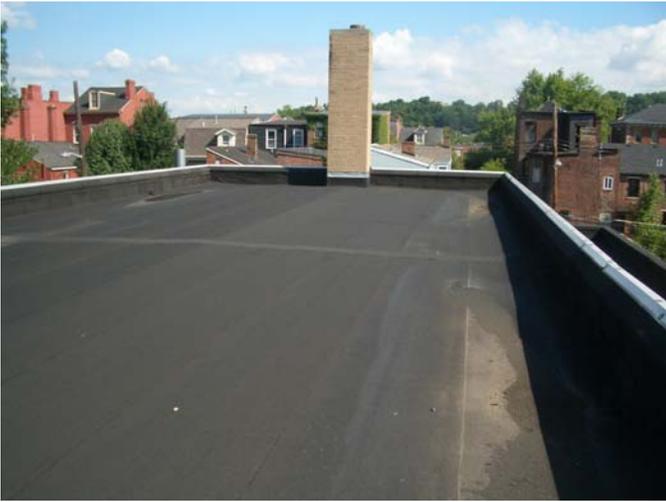
R-1 Truck bay roof looking west

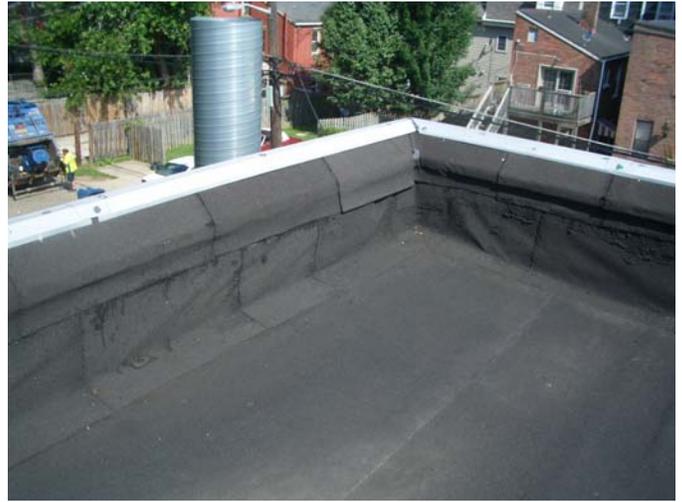
5.2 Condition: The flashing systems are in fair condition. Some repairs and patches were observed. In some areas the flashing is loose from the walls. The flashing is buckled at most corners. Some vertical joints in the buckled areas are open.

R-4 Truck bay, buckled flashing on NE corner

1 year: Contact the roofing manufacturer (US Intec) for flashing repairs under the warranty terms. Estimated cost: None - warranty claim **NOTE: The building walls should be addressed in order to maintain the structural integrity.**

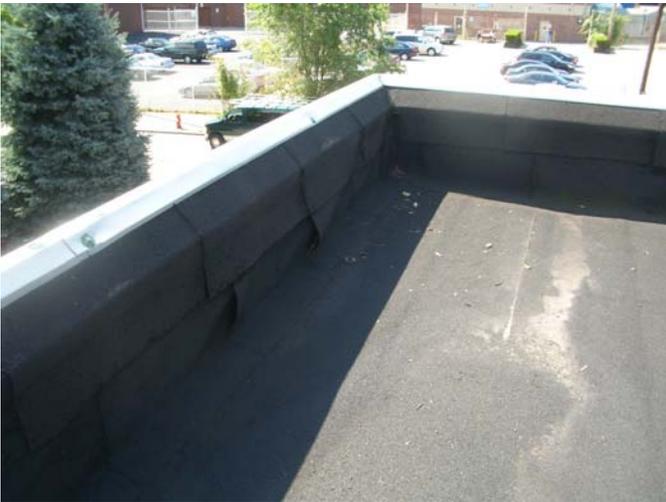
R-2 Truck bay SE corner, buckled and open flashing

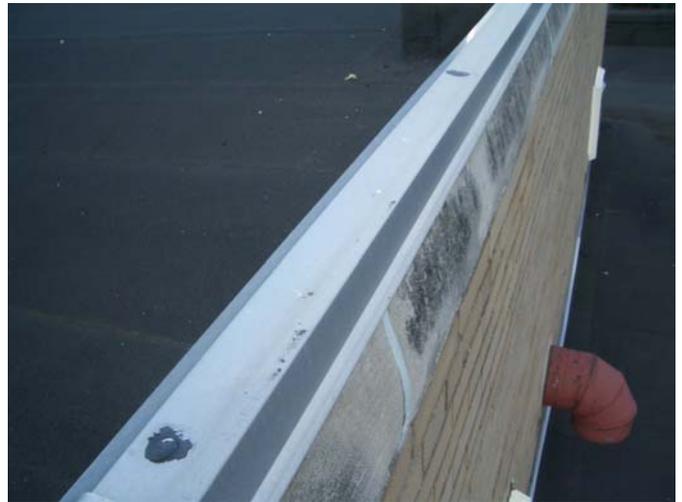
R-5 Truck bay, metal edge termination on coping stone

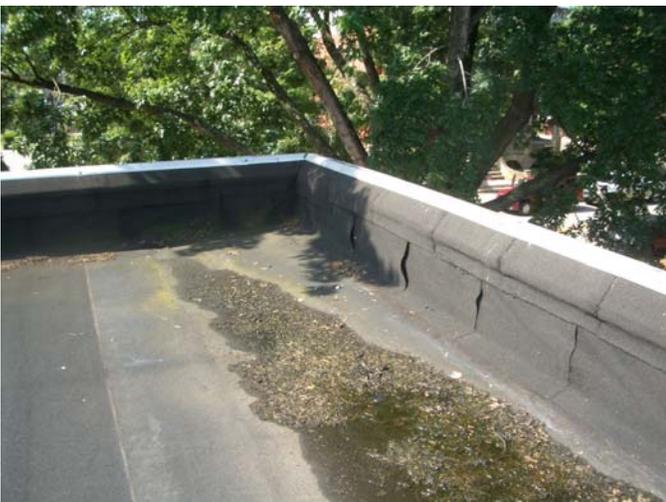
R-3 Truck bay SW corner, buckled and open flashing

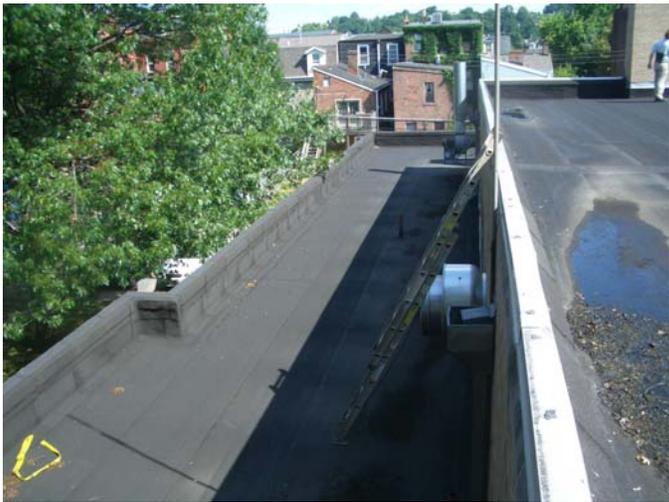
R-10 Main roof, west side

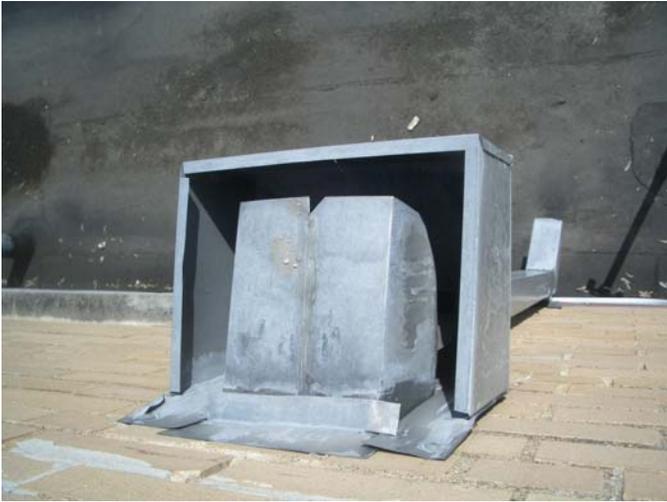
R-8 Truck bay, scupper, conductor head and downspout to main roof

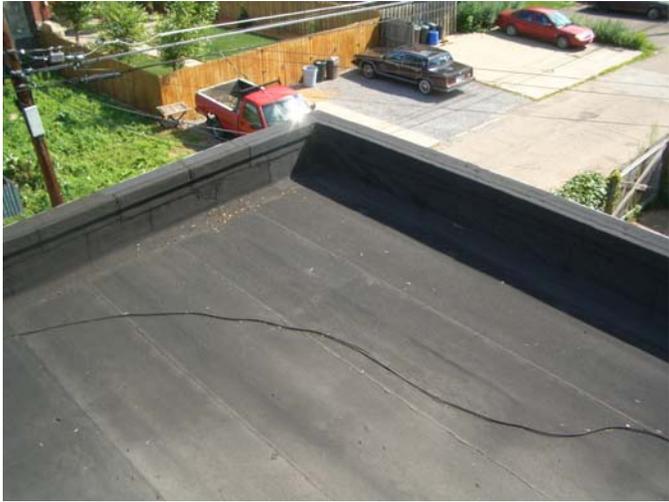
R-11 Main roof, NE corner

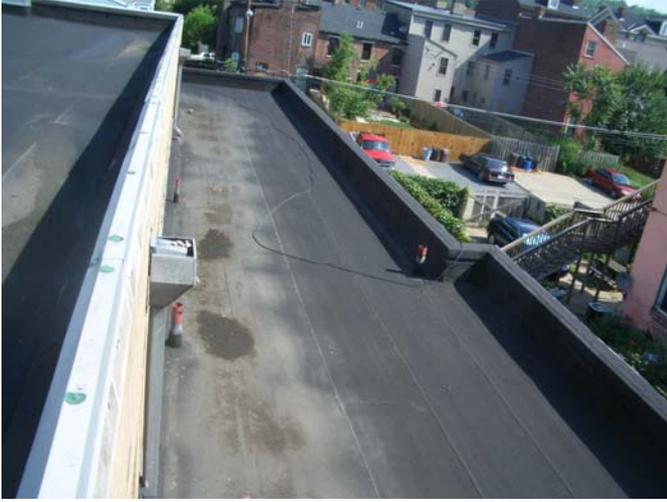
R-9 Main roof, east side

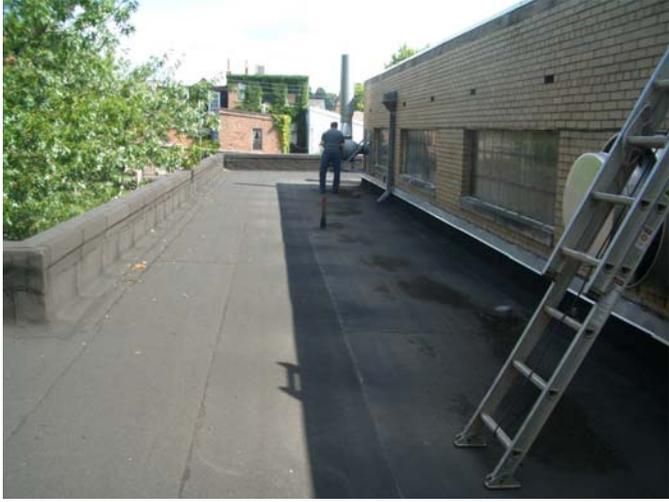
R-12 Main roof, west side looking north

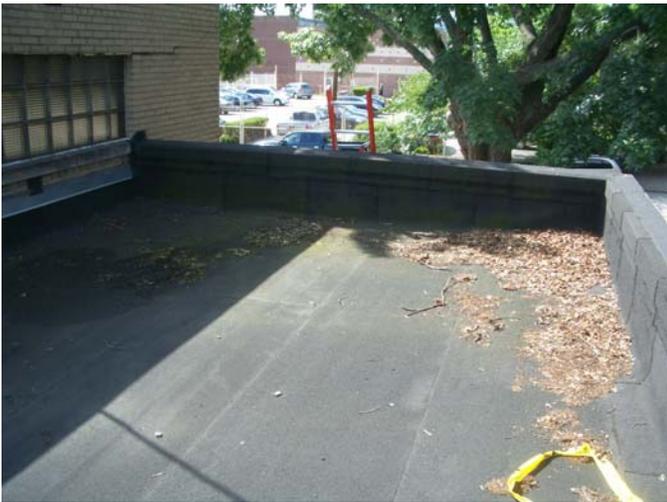
R-13 Main roof, debris at SW end

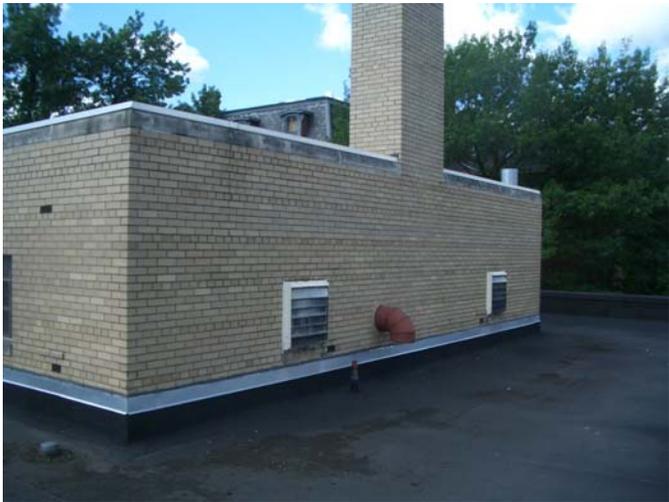
R-17 Main roof, north end

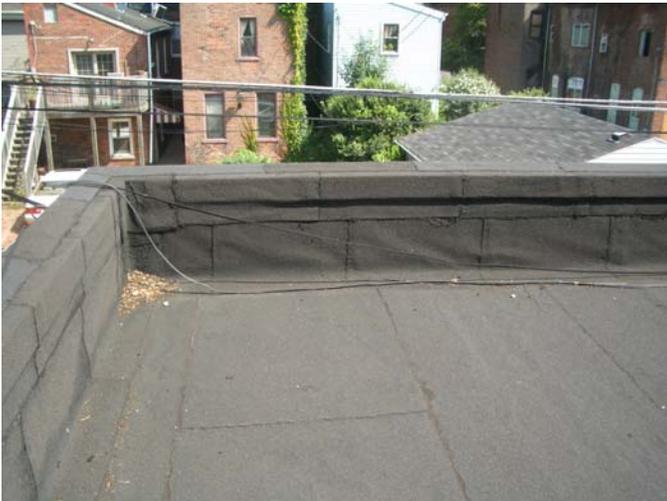
R-15 Main roof, buckled flashing at NW corner

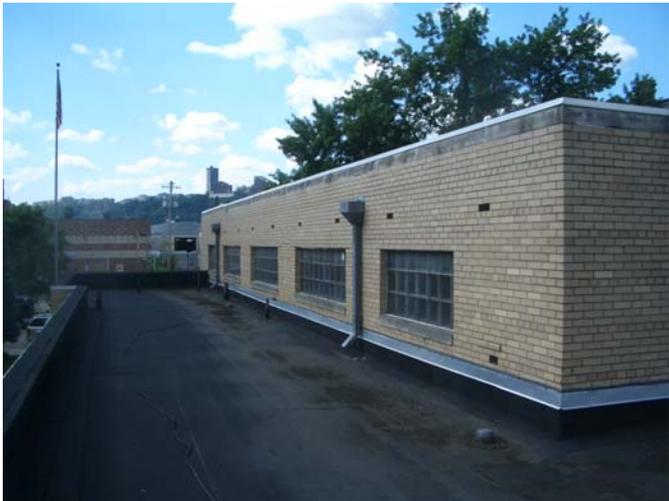
R-18 Main roof, east side looking south

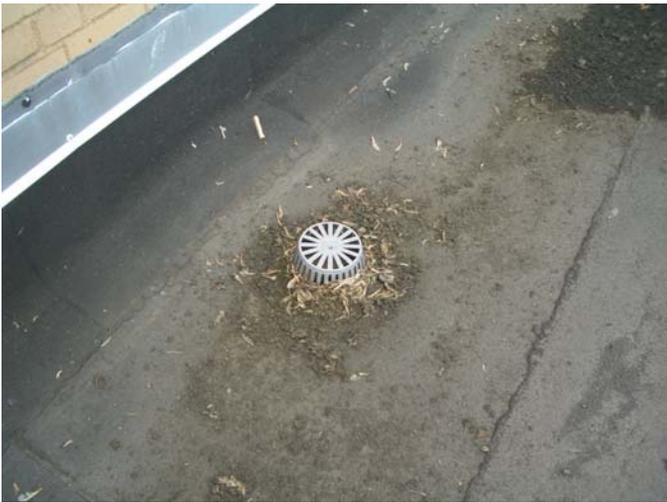
R-19 Main roof, interior roof drain, debris, east side

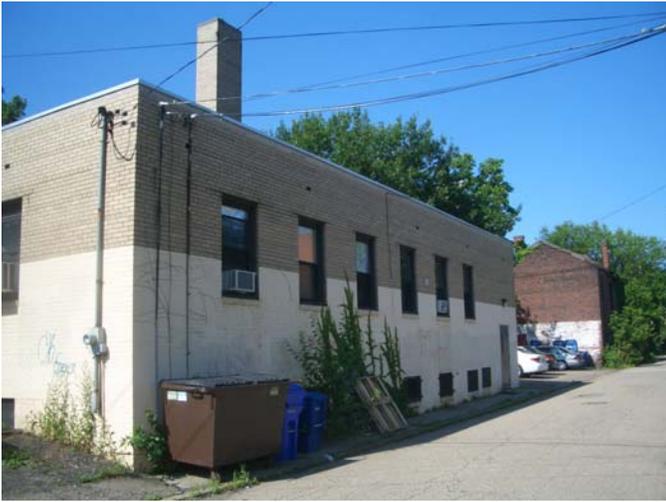
W-6 SE corner and east wall

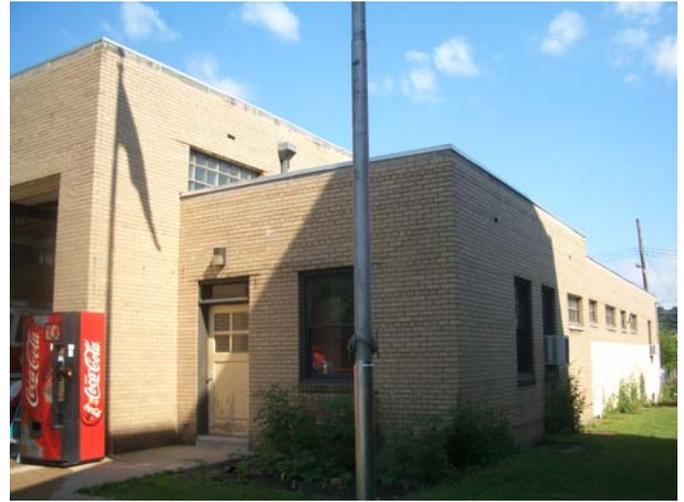
W-4 East wall

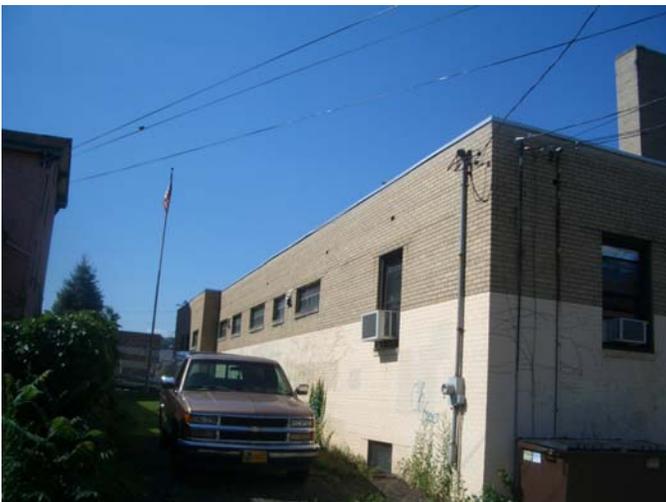
W-7 Cracks in brick and wall blister at SW corner of Truck bay

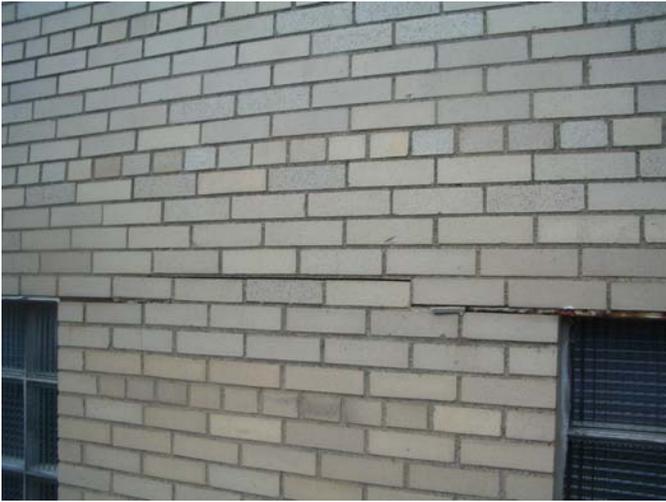
W-12 Truck bay, SE corner, open mortar joints

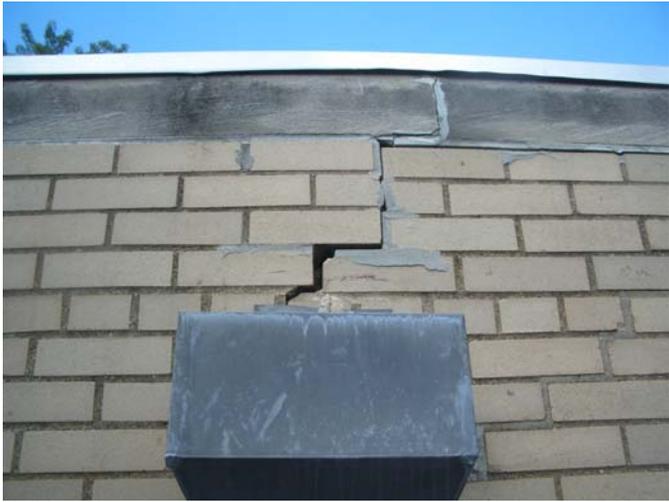
W-10 Truck bay SE corner, open mortar joints

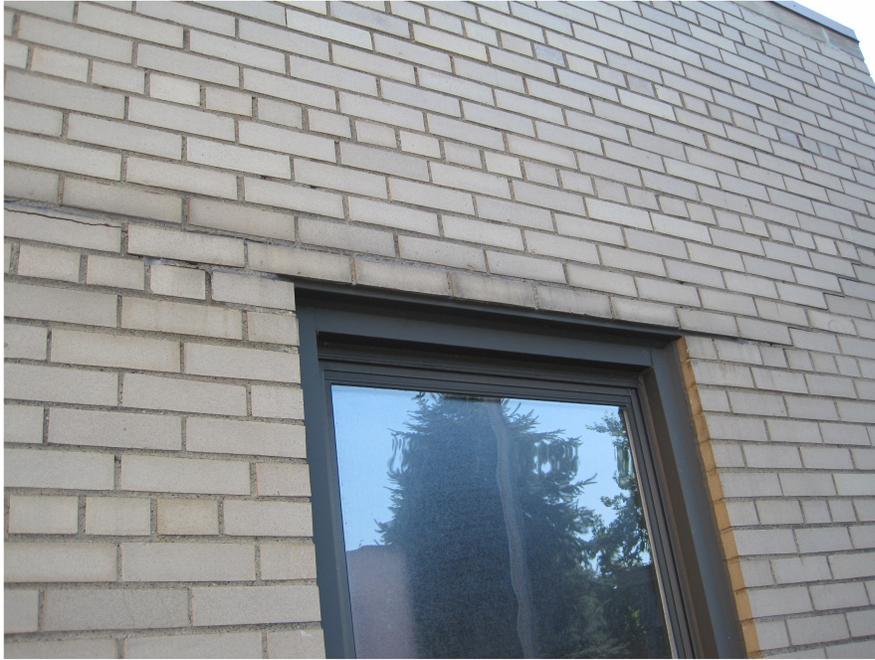
Photo S1

- 1) Repoint step cracks at windows & paint steel lintels (1yr) **(Photo S1)**
- 2) Clean and paint area way grating (1yr) **(Photo S2)**
- 3) Remove vines @ southwest corner (1yr)
- 4) Replace lintels at 10 high bay windows. 10 steel angle lintels at 7 ft each and 30 sf of brick removal and replacement at each location. (1yr) **(Photo S3)**
- 5) Reflash scupper @ southeast corner of high bay (1yr) **(Photo S4)**
- 6) Rebuilt parapet at southwest corner of high bay - approx 80 sf (1yr) **(Photo S5)**
- 7) Remove non-breathable sealants and caulking at lintels. These materials trap water and accelerate deterioration. clean and paint exposed steel. (1yr) **(Photo S6)**
- 8) Repoint chimney (5yr)
