CITY OF
PITTSBURGH
PROPERTY CONDITION REPORT

B150 – Medic 4
Federal & Lafayette Streets
Pittsburgh, Pennsylvania 15214

June 2014

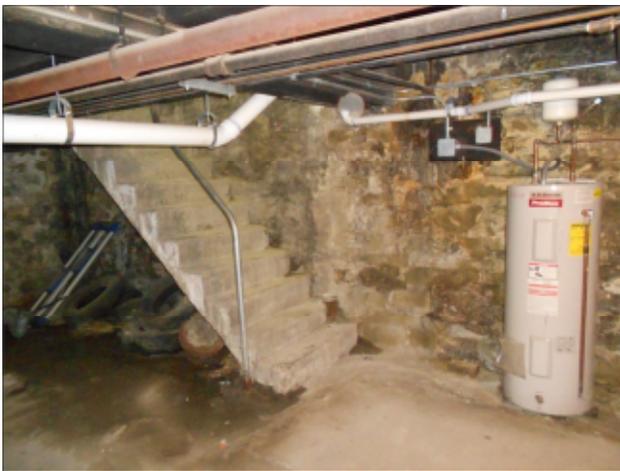
1. Foundation is stone masonry- Good condition
2. Slab on grade: The basement floor slab has areas of light cracking and is in Fair condition.

SS1 – Basement floor and stair

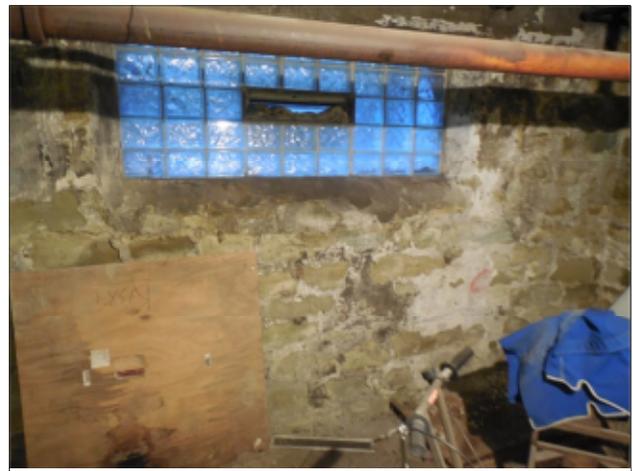
SS2 – Typical foundation wall

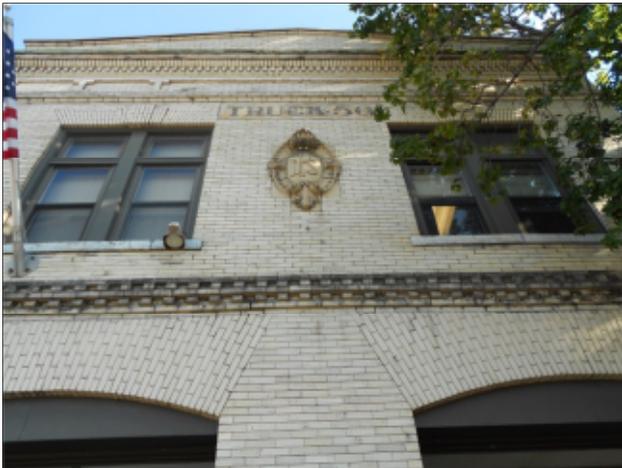
SH1 – South façade – brick cornices

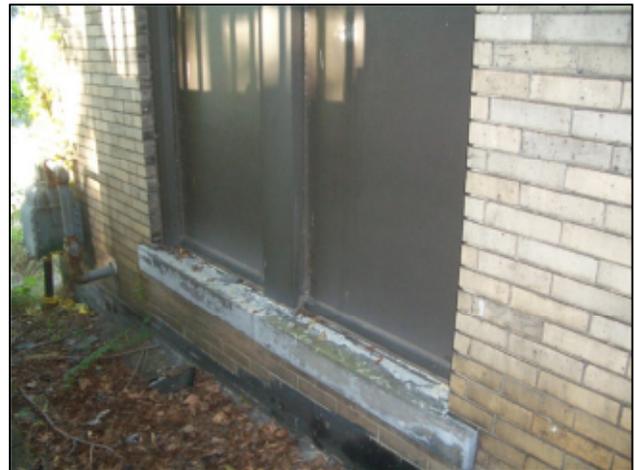
SH4 – East wall – typical window / sill

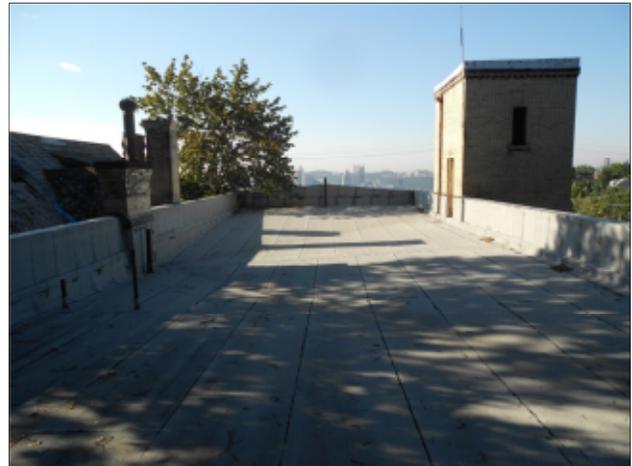
SH8 – Main roof looking south, hose tower at left

10 year: Replace the main roofing and flashing system, replace the metal cornice cover – Estimated cost: \$43,200 (roof - 2,880 SF x \$15/SF) (cornice - \$12,000). Maintain a pro-active maintenance program. Inspect the roof system and walls on a regular schedule – minimum twice a year (late spring and late fall). Estimated cost: none (perform in-house)

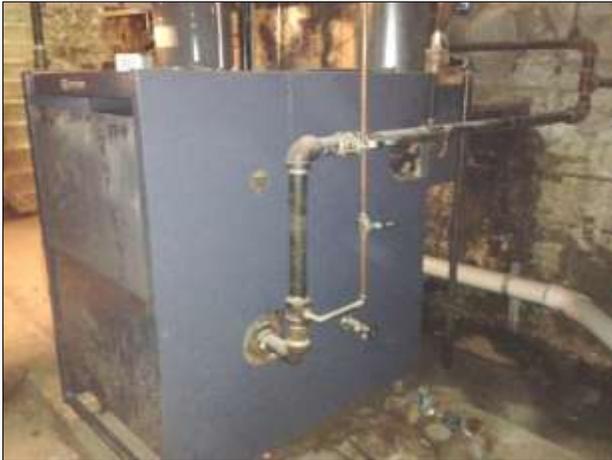
HVAC 16 – Hot water heating boiler - 1

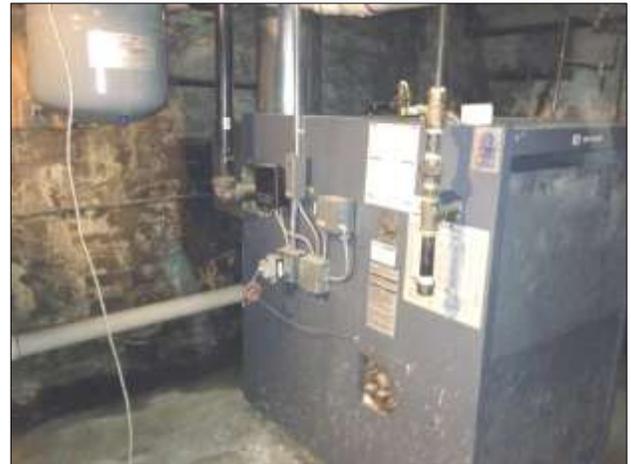
HVAC 17 – Hot water heating boiler - 2

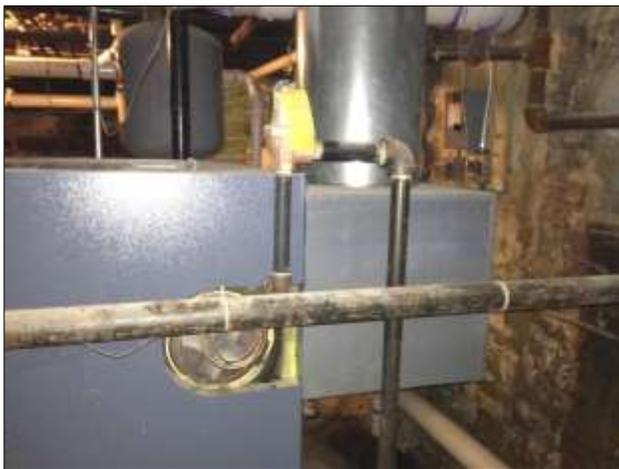
HVAC 18 – Hot water heating boiler - 3

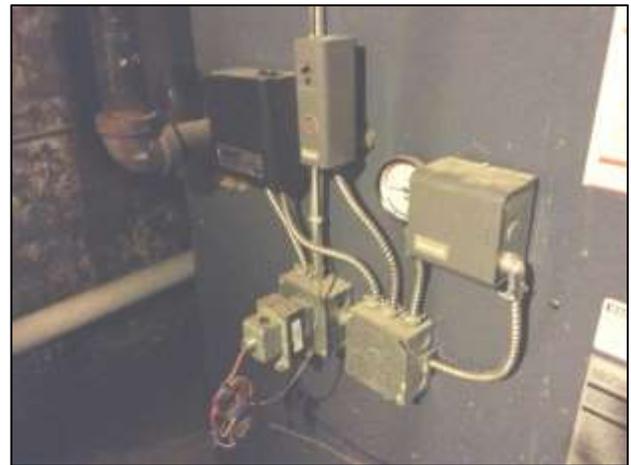
HVAC 19 – Hot water heating boiler - 4

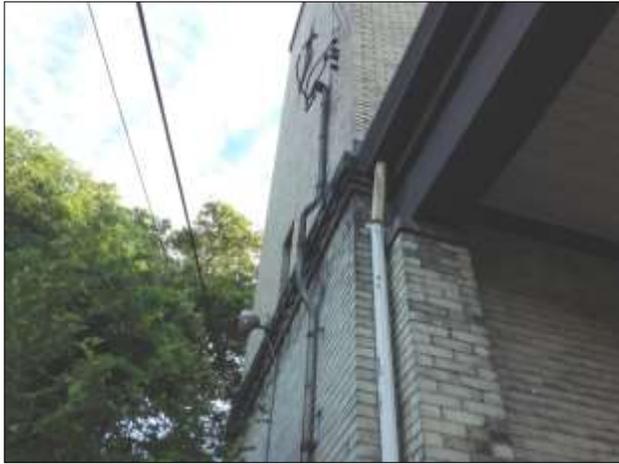
E18 – Electric service - 1

3. Utilities Service
 - 3.1. Construction
 - 3.1.1. One (1) 3-phase original electric service.
 - 3.2. Condition Assessment
 - 3.2.1. Condition Power Service: **Fair**
 - 3.2.2. Condition Electric Meter: **Good**

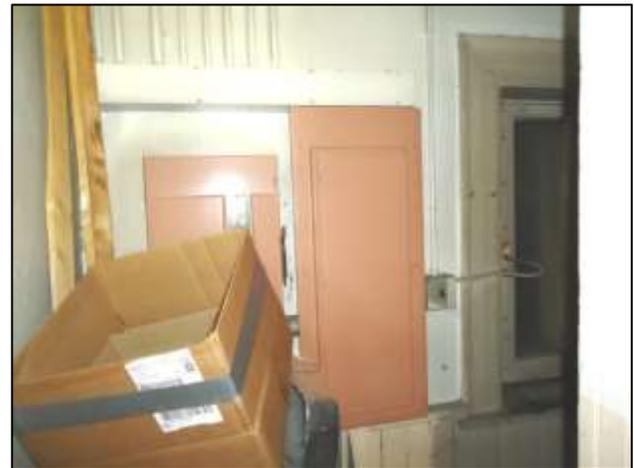
E21 – Breaker panel - 1

2. Power Distribution
 - 2.1. Construction and condition
 - 2.1.1. Distribution panels (original to building): Condition-**Fair**
 - 2.1.2. General Receptacles (original to building): Condition-**Fair**

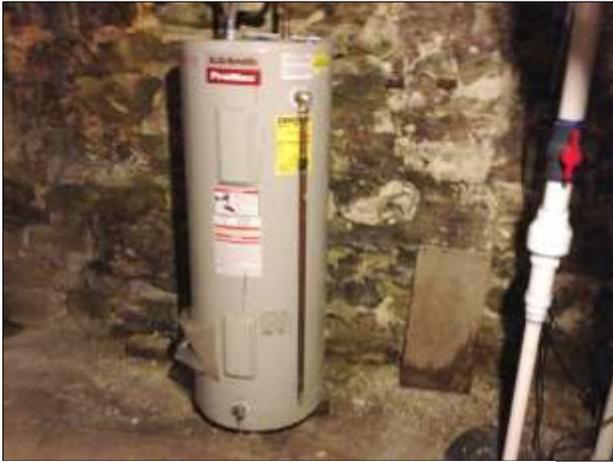
P13 – Domestic water heater - 1

2.1.1 Water Heater Condition: **Fair**

- 5.1 De minimus conditions
 - 5.1.1 Insulate supply pipes from water heaters.

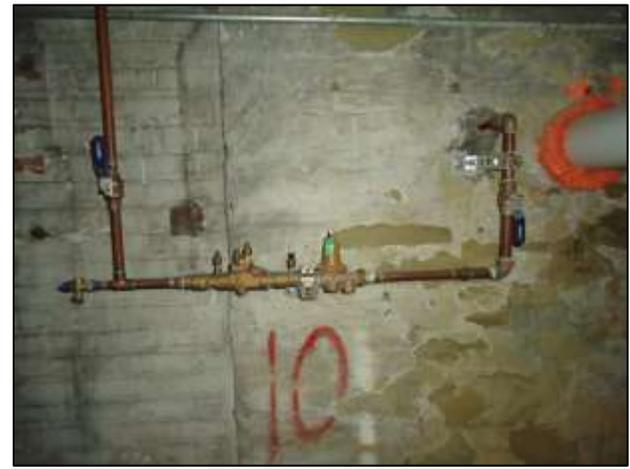
P16 – Domestic water meter and piping

- 3.1 General Description: Potable water supply
- 3.2 Construction
 - 3.2.1 Original meter, shut-off valve, and piping.
- 3.3 Condition Assessment: **Fair**

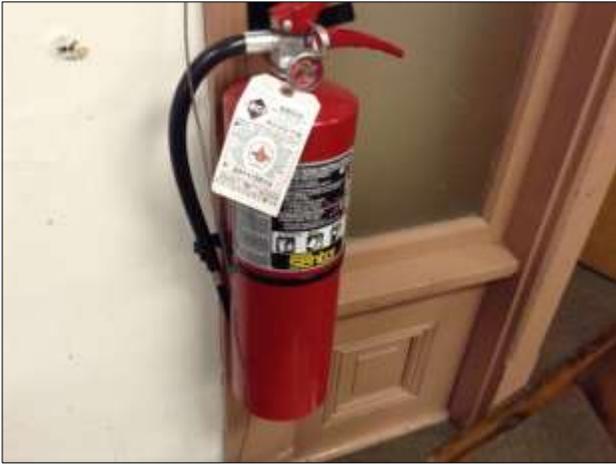
FP1 – Extinguisher 1st floor (testing out-of-date)
