CITY OF
PITTSBURGH
PROPERTY CONDITION REPORT

B153 – Medic Headquarters
700 Filbert Street
Pittsburgh, Pennsylvania 15232

June 2014

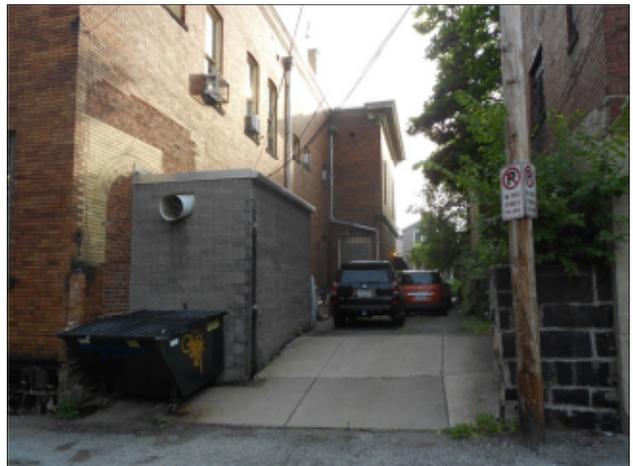
ST4 – Entrance to parking area from Culloden Way. Retaining wall at right, compressed gas storage room is CMU addition at left

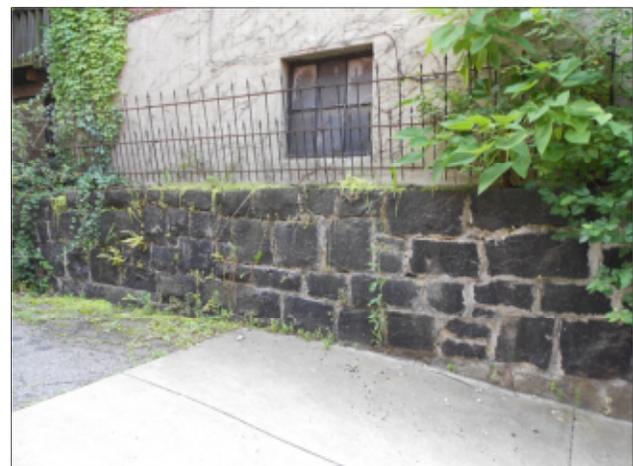
- Replace asphalt at drive
4. Landscaping and Appurtenances – Consists of a small grass lawn area bordered by low hedge, in Good condition.
 5. Site Amenities / Accessory Structures- A stone masonry retaining wall with decorative iron railing at the south side of the lot appears to be in Fair condition. Some mortar loss and corrosion at the rail is apparent.

ST6 – Retaining wall at south edge of parking area

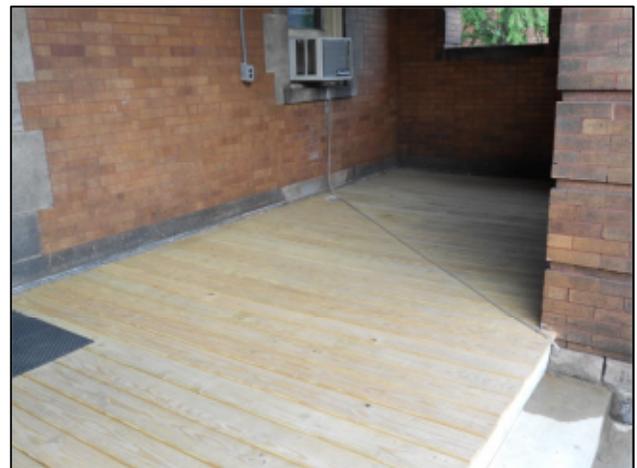
SH6 – Recent repair at recessed porch on east side

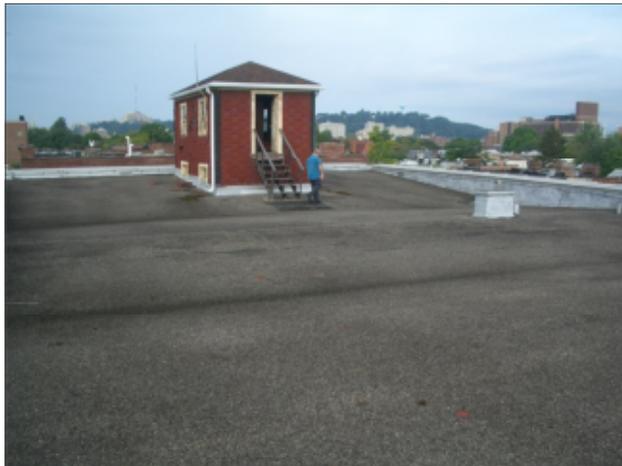
- Masonry at the shell requires restoration.
- Exterior painted surfaces need painting.
- Hose Tower Penthouse needs re-clad and repairs.
- Boiler lacks ductwork for combustion air.
- The fire detection/notification and protection systems are inadequate.

SH9 – Main roof looking NW, hose tower penthouse is at center

3.3	SHELL							
a	Secure 2nd Flr. window lintel	1	EA	\$2,500			\$2,500	
b	Masonry restoration	1	EA	\$400,000				\$400,000
c	Hose Tower Penthouse - re-clad and reglaze, replace door and stair to roof	1	EA	\$20,000				\$20,000
d	Replace missing downspout on low addition	1	EA	\$100				\$100
e	Roof and flashing coating	1	EA	\$2,000				\$2,000
f	Paint all existing exterior painted surfaces	1	EA	\$25,000				\$25,000

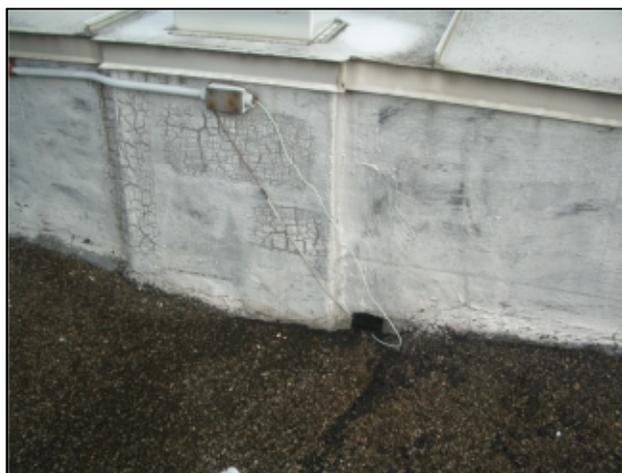
SH11 – Typical through-wall scupper with heat trace

3.5	SERVICES							
	Plumbing							
	HVAC							
a	Remove combustible materials near Boiler / Boiler Safety Testing	1	EA	\$750			\$750	
b	Combustion air for boiler and water heater	1	EA	\$7,500			\$7,500	
c	Restroom exhaust fan	1	EA	\$1,200			\$1,200	
	Fire Protection							
d	Add fire extinguishers at basement	2	EA	\$1,800			\$3,600	
e	GFI receptacles	3	EA	\$1,800				\$5,400
f	CO detector in Boiler Rm.	1	EA	\$3,500				\$3,500
g	Compressed gas and fuel Storage - NFPA Hazard Classification Study	1	EA	TBD				
	Electrical							
h	Replace heat trace elements	1	EA	\$2,500			\$2,500

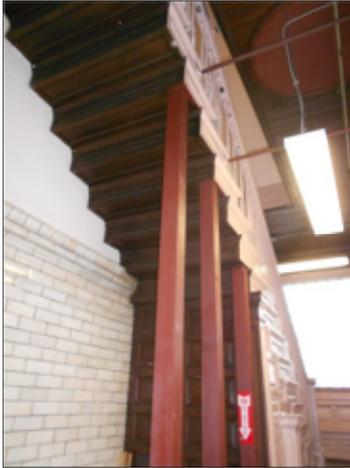
17 – Main stair with temporary supports in foreground

3.4	INTERIORS							
a	Main stair - remove temporary supports, stabilize and repair	1	EA	\$25,000			\$25,000	
b	Evaluate second floor resilient tile for potential ACM	1	EA	TBD

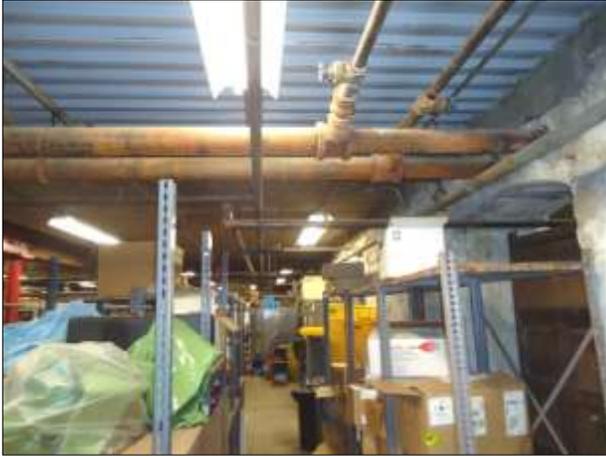
HVAC 13 – Uninsulated hot water piping: Convective heat source

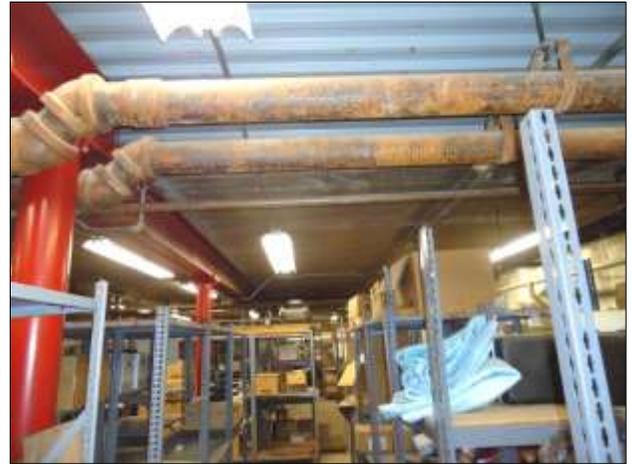
HVAC 14 – HVAC 13 – Uninsulated hot water piping: Convective heat source

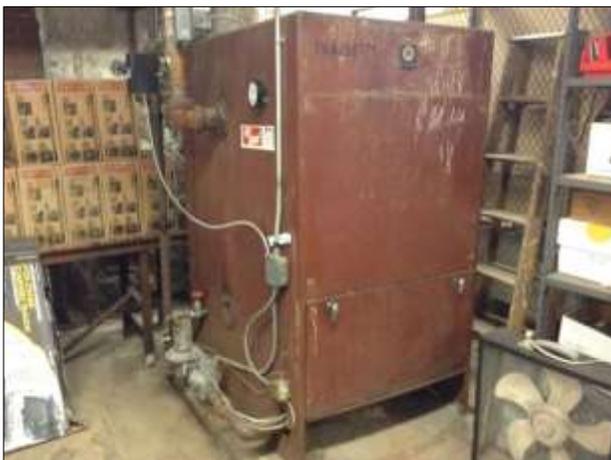
HVAC 17 – Boiler: Convective heat source

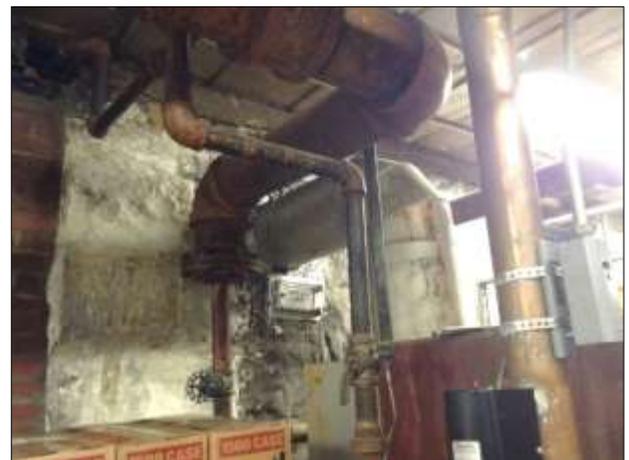
HVAC 18 – Uninsulated Boiler breaching: Convective heat source

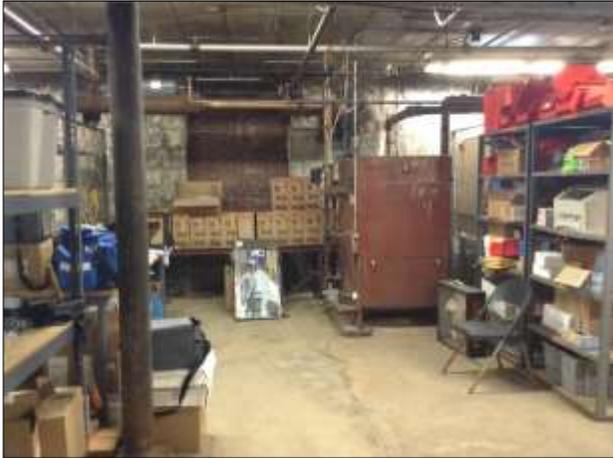
HVAC 46 – Boiler

- 4.3.3. Replace existing boiler with two (2) high efficiency model (Triad 300SH): \$26,500

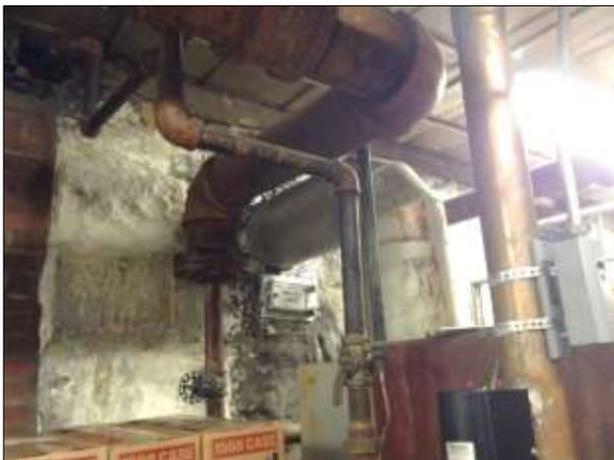
HVAC 50 – Boiler breeching

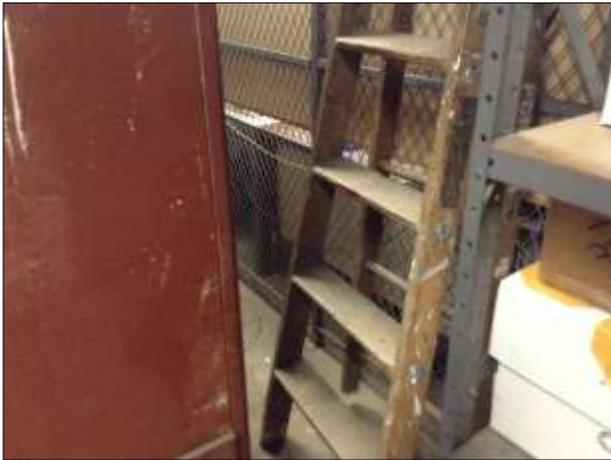
HVAC 52 – Boiler: Clearance to combustibles – Safety and Building code concern

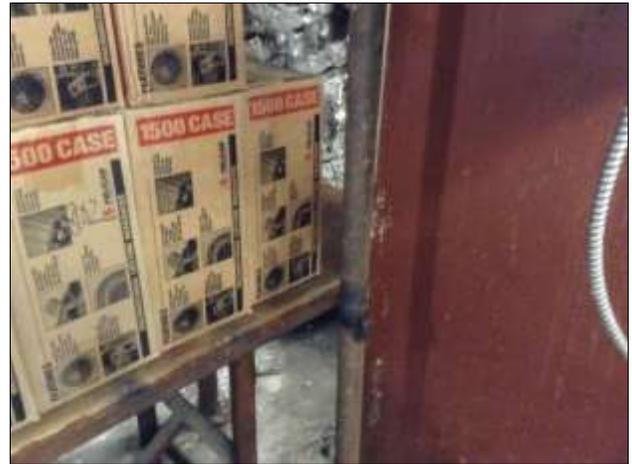
HVAC 53 – HVAC 35 – Boiler: Clearance to combustibles – Safety and Building code concern

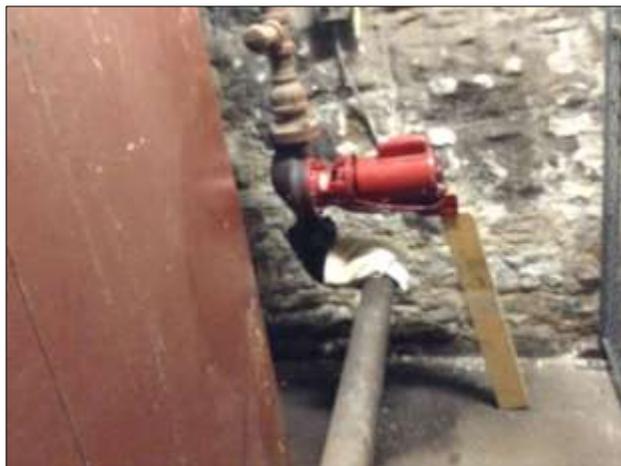
HVAC 54 – Hot water pump: Undersized, poor location and support

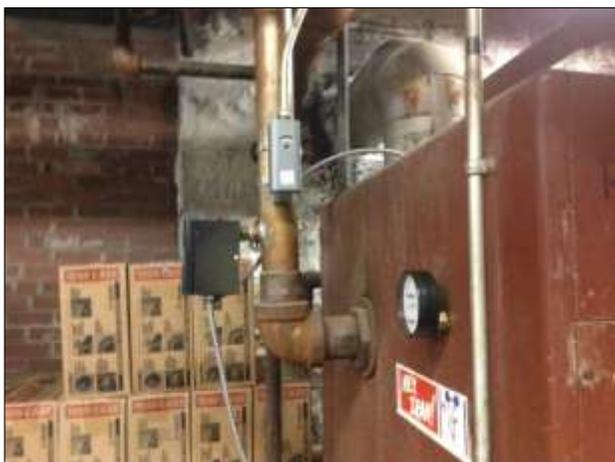
HVAC 56 – HVAC 35 – Boiler: Clearance to combustibles – Safety and Building code concern

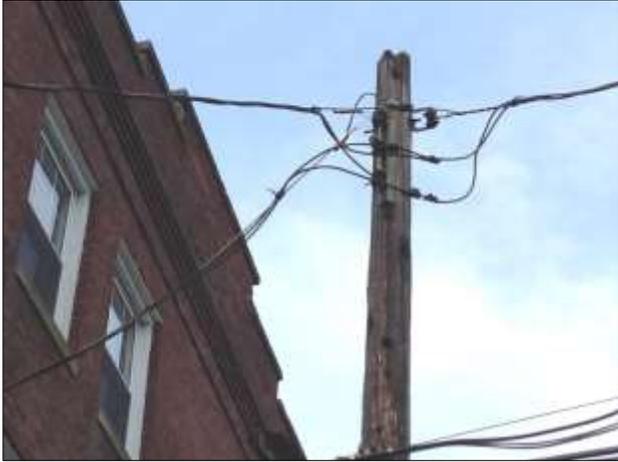
3. Utilities Service
 - 3.1. Construction: Utility connection and galvanized conduit.
 - 3.2. Condition Assessment
 - 3.2.1. Condition Power Service: **Poor**
 - 3.2.2. Condition Electric Meter: **Good**

E36 – Service - 1a

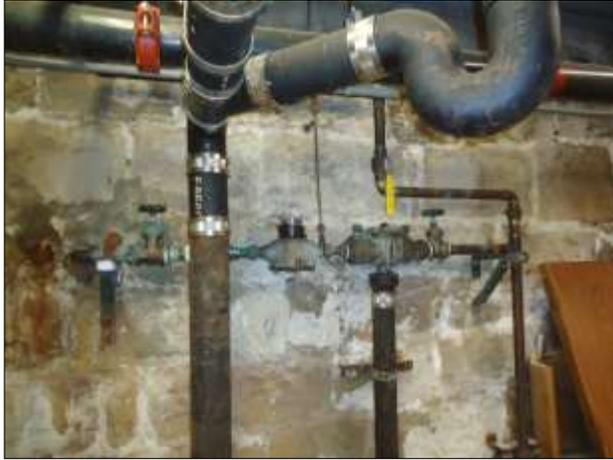
P29 – Domestic water service

- 3.1 General Description: Potable water supply
- 3.2 Construction
 - 3.2.1 Meter, shut-off valve, back-flow preventer, and piping.
- 3.3 Condition Assessment: **Poor**

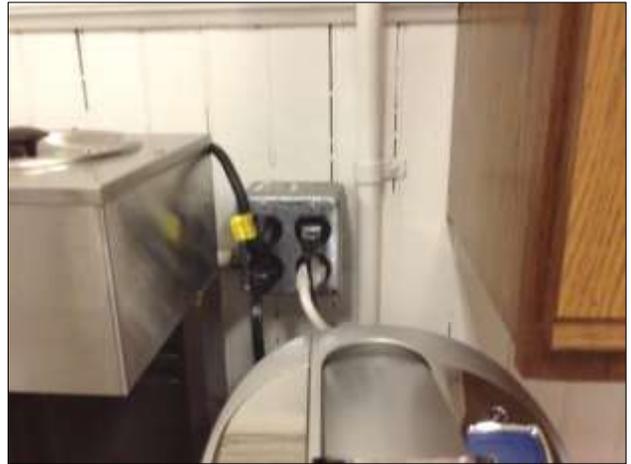
LS 11 – Kitchen receptacle

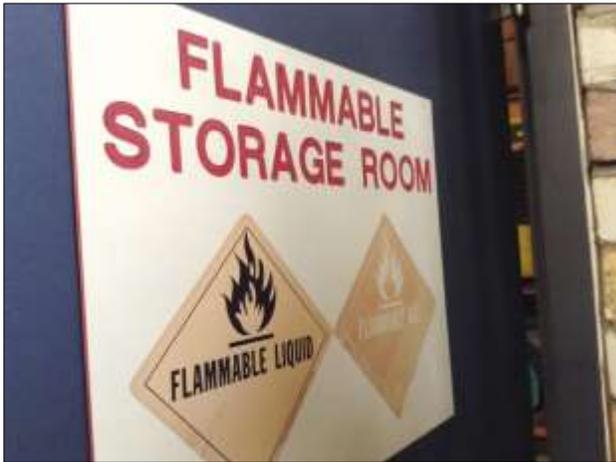
LS 17 – Flammable Storage safety sign

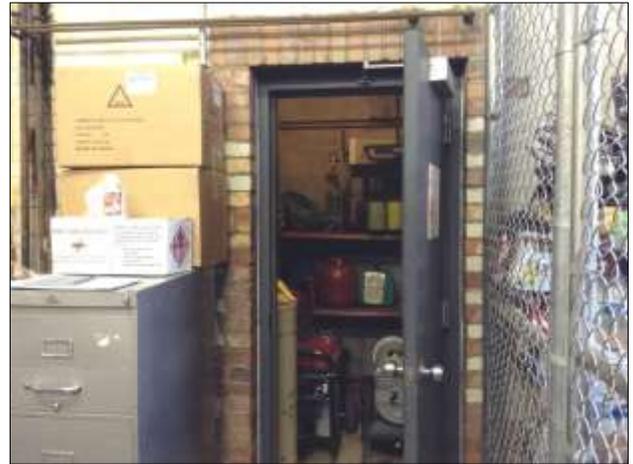
LS 18 – Flammable Storage room: Solid door no Make-up air

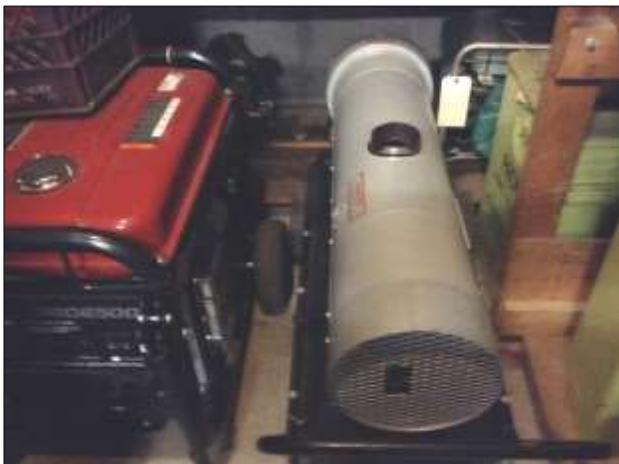
LS 21 – Gasoline generators: Integral tanks

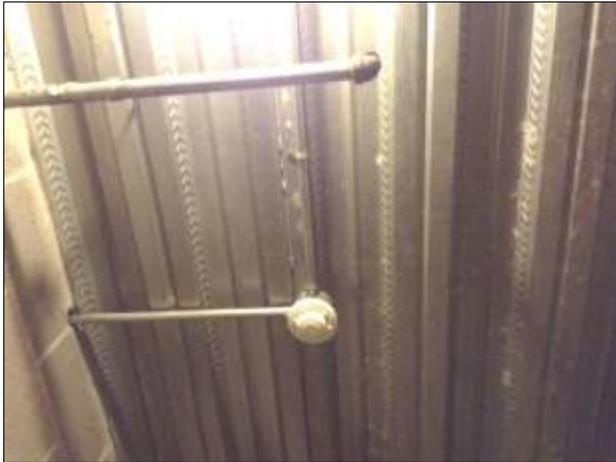
LS 31 – Sprinkler head, fire/smoke detector, EMT conduit (open), non-rate light fixture

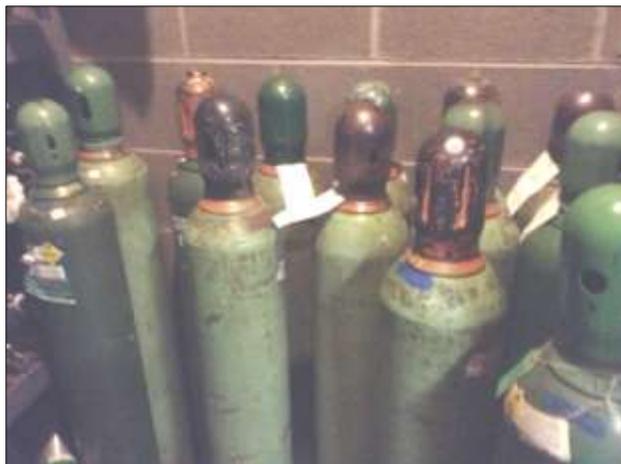
LS 37 – O2 cylinders: Unrestrained

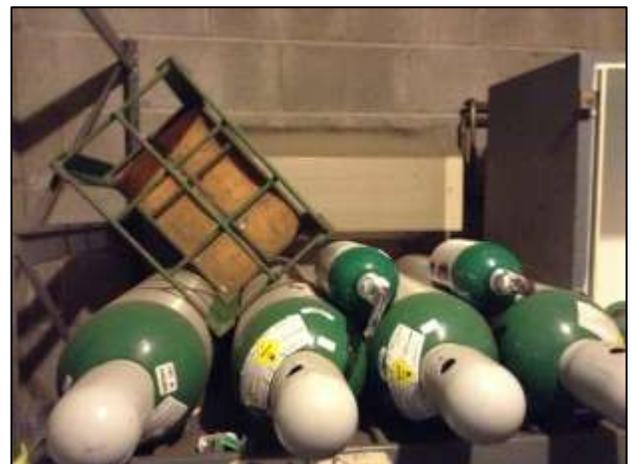
LS 38 – O2 cylinders: Horizontal storage

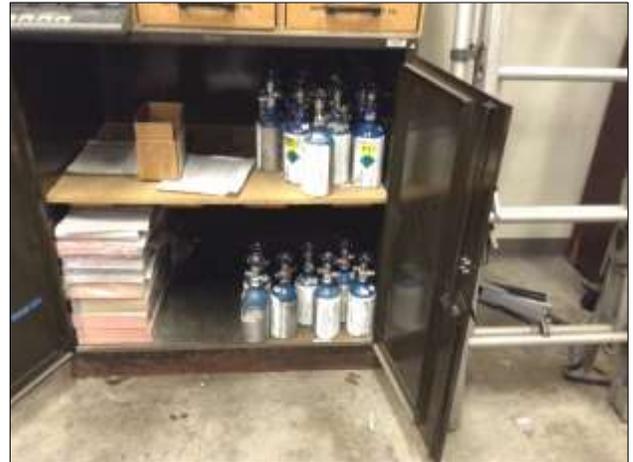
LS 40 – Nitrous Oxide storage: Non-classified area: Apparatus room
