CITY OF
PITTSBURGH
FACILITY ANALYSIS REPORT

Medic Training
2100 Liberty Ave.
Pittsburgh, Pennsylvania 15222

Medic Training (B151)

2100 Liberty Avenue
Pittsburgh, PA 15222

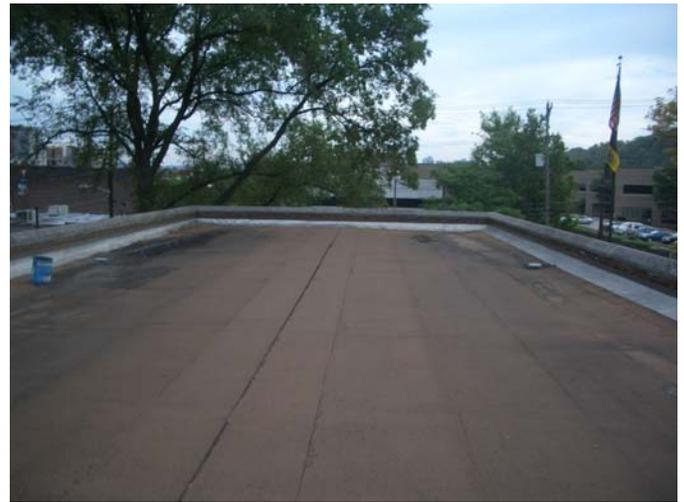
R-4 Truck bay, looking east

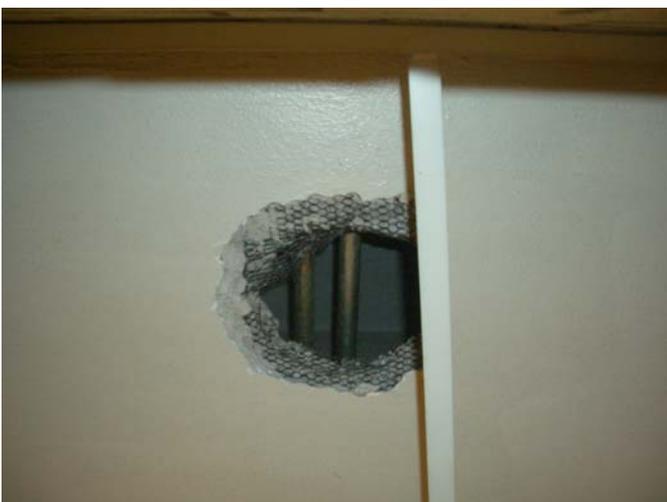
R-3 Underside of roof deck, concrete plank

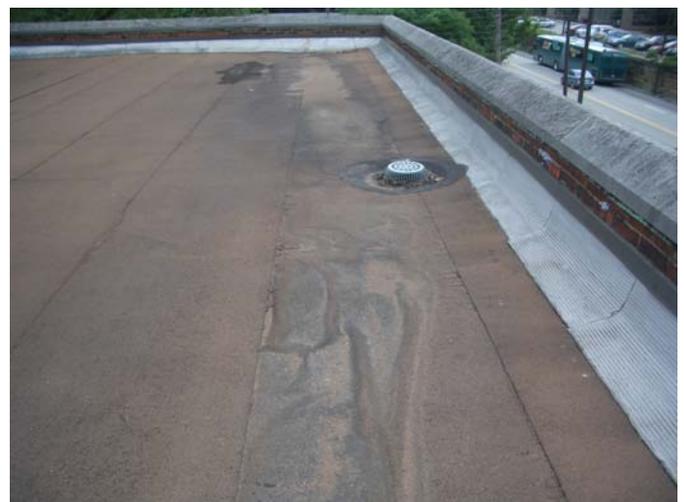
4.2 Condition: The modified roof system on all roof areas is in fair condition. Some ridges and a few blisters were observed. Some repairs were observed around the roof drains on the truck bay area. Debris was observed at some roof drains.

R-6 Truck Bay, ridges in roof membrane at drain line

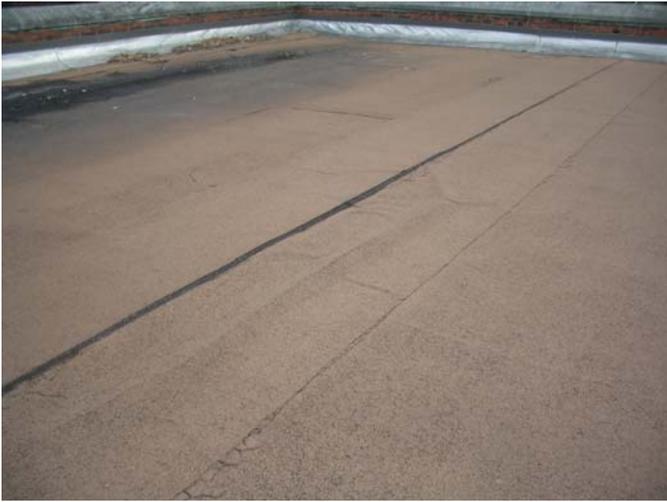
R-7 Truck Bay, ridge in middle of the roof

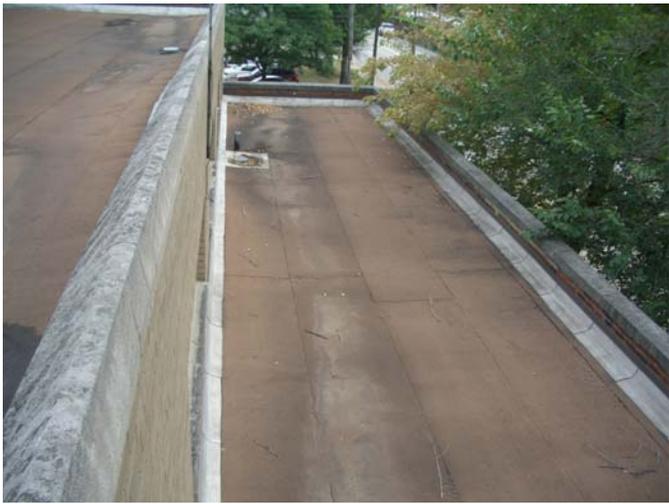
R-16 Main Roof, south side looking east

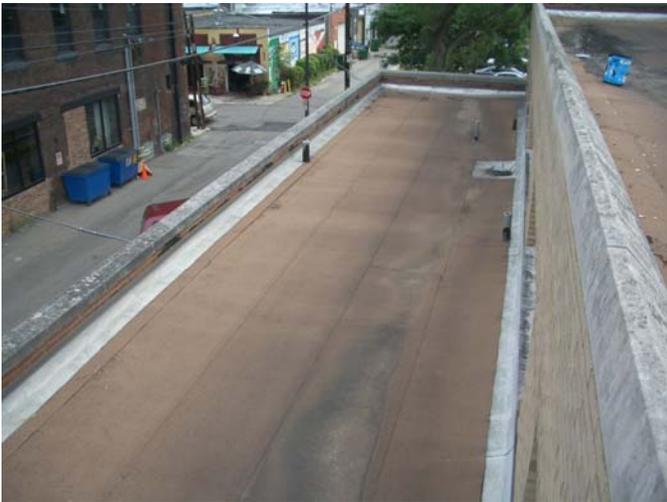
R-14 Main Roof, north side looking east

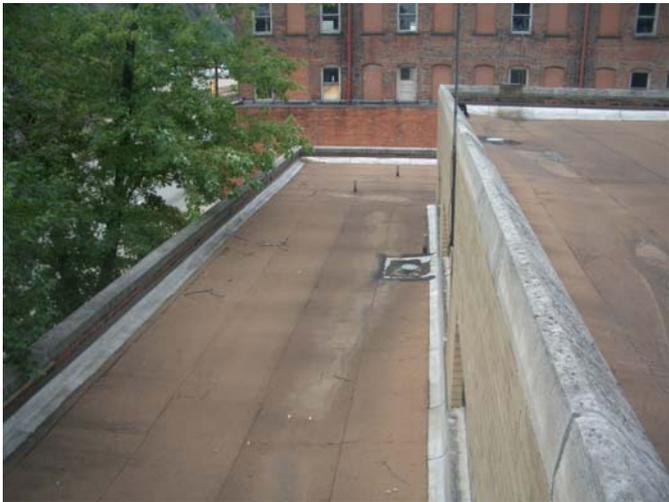
R-17 Main Roof, south side looking west

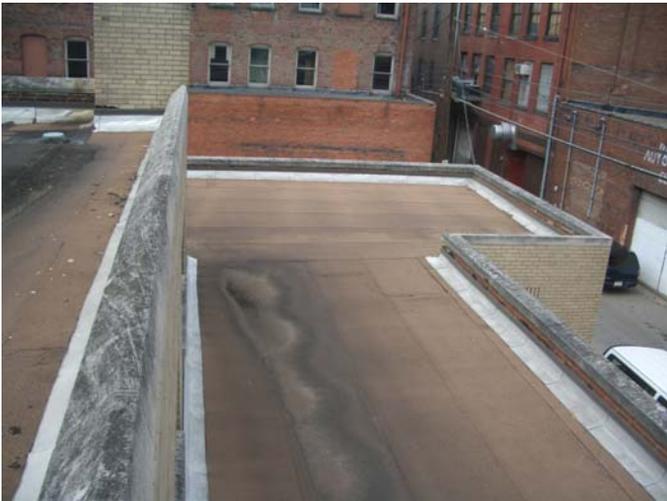
R-15 Main roof, north side looking west

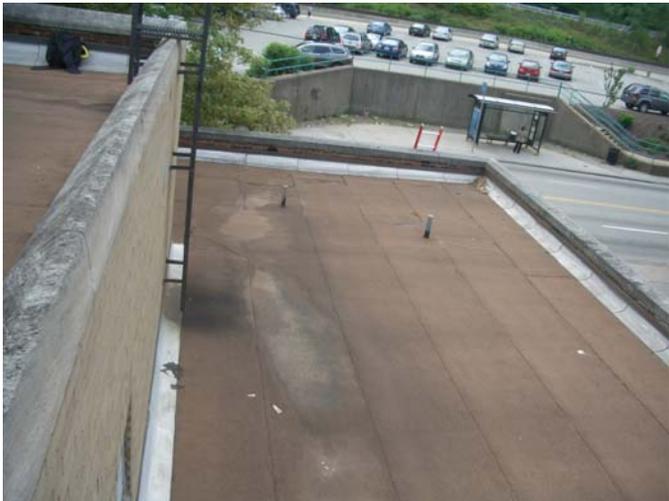
R-18 Main roof, west end looking south

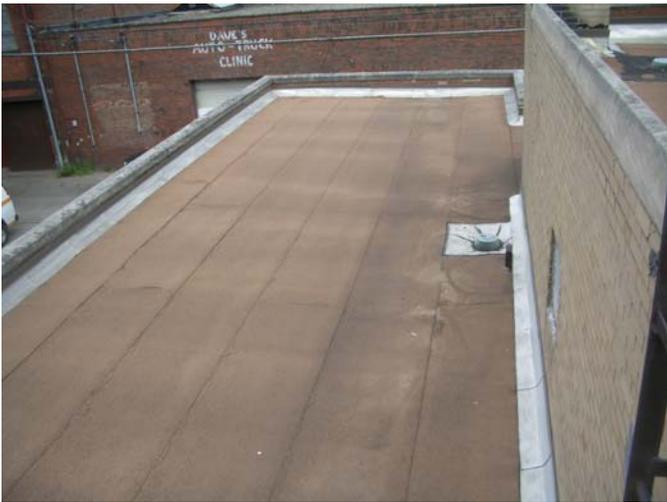
R-19 Main Roof, west end looking north

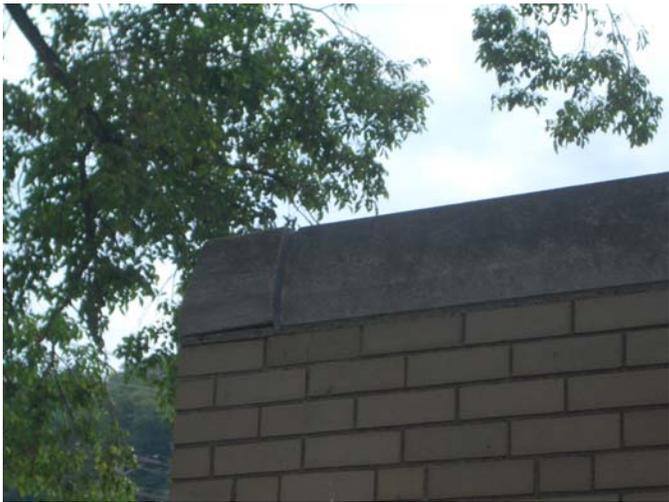
6.2 Condition: The coping is in fair condition. The caulking in a few butt joints is cracked and open. Some mortar is cracked and missing on the exterior bed joints. Cracks in the caulking was observed at the wall penetrations.

R-22 Main Roof, NE corner of Truck Bay, open mortar joint in coping

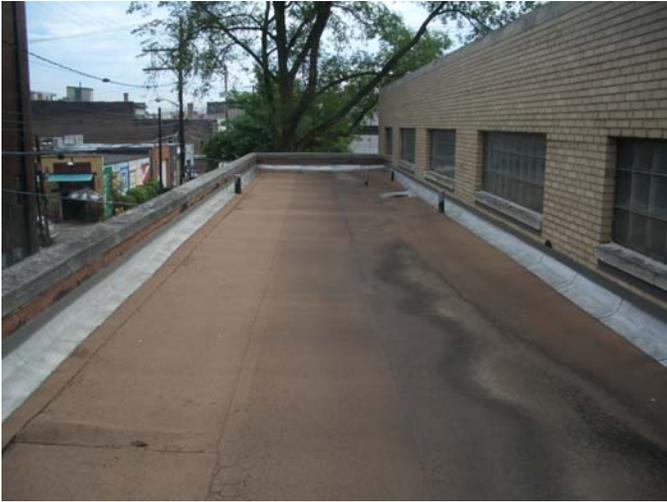
R-20 Main Roof, looking east on north side

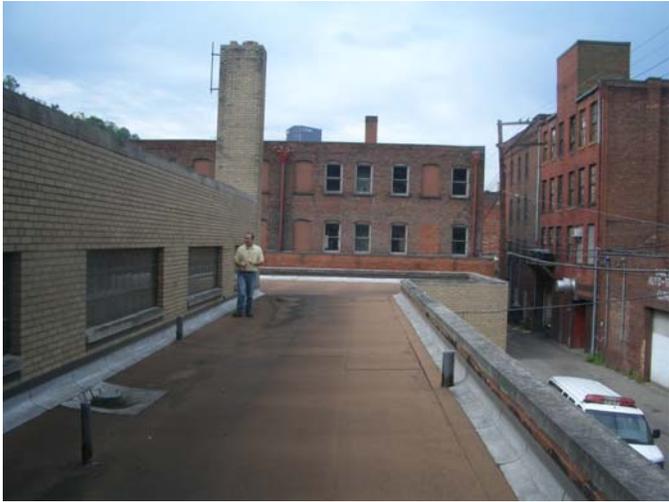
R-23 Main roof, north side looking west

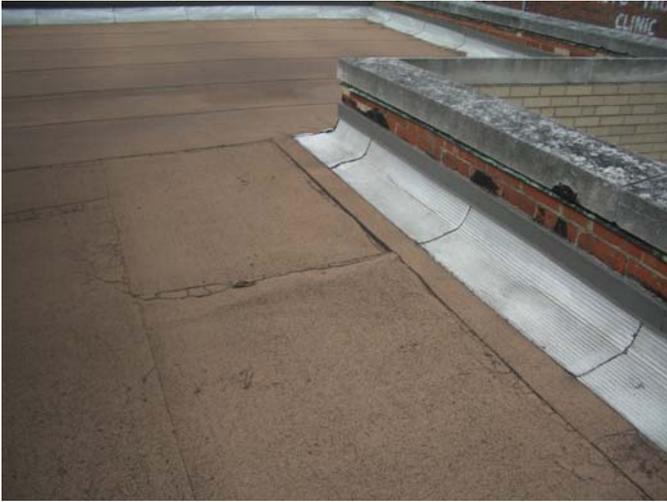
R-21 Main Roof, north side, blister in roof membrane

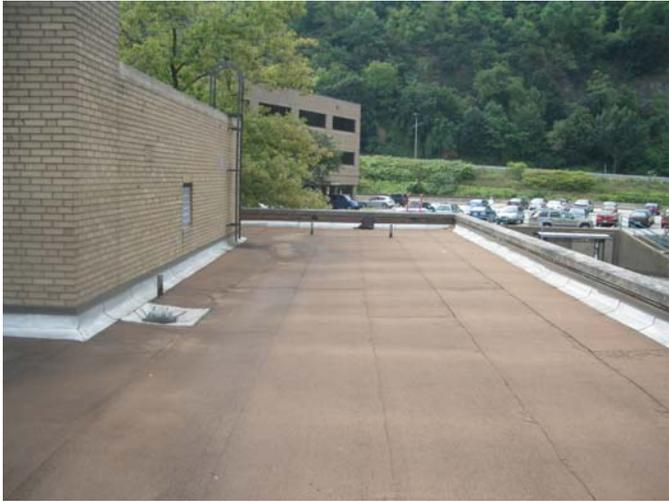
R-24 Main roof, west end looking south

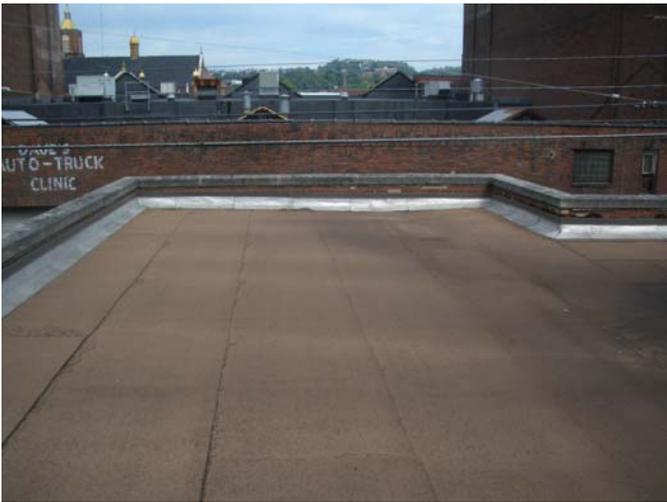
R-25 Main Roof, west end looking north

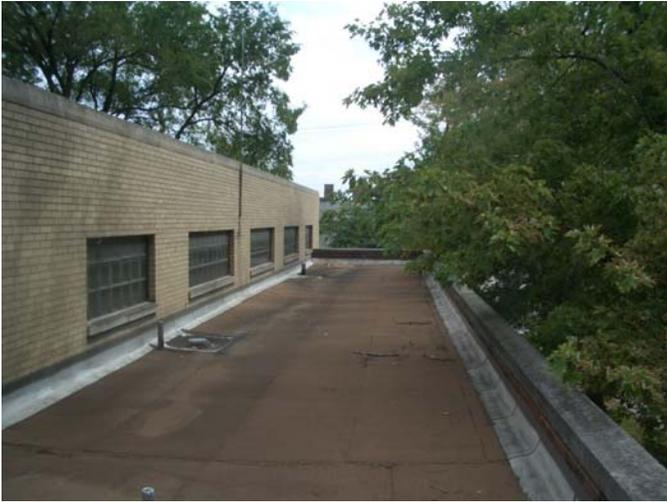
R-26 Main Roof, south side looking east

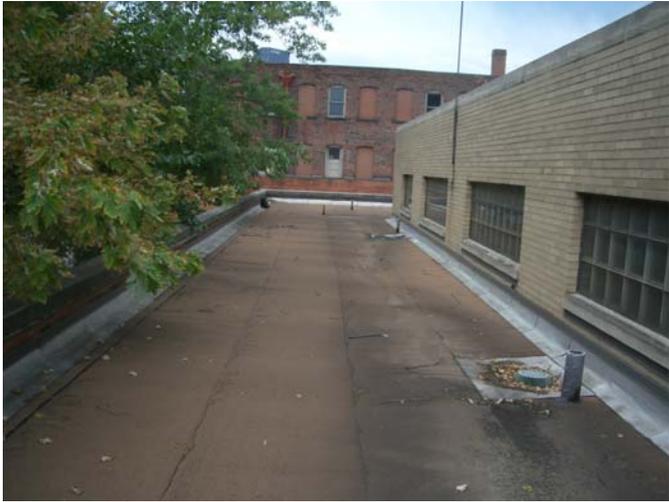
R-29 Main Roof, south side looking west

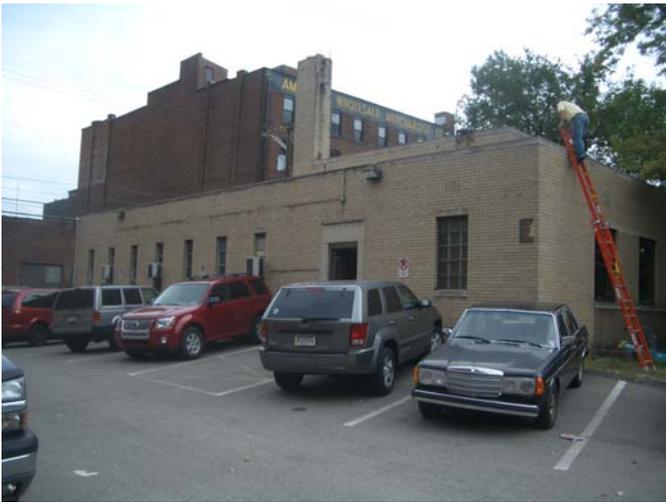
W-1 West Wall and SW corner

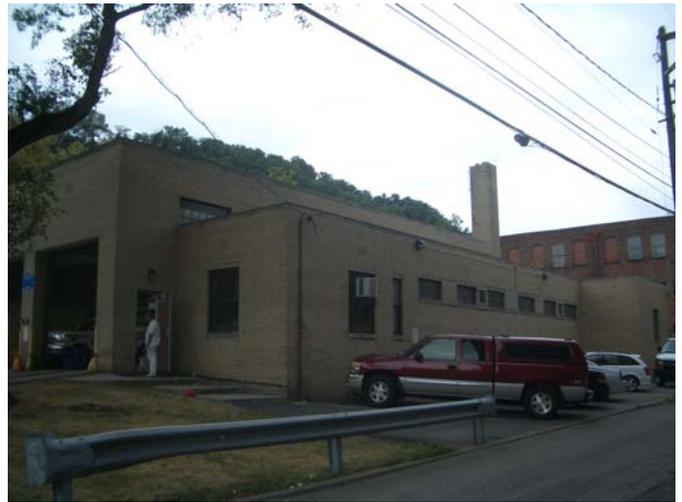
W-4 NE corner looking and north wall and entry (east wall)

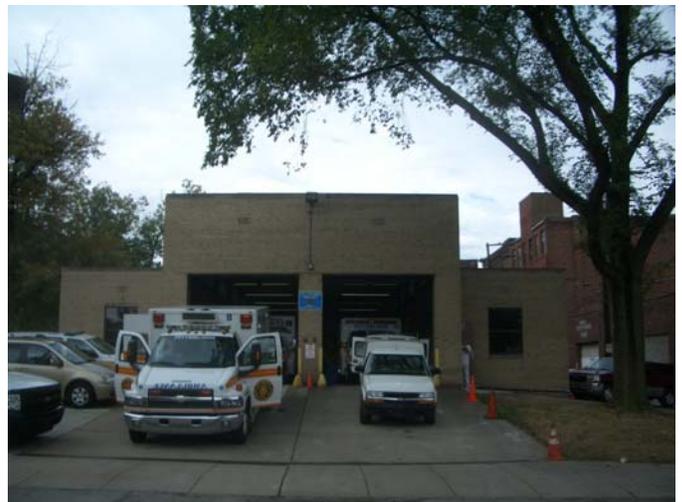
W-5 East wall (entry)

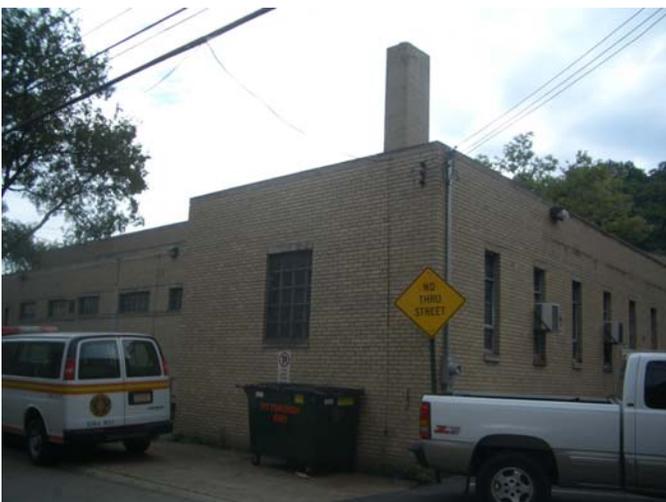
W-3 NW corner looking at west and north walls

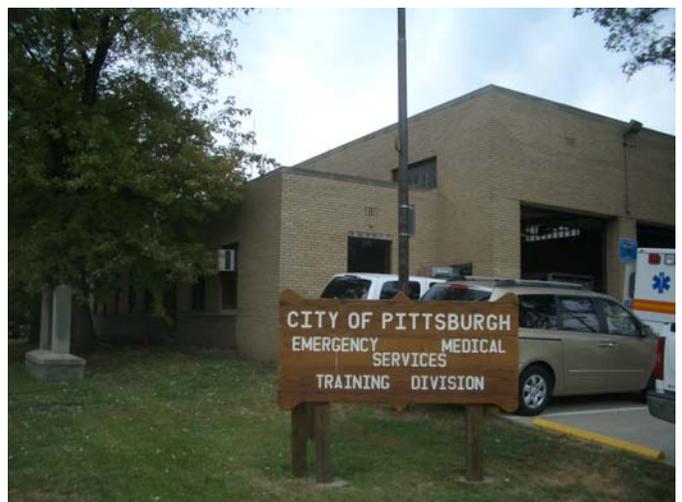
W-6 SE corner looking at east wall and south wall

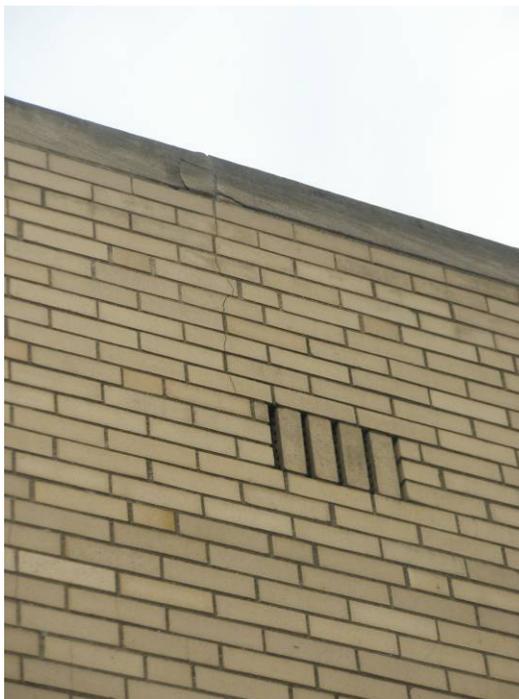
Photo S2

- 2.) Above the garage doors on the east face, there are cracks in the brick. Recommend repairing brick and repointing mortar joints. (1 to 5 yrs) **(Photos S2 & S3)**

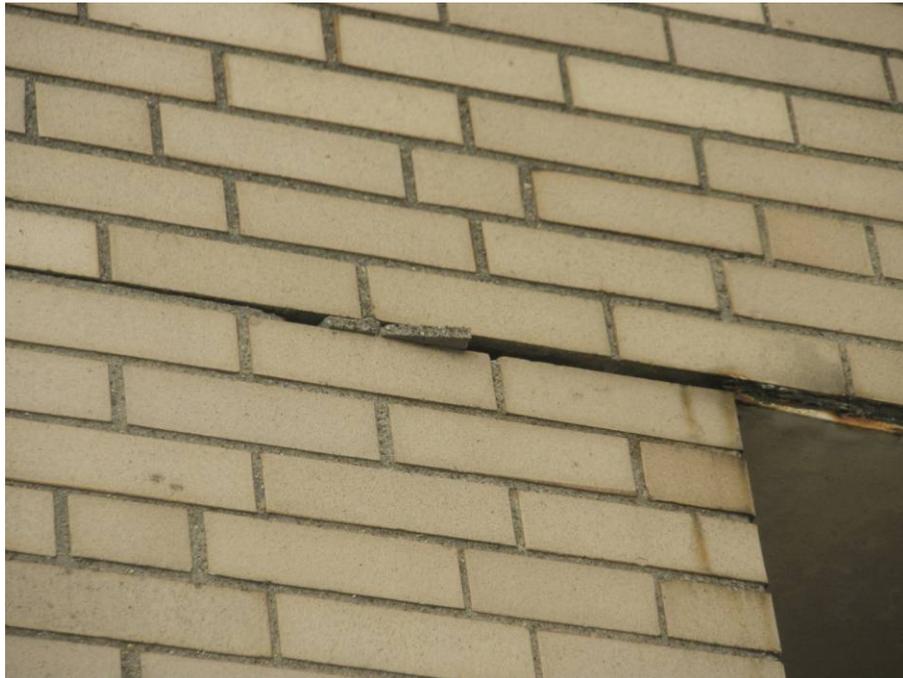
Photo S4

- 3.) Above the garage door jambs, the steel lintel appears to be corroding and causing the mortar and brick to crack and push out. Recommend cleaning lintel and repointing the mortar (1 to 5 yrs) **(Photos S4, S5, & S6)**

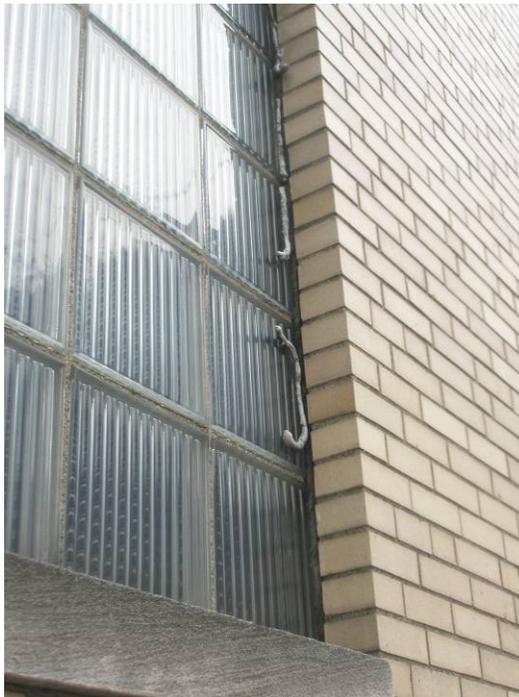
Photo S10

- 5.) On the north face, windows observed had failed caulking and sealant. Recommend replacing all window caulking and sealants (1 to 5 yrs) **(Photo S10)**

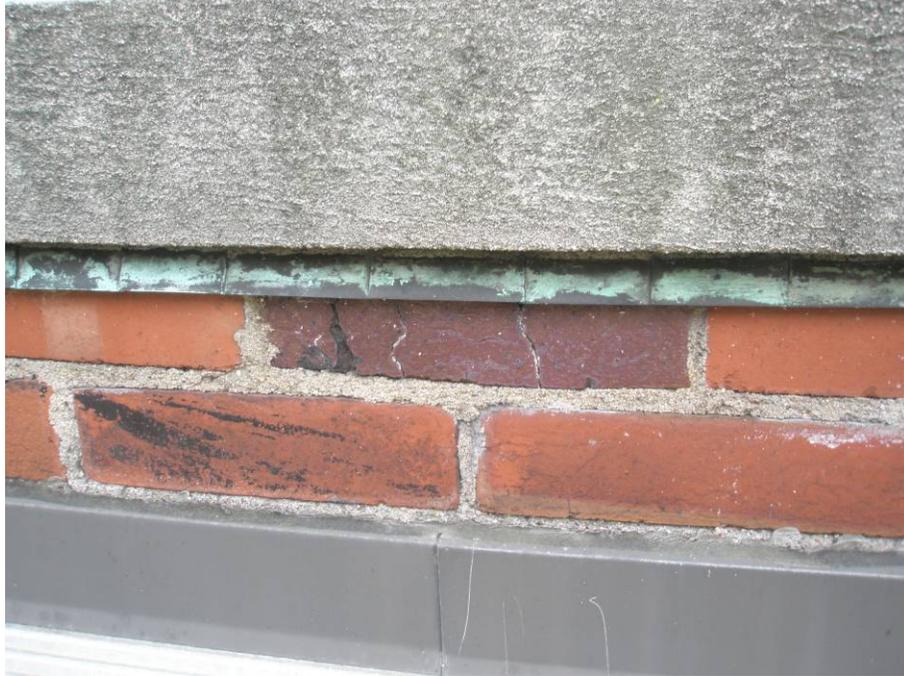
Photo S13

- 6.) Roof drains are all clogged. Recommend cleaning debris from drains (1 yr) **(Photo S11)**
- 7.) Parapet brick and mortar joints are cracked throughout on back face of parapet. Recommend repairing brick and repointing mortar joints. (1 to 5 yrs) **(Photos S12 & S13)**

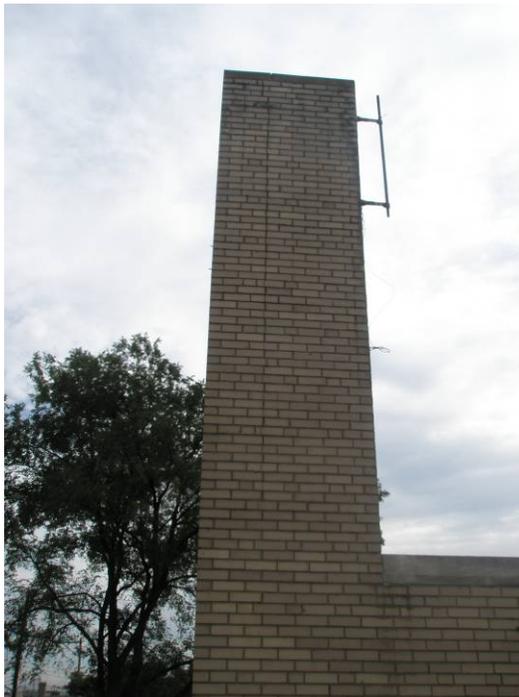
Photo S14

- 8.) There is a large crack in the brick and mortar running up the west face of the chimney. Recommend repairing the brick and repointing mortar joints. (1 to 5 yrs) **(Photo S14)**

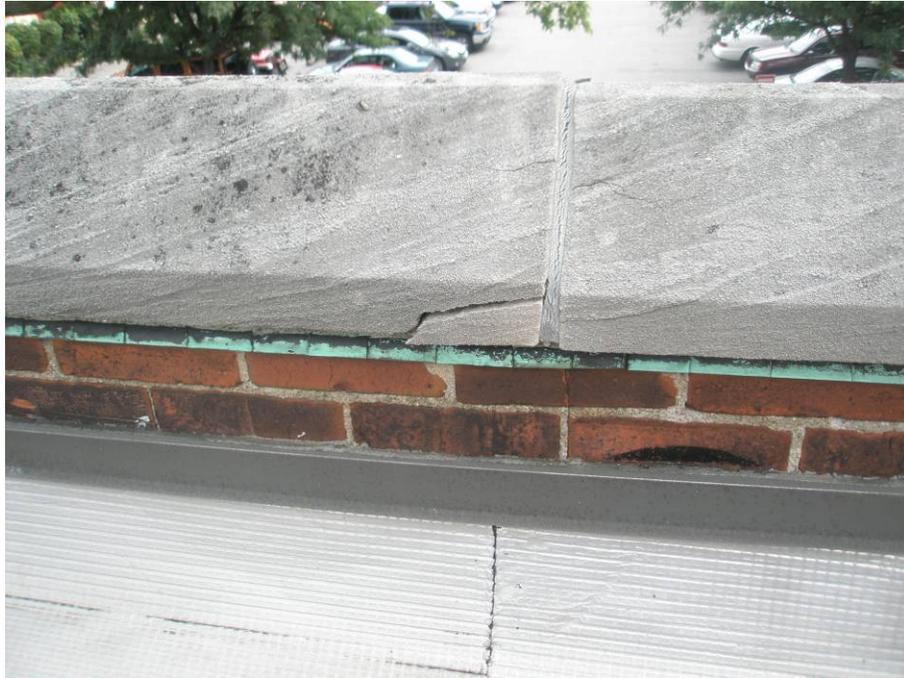
Photo S15

- 9.) There are cracked and dislocated coping stones on the east parapet of the roof. Recommend removing and resetting the dislocated stones and replacing or caulking the cracked stones. (1 to 5 yrs) **(Photos S15 & S16)**

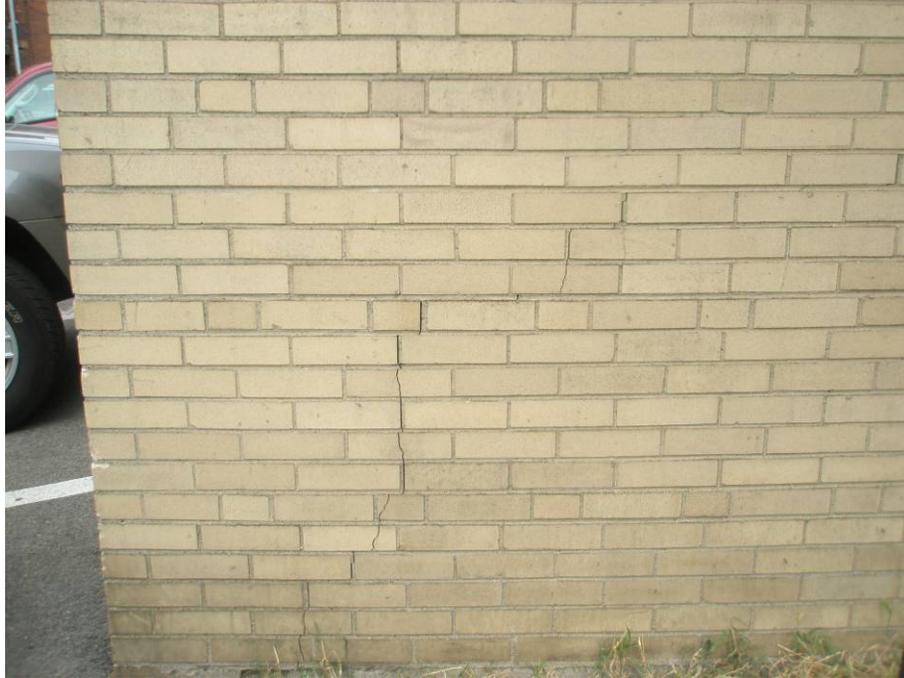
Photo S17

- 10.) There are cracked bricks and mortar joints near the ground in the south face of the southeast corner of the building. Recommend repairing bricks and repointing mortar. (1 to 5 yrs) **(Photo S17)**

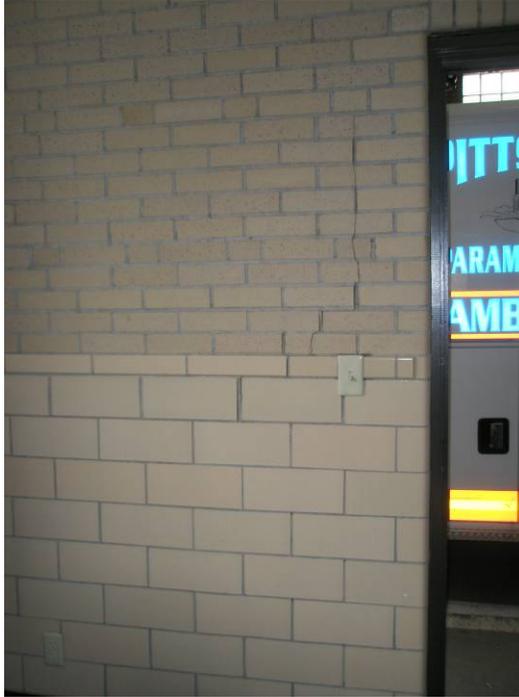
Photo S21

- 13.) There is a large diagonal crack through the brick and glazed tile wall on the north side of the garage, adjacent to an office doorway. Recommend repairing or replacing broken brick and tile, and repointing mortar (1 to 5 yrs) **(Photos S21 & S22)**

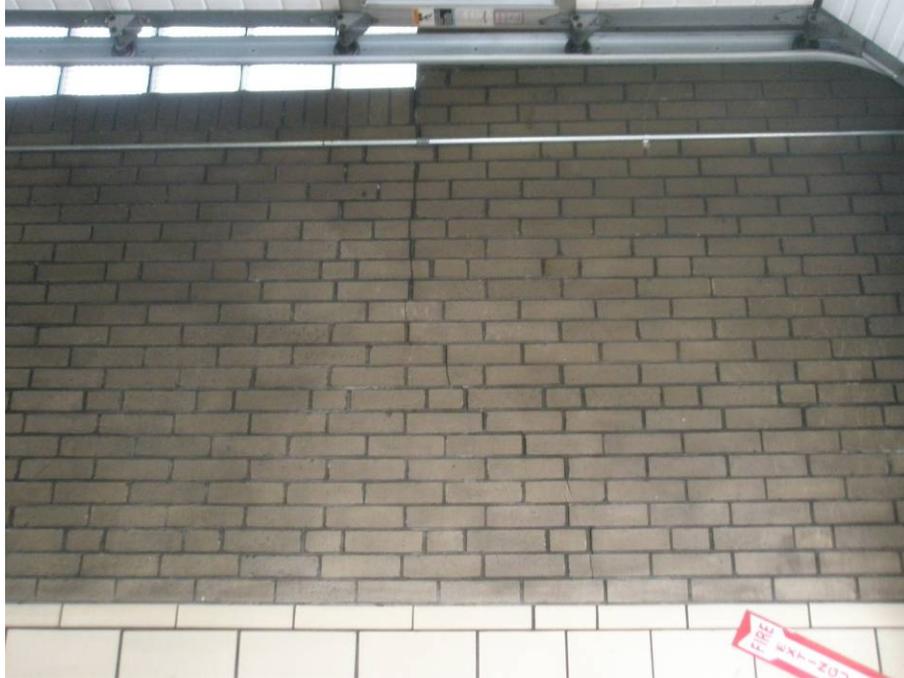
Photo S23

- 14.) There is a long crack in the brick on the north inside face of the garage. Recommend repairing brick and repointing mortar. (1 to 5 yrs) **(Photo S23)**

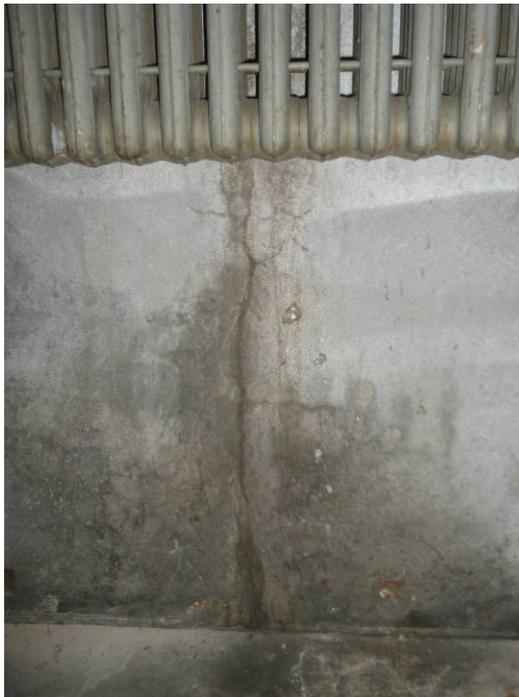
Photo S24

- 15.) There are cracks in the south wall of the basement, and there has been some water infiltration through these cracks. Recommend routing and sealing these cracks. (1 to 5 yrs.) **(Photo S24)**

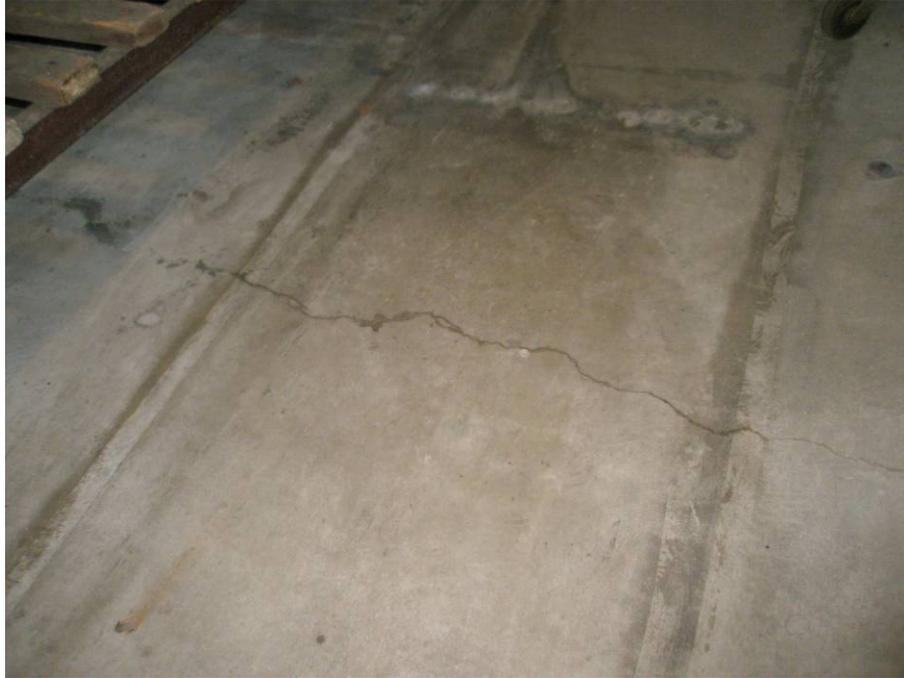
Photo S25

- 16.) There are cracks in the basement floor slab, and there has been some water infiltration through these cracks. Recommend routing and sealing these cracks. (1 to 5 yrs.) **(Photo S25)**
