CITY OF
PITTSBURGH
FACILITY ANALYSIS REPORT

Morningside Senior Center (B094)
644 President Way
Pittsburgh, Pennsylvania 15206

May 5, 2010

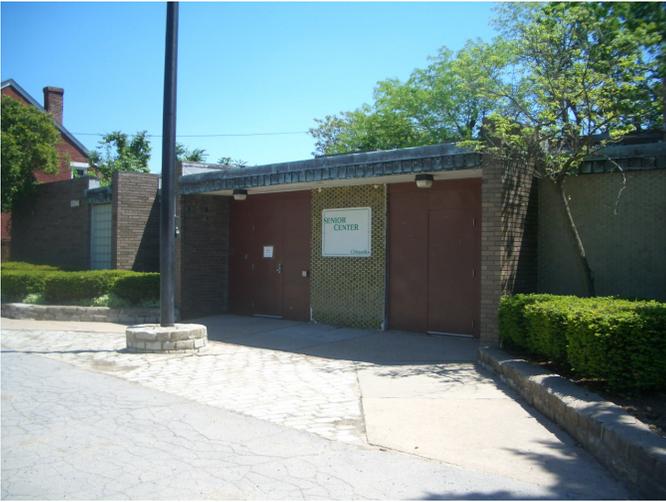
EW-1 Front entry, west elevation

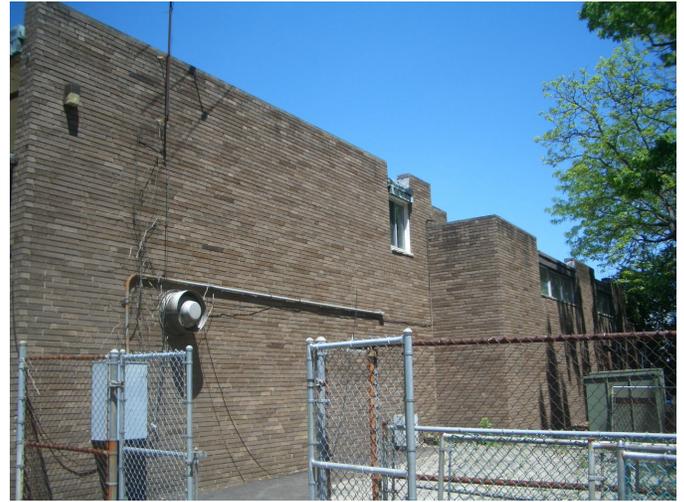
EW-4 Rear, east elevation

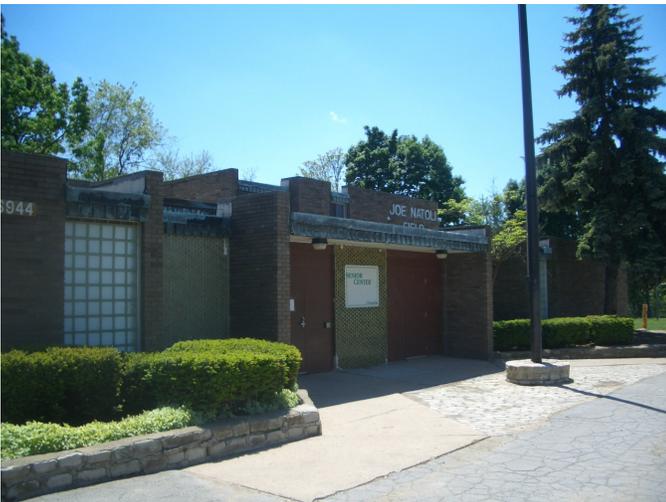
EW-2 Front entry, west elevation

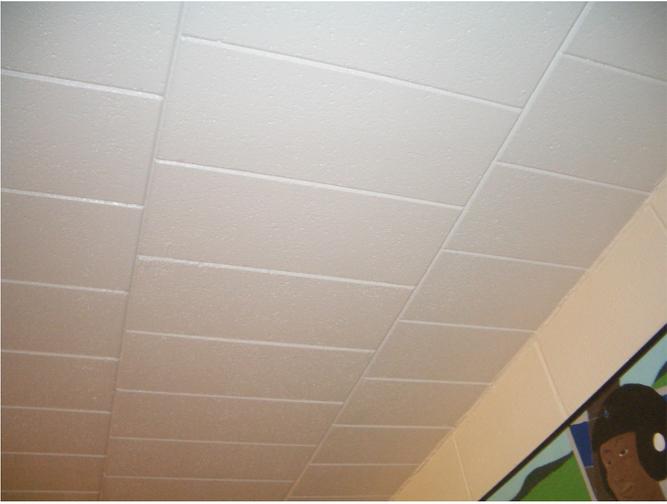
R-1 Underside of roof typical, Doxplank concrete deck

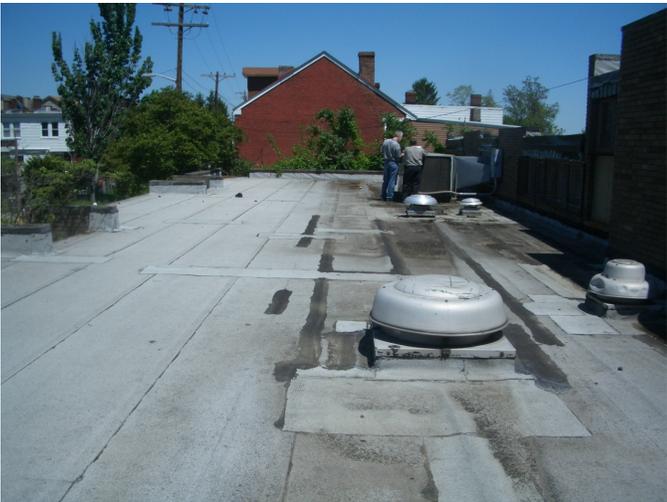
R-2 Office/Entry roof looking north

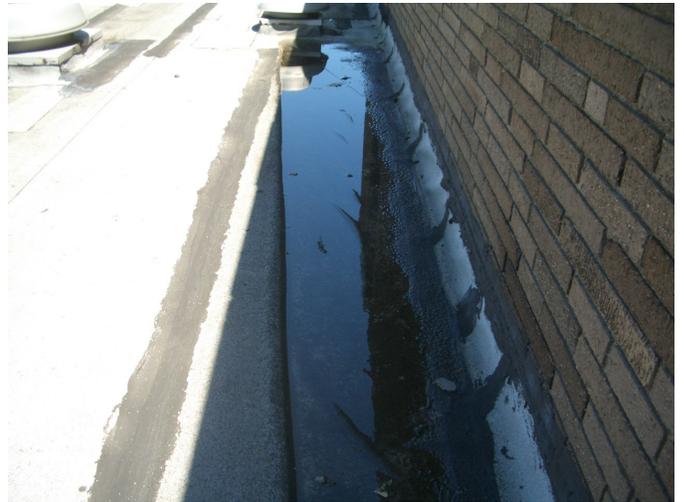
4.2 Condition: The roof membrane appeared in poor to fair condition. Blisters were observed throughout all three roof levels. Patches and repair were observed in some areas. Debris was observed on the roof (leaves and pine needles) in a few areas. Ponding water was observed on the south end of the first level.

R-5 Ponding water on Office/Entry roof area

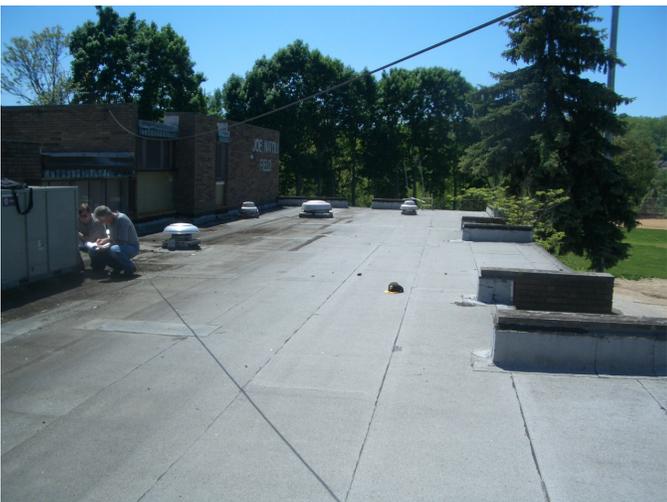
R-3 Office/Entry roof looking south

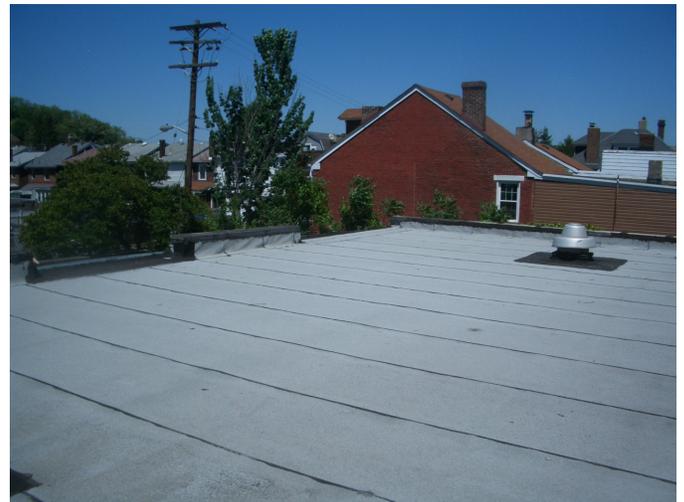
R-11 Community room roof area looking north

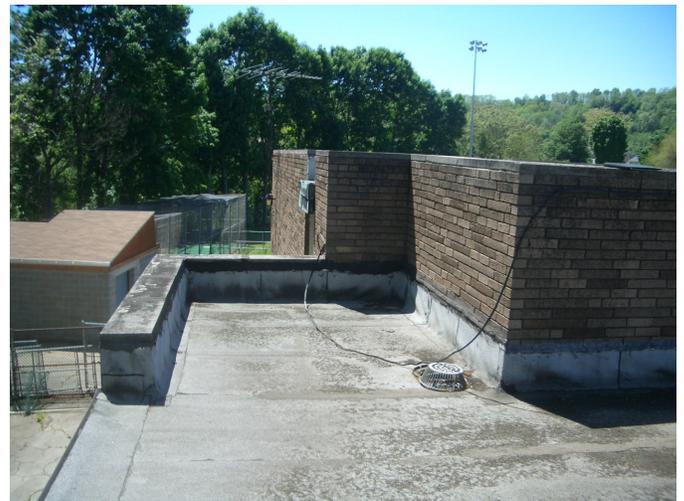
R-12 Community room and apartment wall, coping, gravel stop and drain

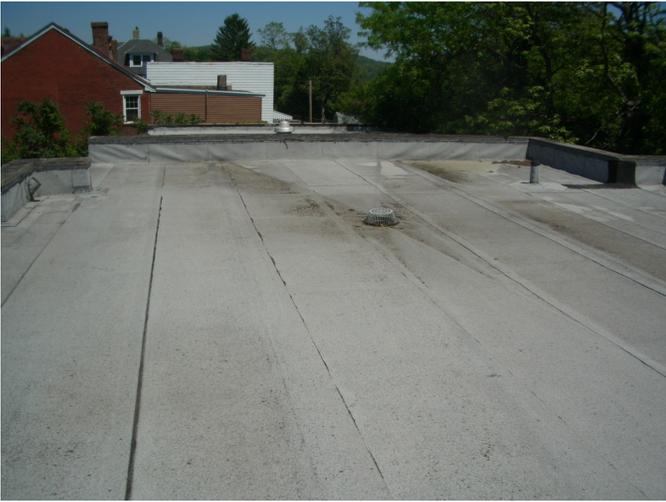
R-13 Apartment roof looking north
