CITY OF
PITTSBURGH
FACILITY ANALYSIS REPORT

Police K-9 Facility
1435 Washington Blvd.
Pittsburgh, Pennsylvania 15206

Police K-9 Facility (B085)
1435 Washington Blvd
Pittsburgh, PA 15206

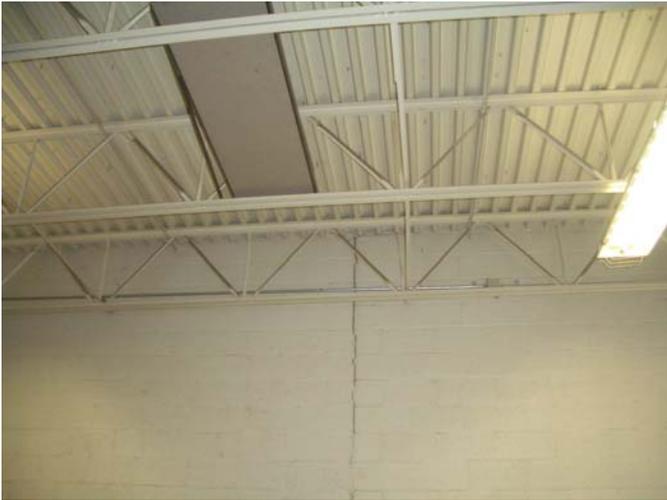
R-1 Underside of training roof roof, metal deck with open web bar joists

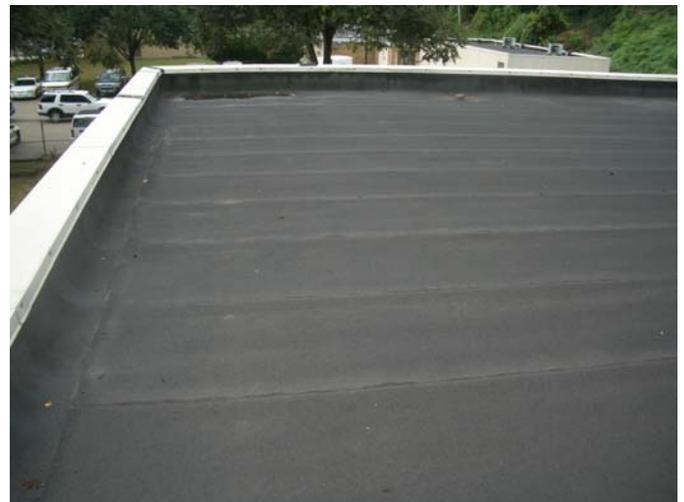
R-5 East wall of training roof looking south

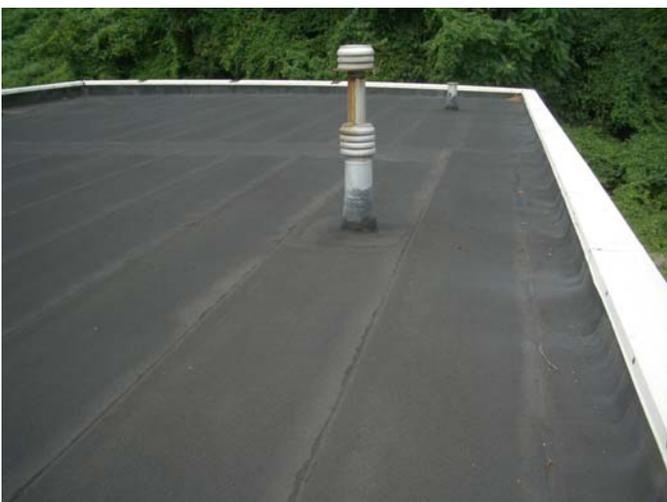
R-3 North wall of training roof looking west

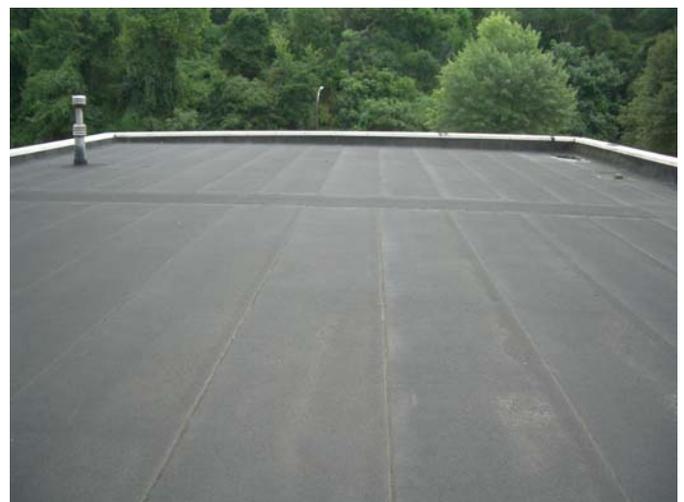
R-6 Training roof looking east

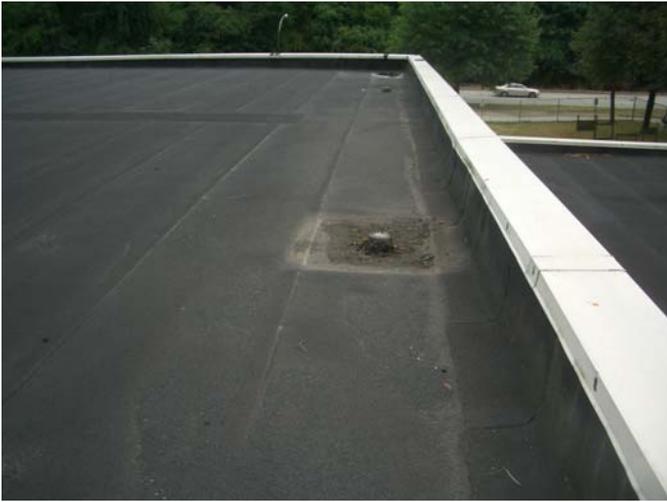
8.2 Condition: Debris observed at some drains. The drainage system appears to be operating properly.

R-7 Training roof south wall looking east, debris at drain

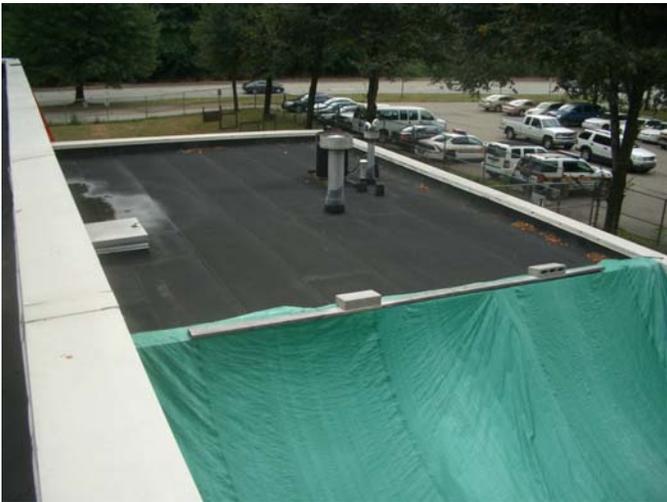
R-8 Office/Kennel roof

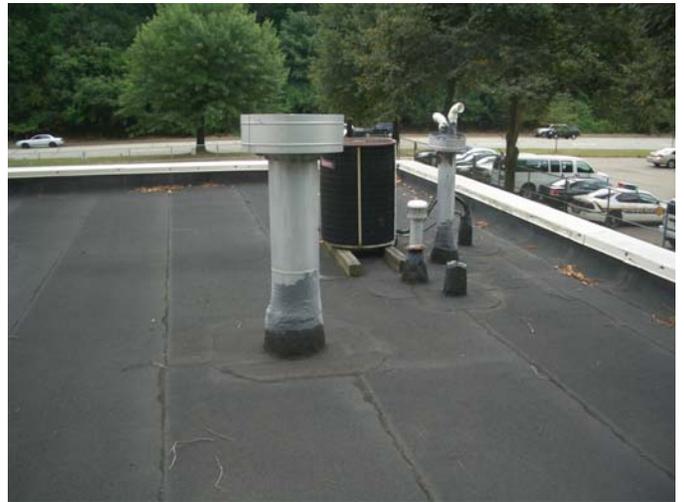
R-11 Office/Kennel roof looking east along south wall

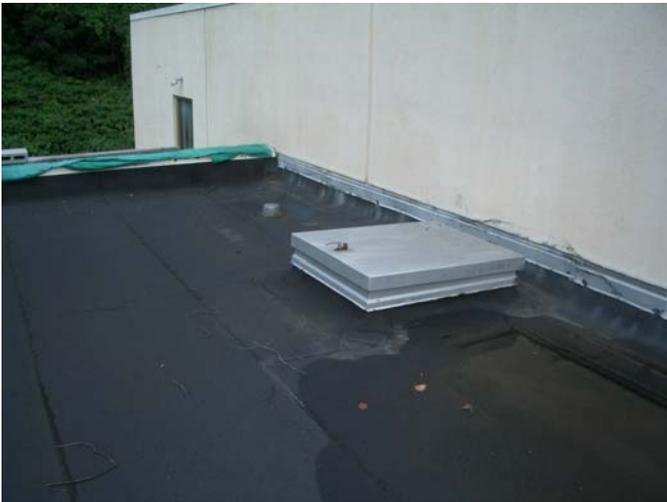
R-9 Office/Kennel roof at training room wall, ponding water

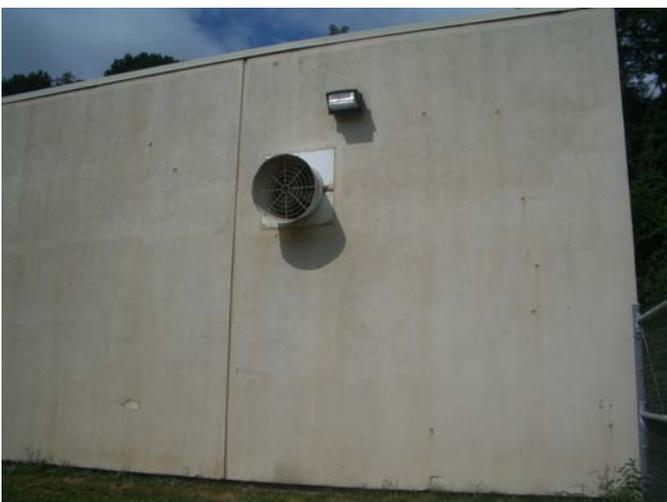
W-2 East wall of Training Room, NE corner

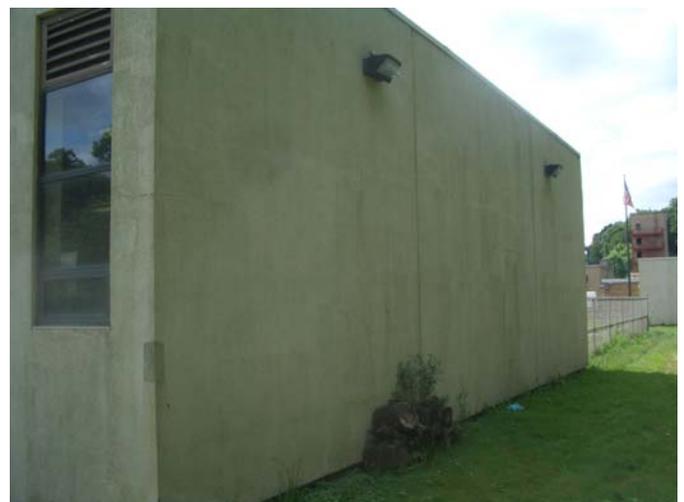
W-5 West wall of Training room

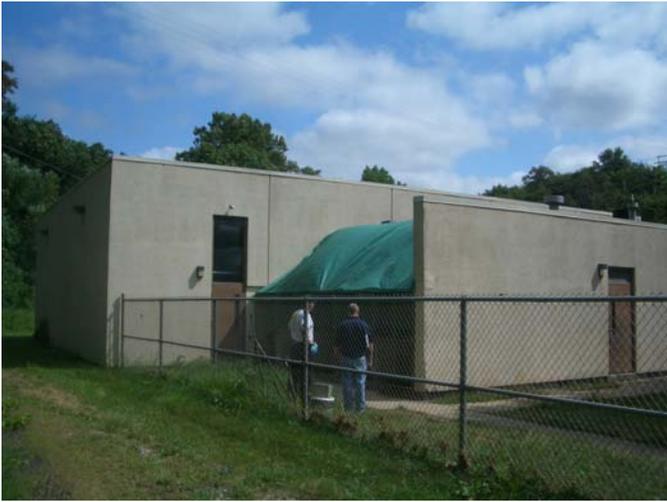
W-6 SW Corner of Office/Kennel area
