CITY OF
PITTSBURGH
FACILITY ANALYSIS REPORT

Police Zone 1 (B379)
1501 Brighton Road
Pittsburgh, Pennsylvania 15212

July 23, 2010

Police Zone 1 (B 379)

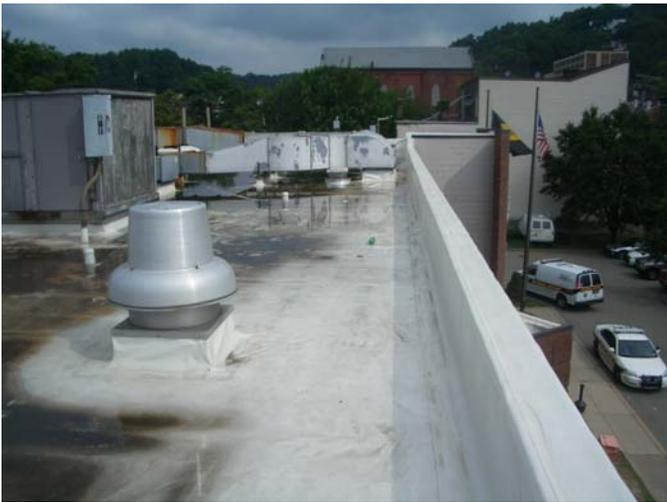
R-1 East side of roof looking north, ponding water

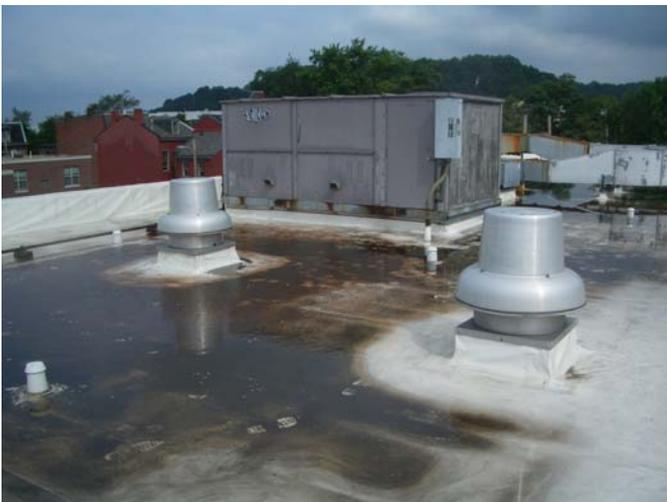
R-2 Ponding water on south end of main roof

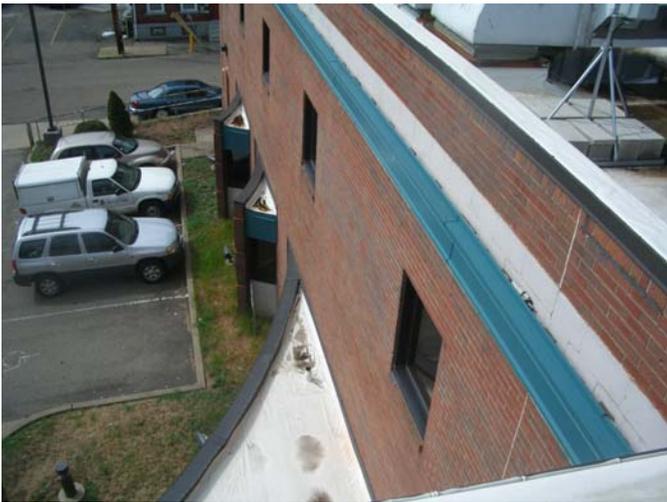
R-7 Entry roof and small window roofs on first floor

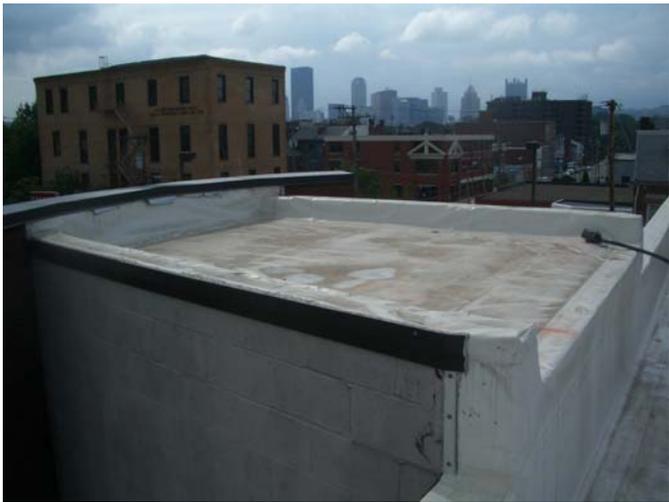
R-10 higher roof above entry

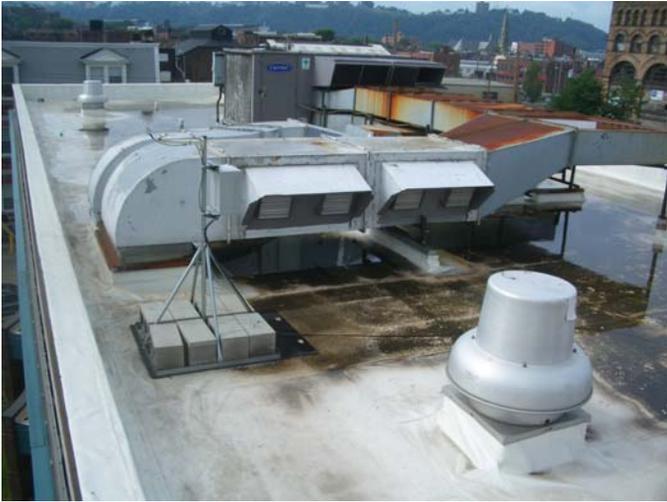
R-8 Middle of roof looking south

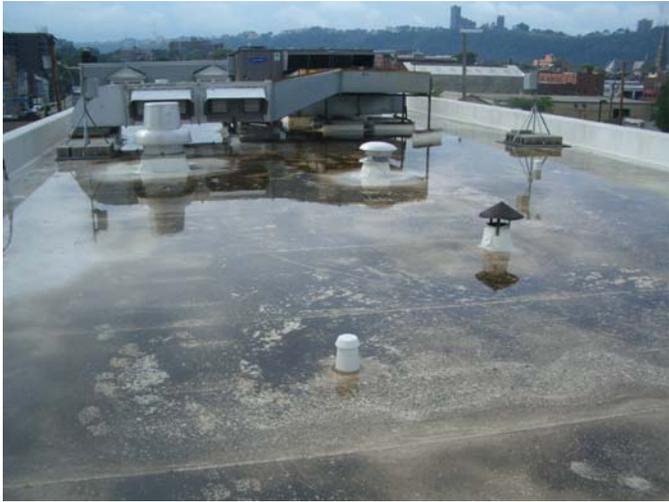
The drainage system is in good condition. The drains appear to be operating properly. The main roof ponds water - drains are on high points.

R-11 Ponding water on main roof

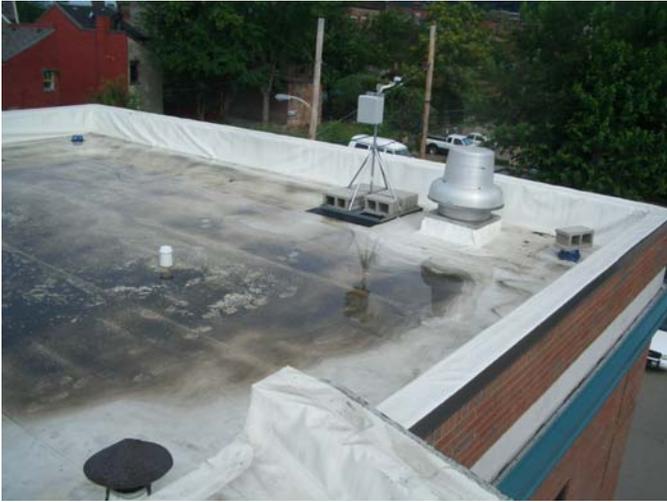
R-9 North end of main roof

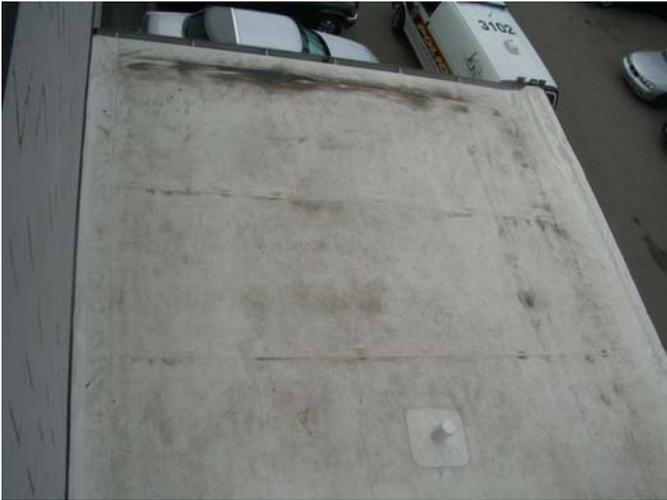
R-13 South end of garage roof

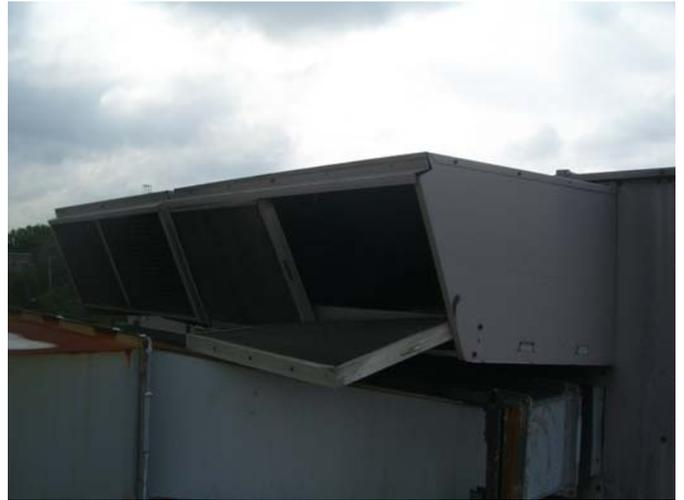
R-16 Filter falling out at HVAC unit

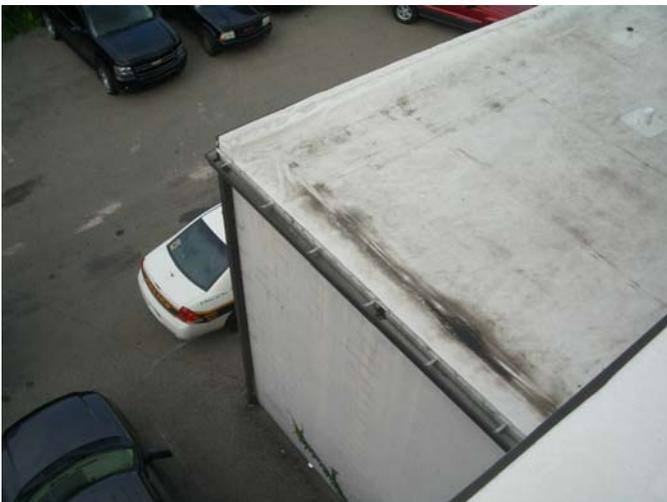
R-14 Gutter system on south end of garage roof

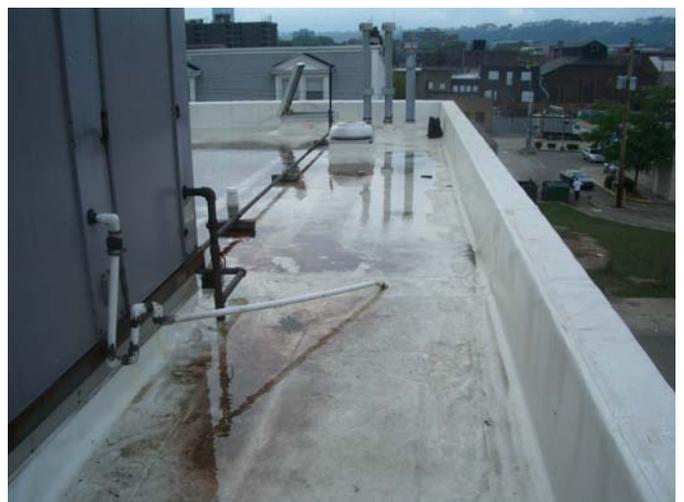
R-18 West wall looking south

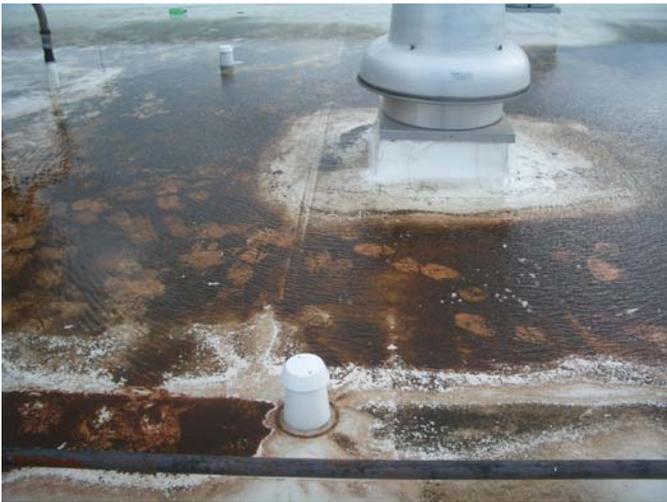
4.2 Condition: The roof system is in good condition. Debris was observed at the roof drains. The white membrane roof surfaces are very dirty and ponds water.

R-19 Dirty roof surface, roof vents and ponding water

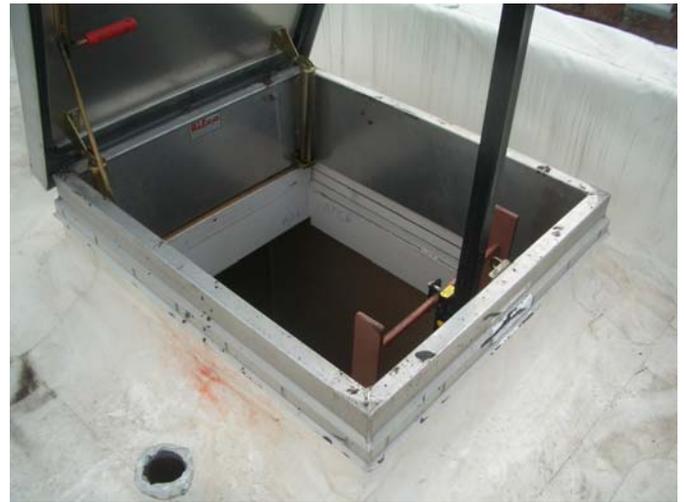
R-22 Roof hatch

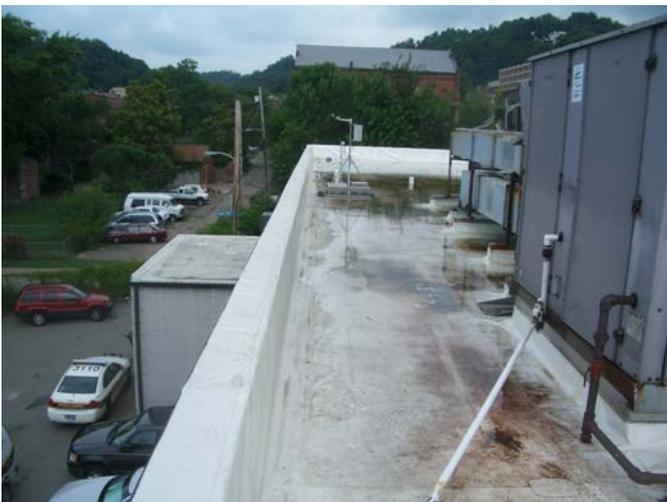
R-20 West wall looking north

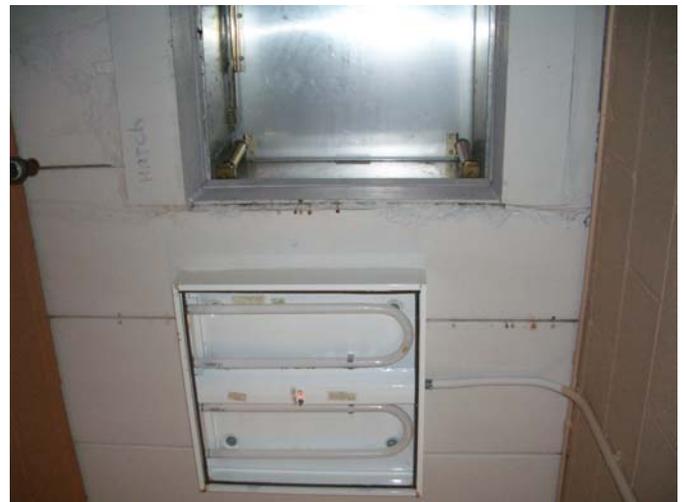
R-23 Underside of deck showing concrete plank

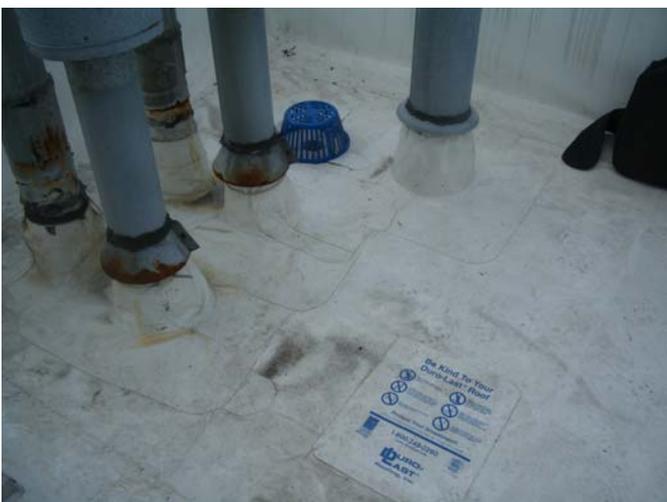
R-21 SW corner and manufacturer's stamp on roof

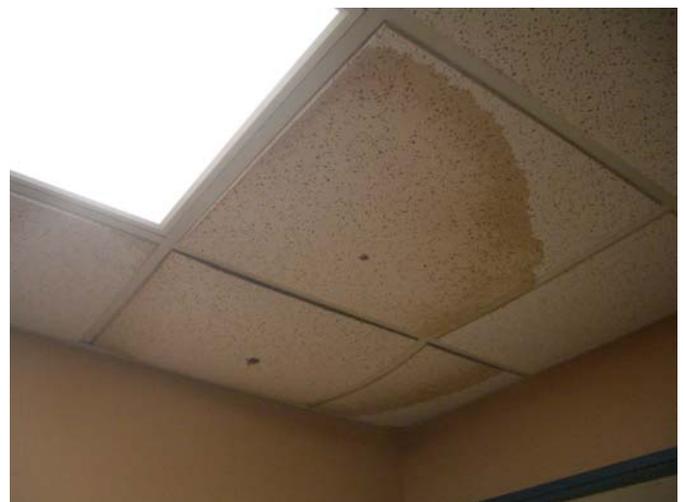
R-24 Stained ceiling in commander's office - leak reported fixed

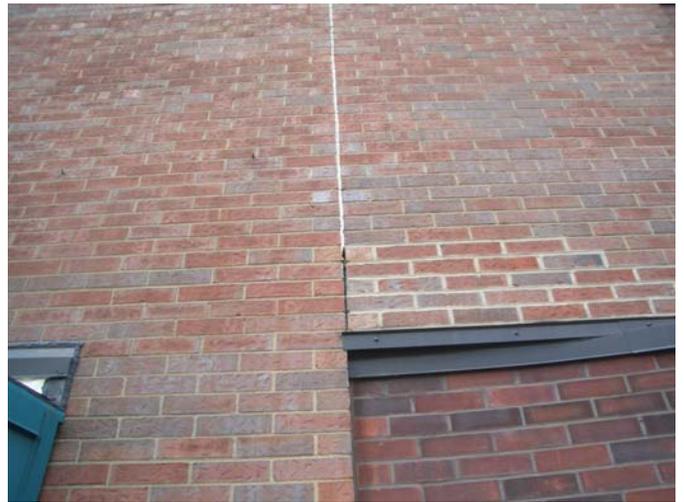
W-4 Caulking missing at front wall

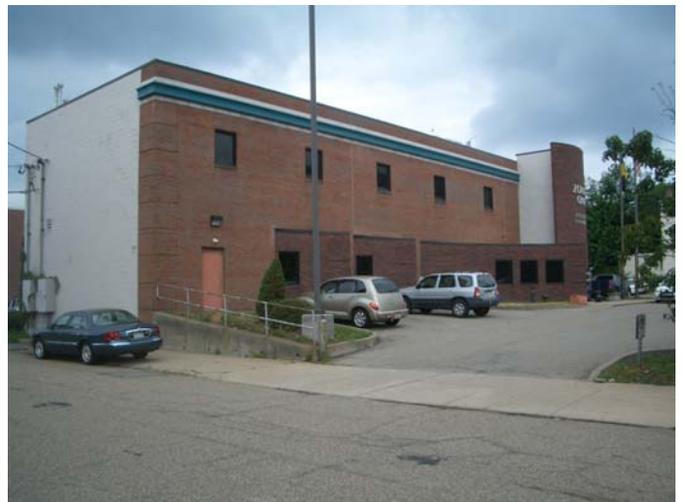
W-5 Front of building from SE

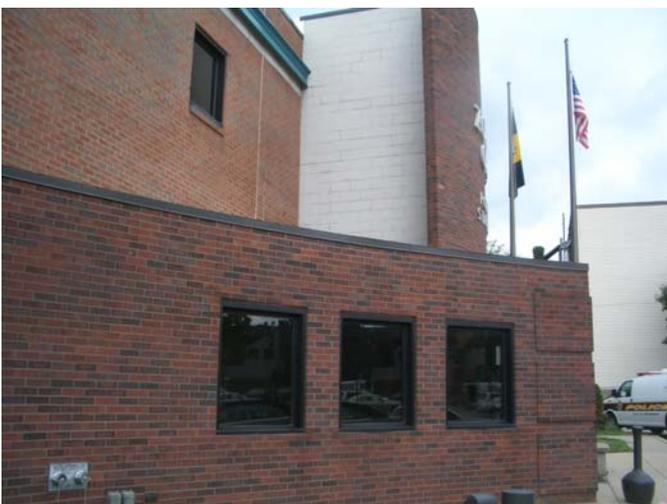
W-3 South side of entry area

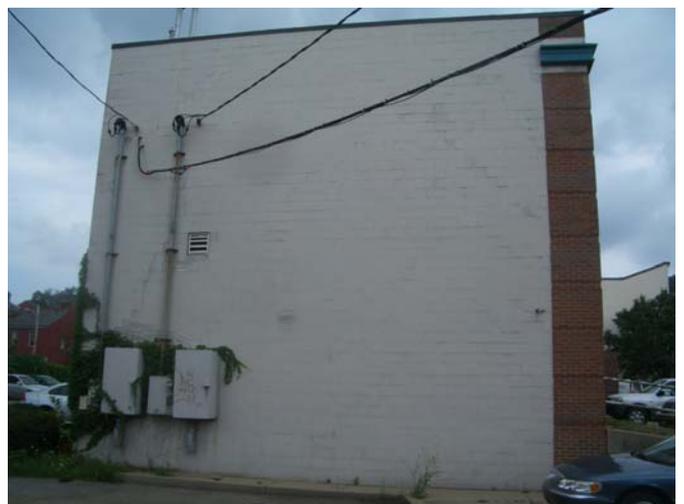
W-6 South wall

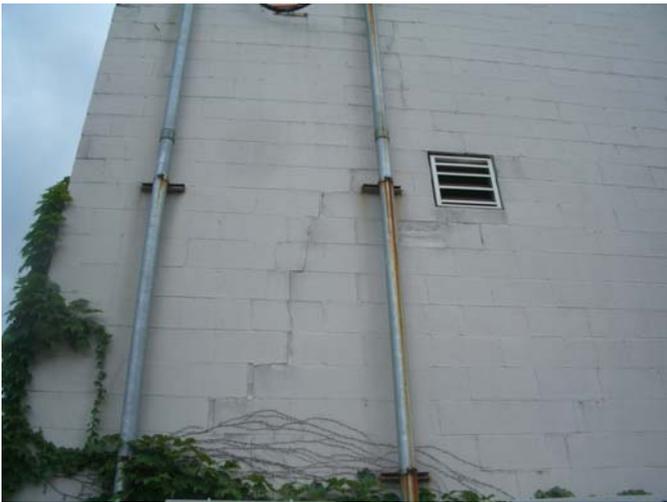
10.1 There are cracked mortar joints in the concrete block walls. The potential for water infiltration is high in these areas.

W-7 Cracked mortar joints in south wall

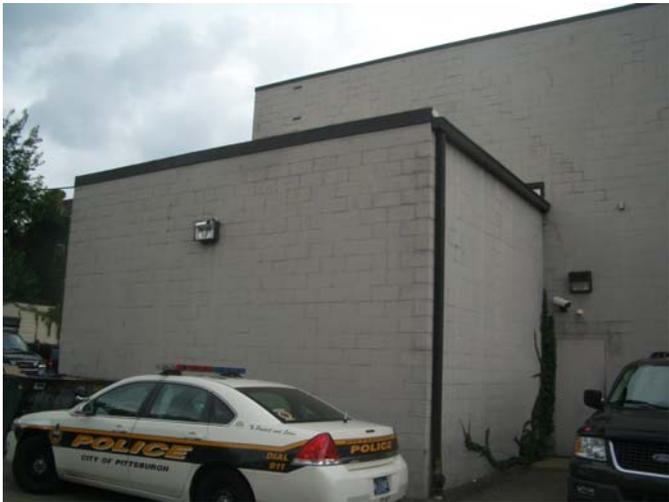
W-11 West wall of garage

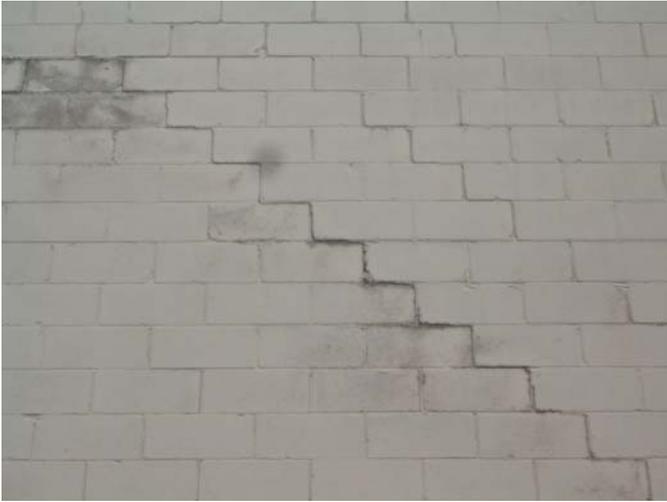
W-9 Cracked mortar joints in west wall

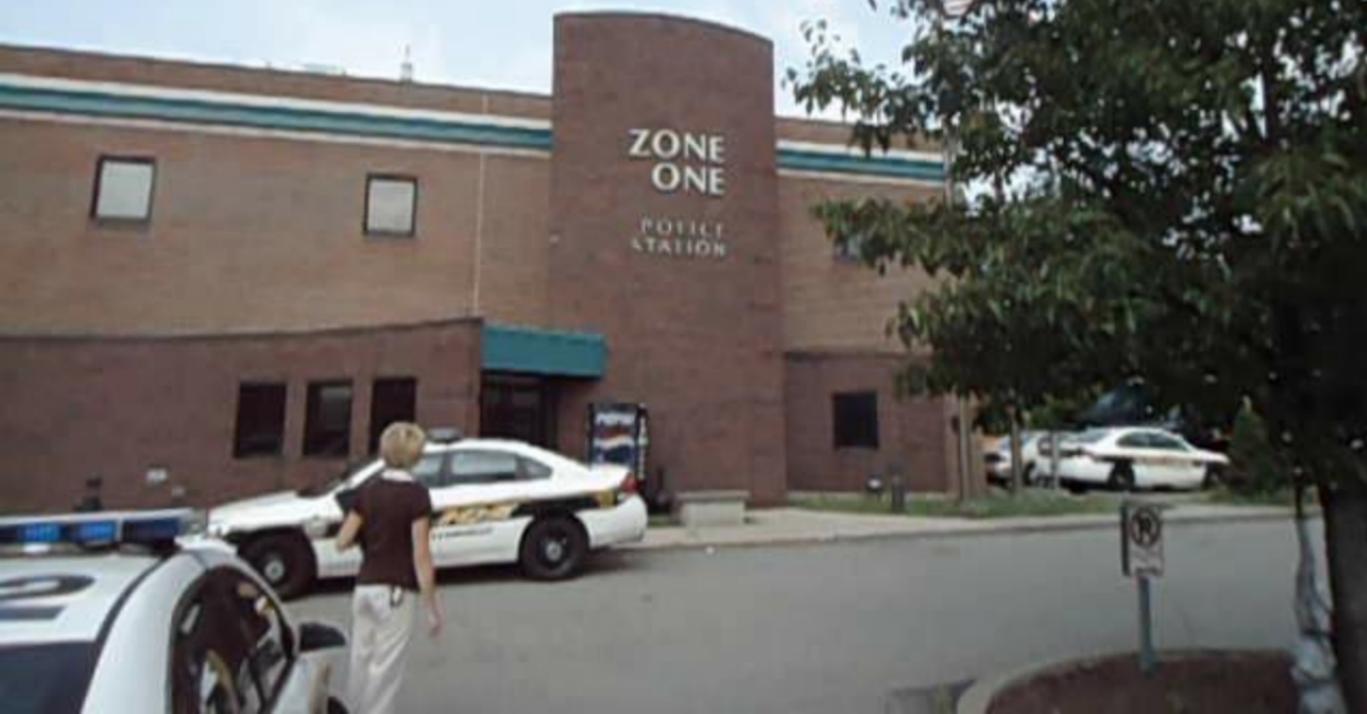
S001

Site lighting is in Fair condition with little Old/Poor - Looks like various types of merc. wall mounted units, high pressure sodium and/or metal halide. Replace Poor in 0-1 year. Replace Fair with induction lighting in 0-5 years.
