CITY OF
PITTSBURGH
FACILITY ANALYSIS REPORT

Pittsburgh Police Zone 2 (B108)
2000 Centre Avenue
Pittsburgh, Pennsylvania 15219

July 21, 2010

Police Zone 2 (B 108)
2000 Centre Avenue
Pittsburgh, PA 15219

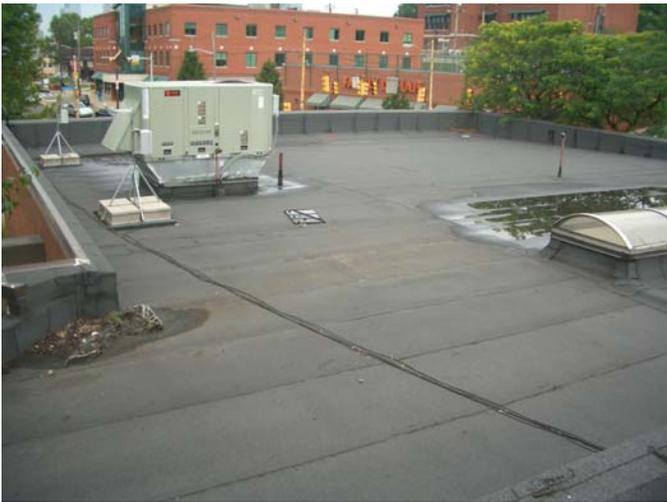
R-1 Looking at NW corner, pond near the skylight

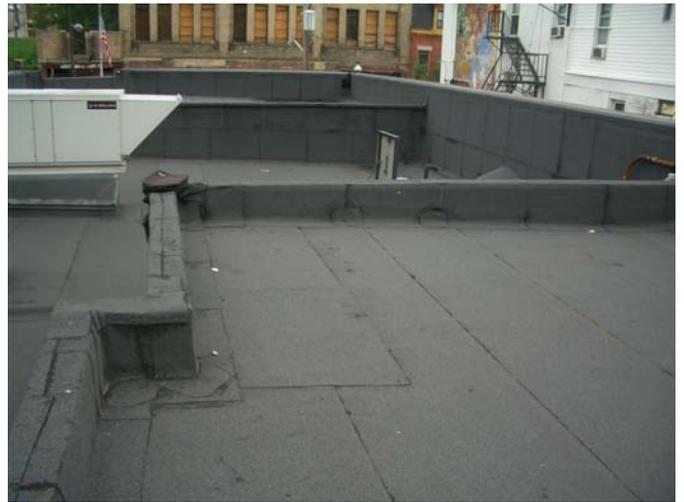
R-4 Looking north along east wall

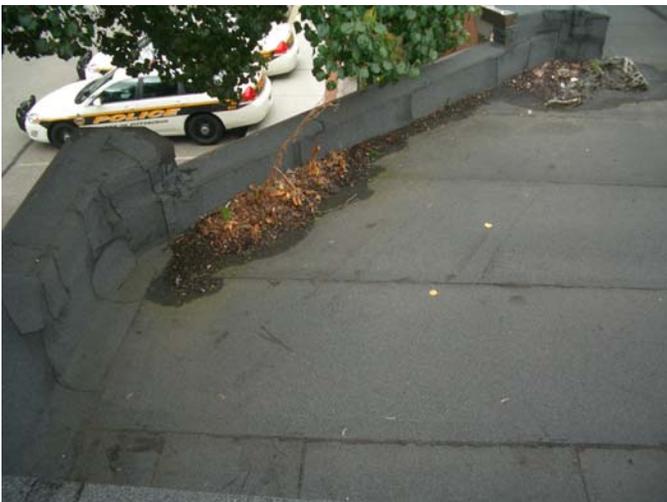
R-2 Debris in the middle of south wall

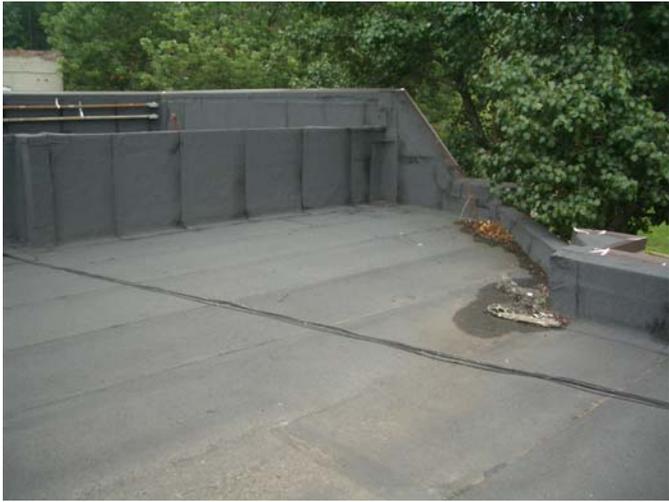
R-10 South wall, debris on roof

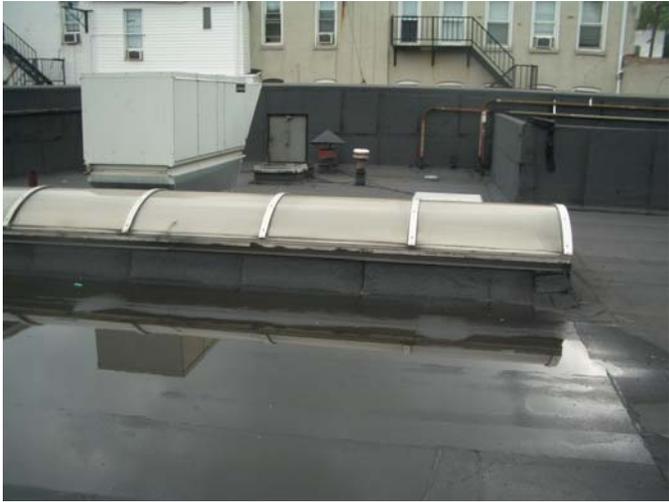
R-11 Pond at skylight, looking east

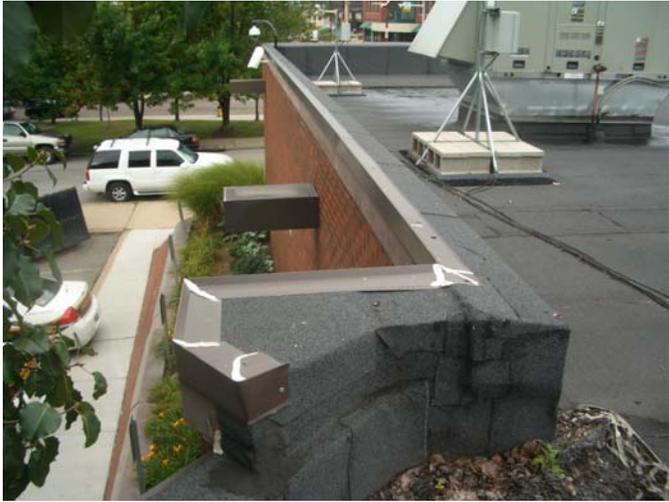
R-12 Parapet with metal drip edge on stone coping

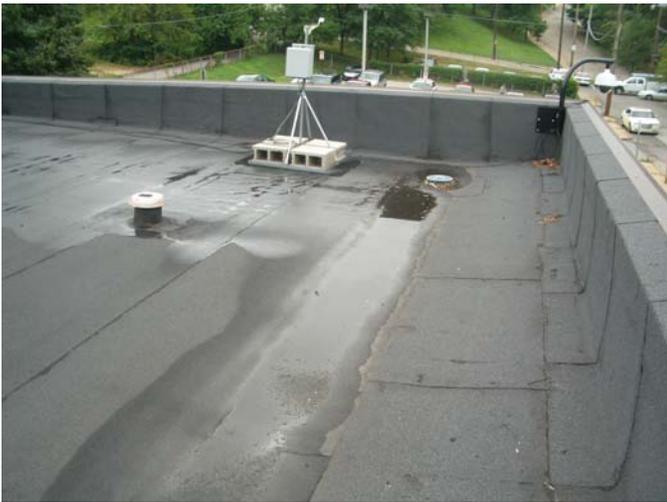
R-13 SW corner, debris at roof drain

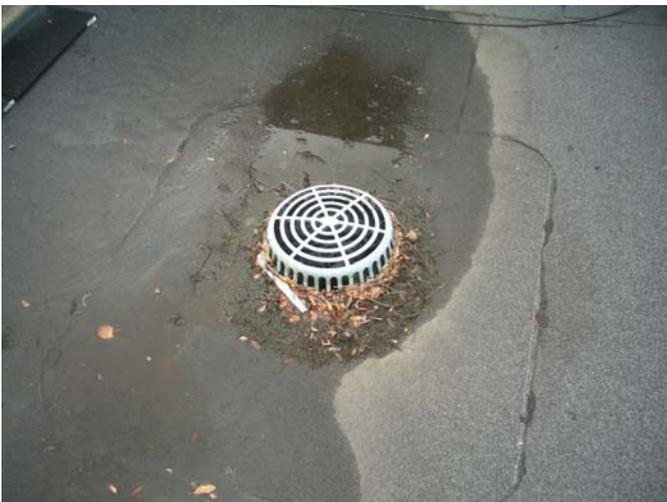
R-14 SW Corner drain with debris

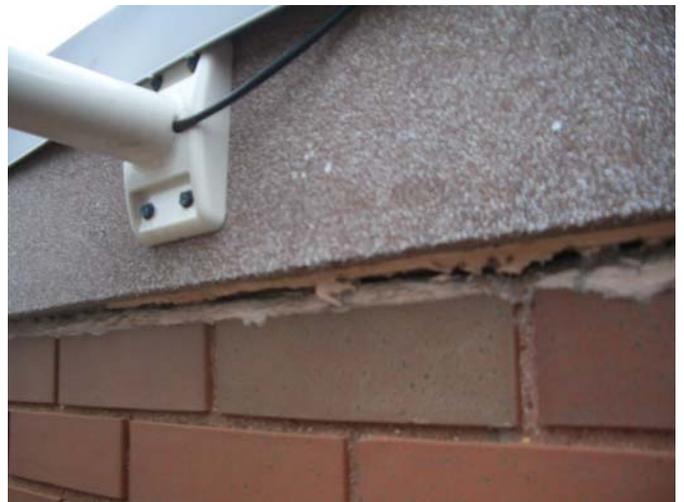
R-17 Open bed joint on north wall coping stone

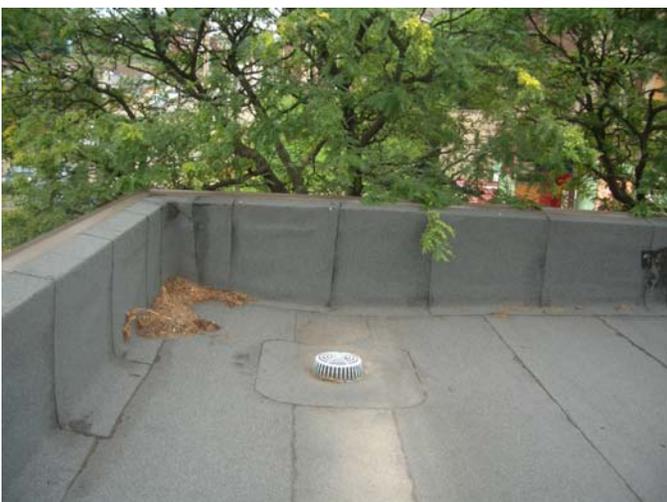
R-15 Debris on roof with overhanging tree branches

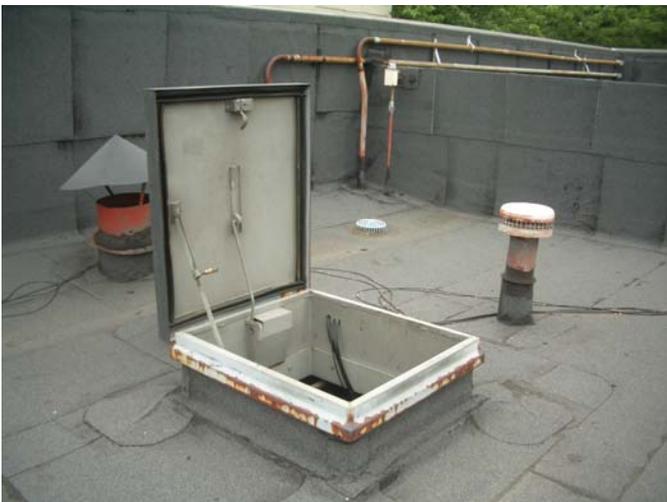
R-20 Roof Hatch

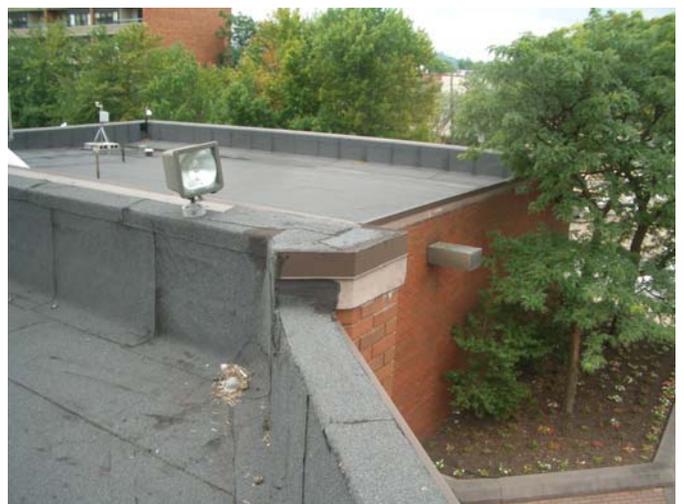
R-21 Pond on NE corner area

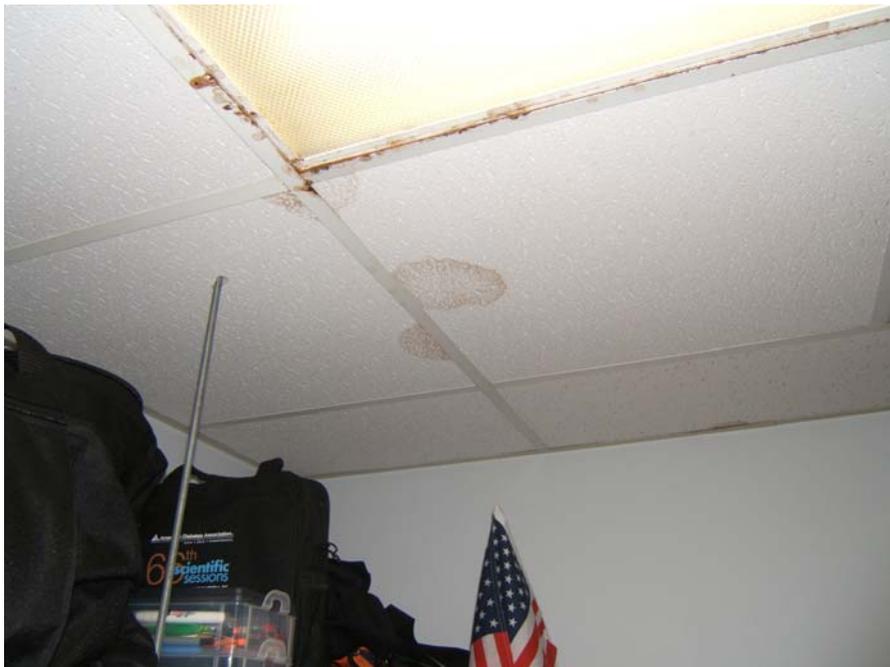
Photo 8

- 8) Water damaged ceiling tile were observed in numerous locations throughout the interior of the building. The water appears to be infiltrating the rolled roofing material. See photos 8 thru 10. Recommend replacing the rolled roofing material with a rubber roof system. See Roofing Report for additional information and recommendations.
