CITY OF
PITTSBURGH
PROPERTY CONDITION REPORT

B405 – Police Zone 3
830 East Warrington Avenue
Pittsburgh, Pennsylvania 15210

June 2014

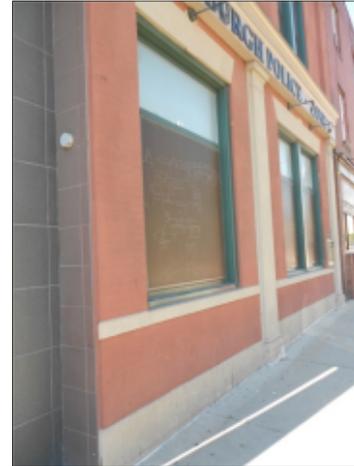
SH2 – North façade : etched aluminum window spandrel panels at grade

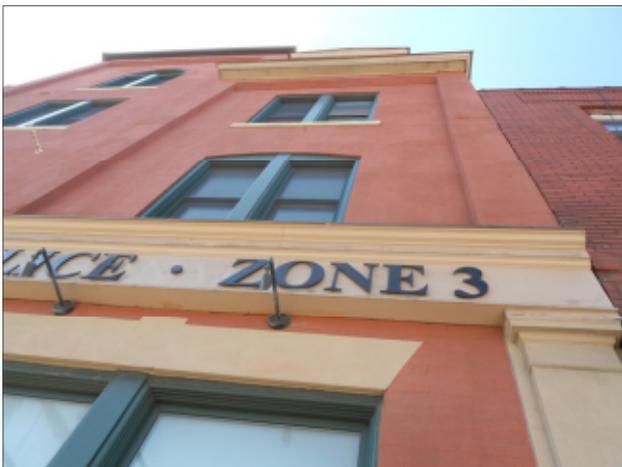
SH3 – North façade: acrylic masonry coating

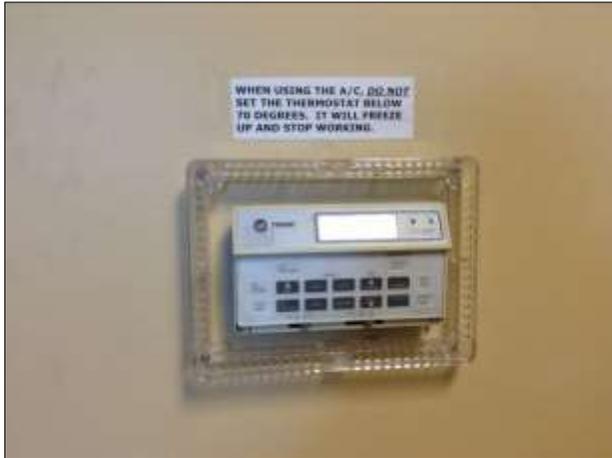
HVAC 19 – Programmable thermostat (set point problem)

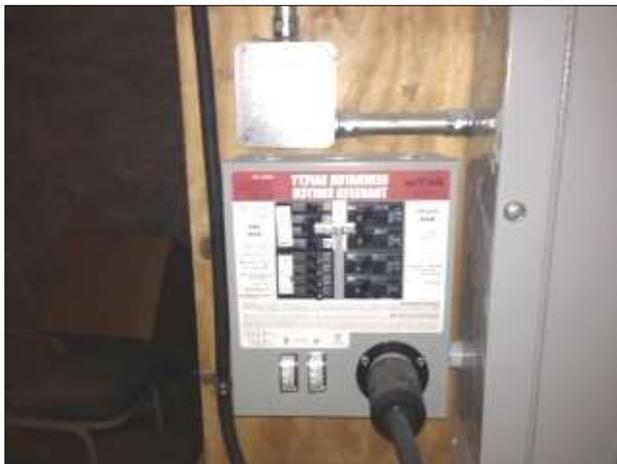
- 3.3. Construction - Central Emergency Generator and system: Emergency Generator located in basement, natural gas type.
 - 3.3.1. Condition Central Emergency Generator: **Good**

E48 – Emergency generator panel

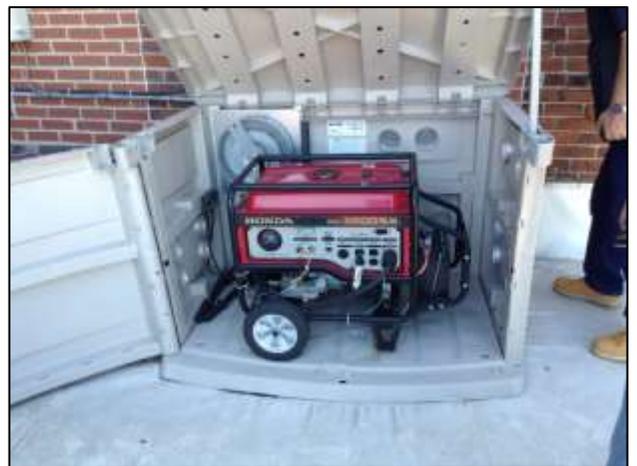
- 3.4. Construction - Small Emergency Generator: Small Emergency Generator located on lower roof. Gasoline type.
 - 3.4.1. Condition Central Emergency Generator: **Good**

E49 – Emergency generator: Lower roof

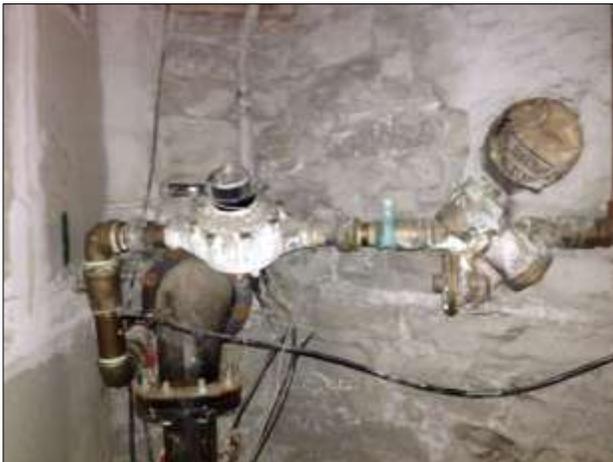
- 3.1 General Description: Potable water supply
- 3.2 Construction
 - 3.2.1 Meter, shut-off valve, back-flow preventer, and piping.
- 3.3 Condition Assessment: **Poor**

P14 – Domestic water service, back-flow preventer, utility meter, and piping

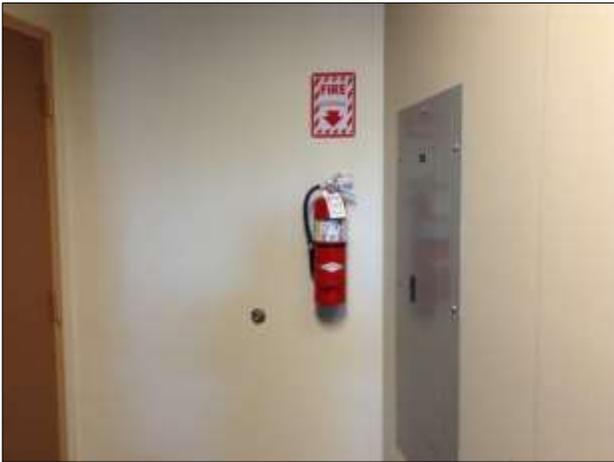
FP 1 – Extinguisher – 1a

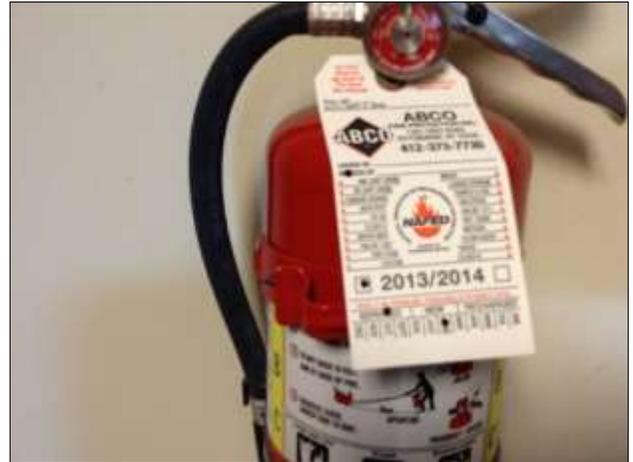
FP 2 – Extinguisher – 1b

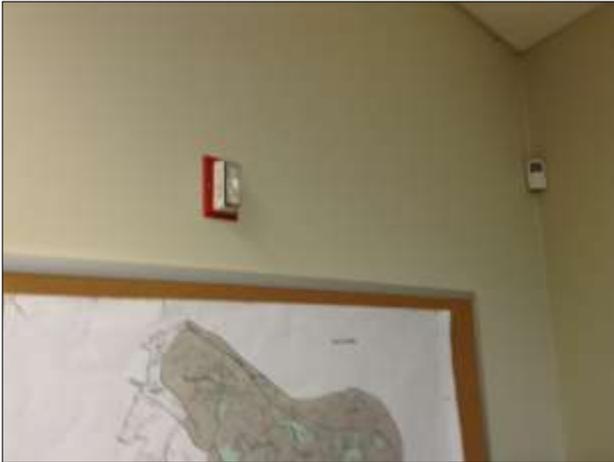
FP 3 – Strobe alarm

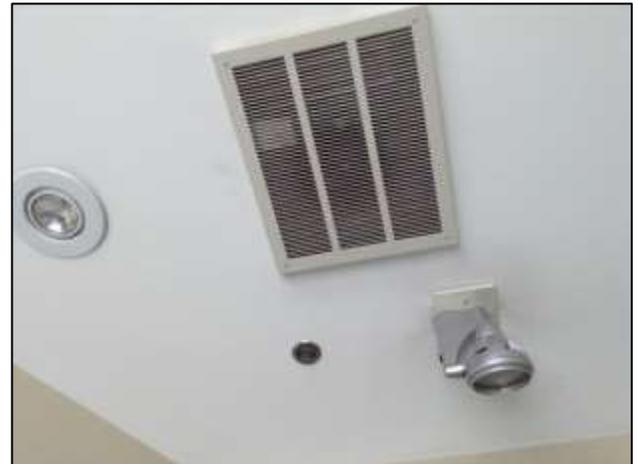
FP 4 – Sprinkler head (typical)

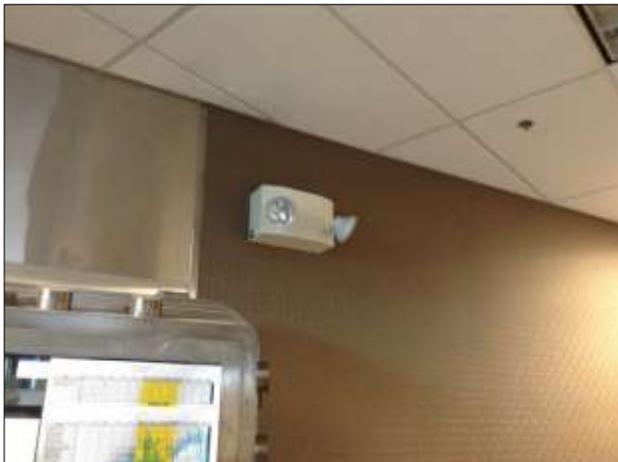
FP 5 – Emergency light (typical)

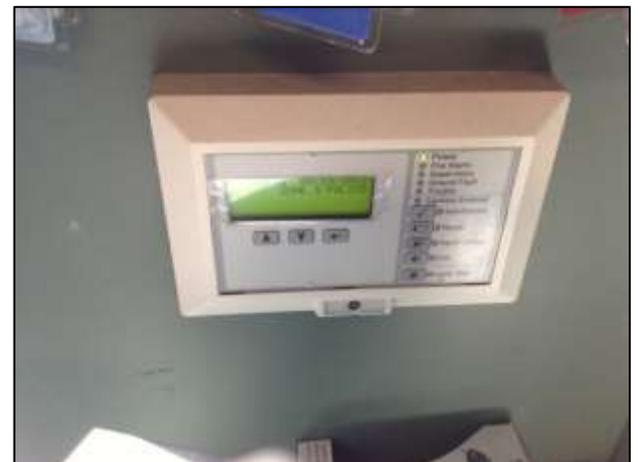
FP 6 – Fire alarm system interface

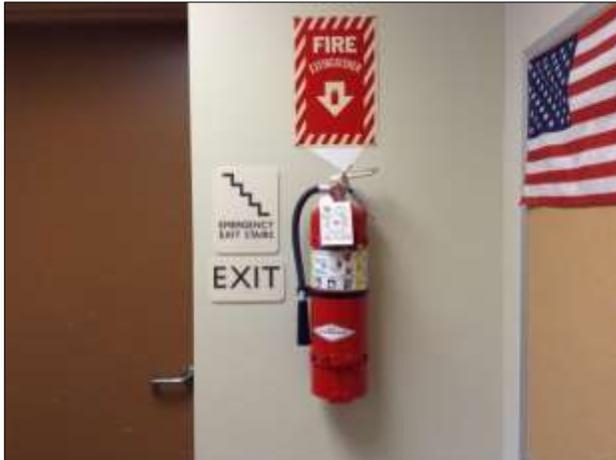
FP 7 – Extinguisher – 2a

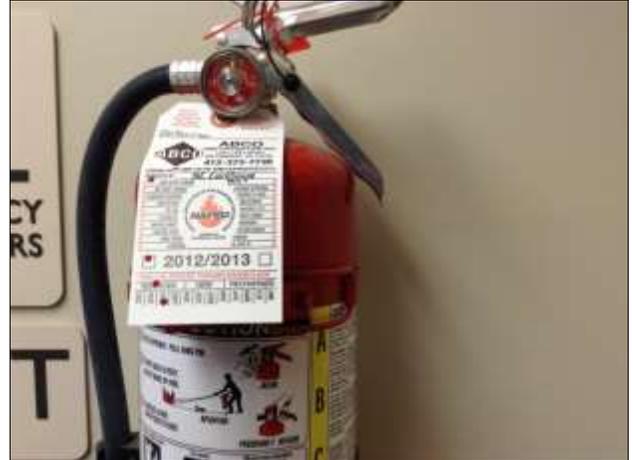
FP 8 – Extinguisher – 2b

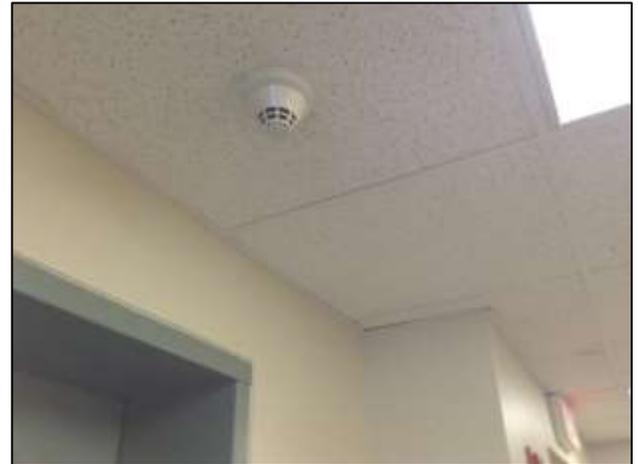
FP 10 – Smoke/Fire detector (typical)

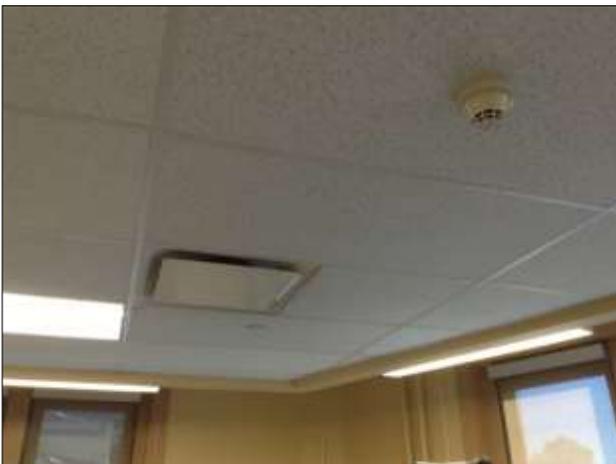
FP 11 – Smoke/Fire detector (typical)

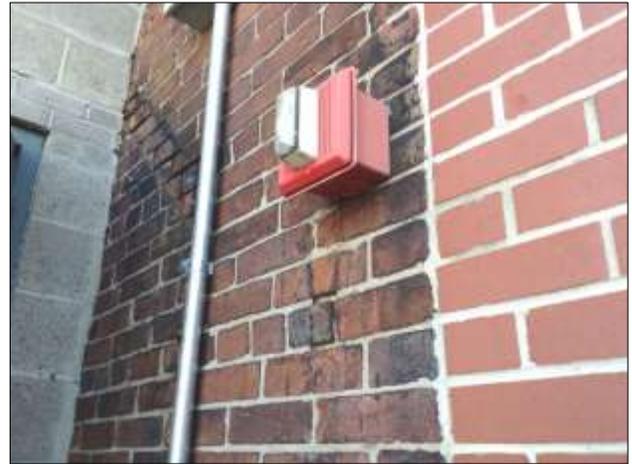
FP 44 – Strobe alarm (weather proof)

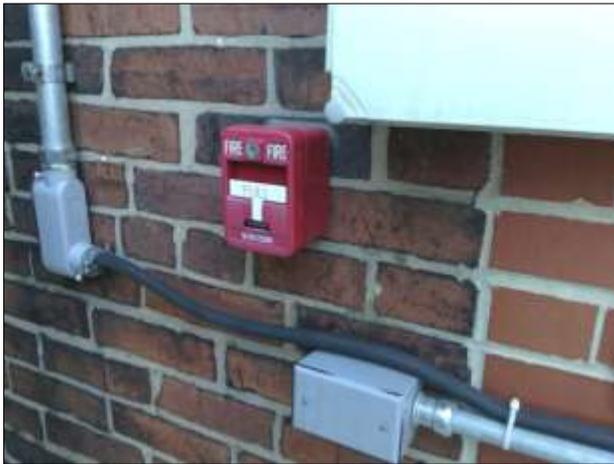
FP 45 – Pull station (weather proof)

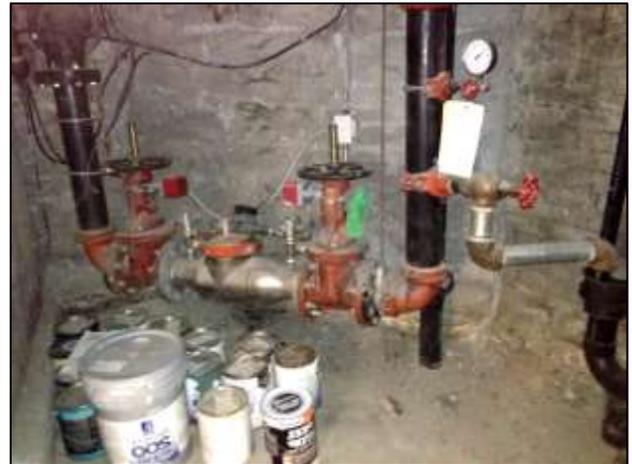
FP 46 – Sprinkler system manifold and valves (basement)

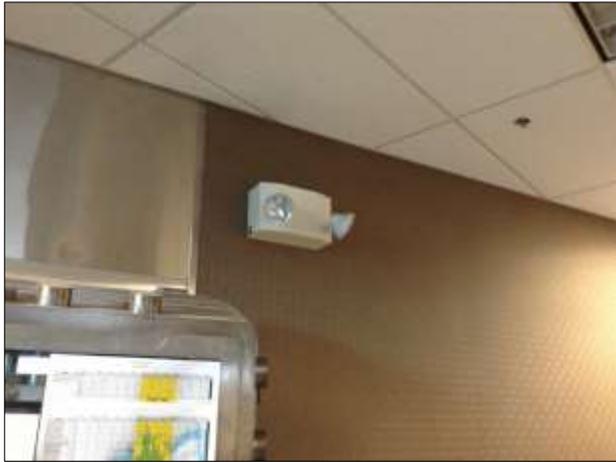
LS 1 – Emergency light fixture (1st Floor)

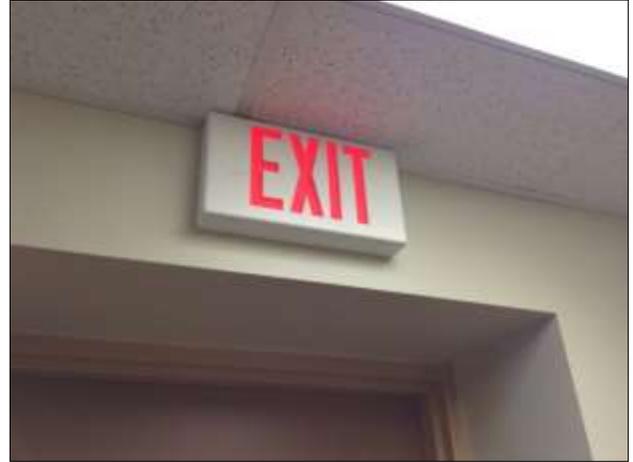
LS 2 – Emergency light / sign fixture

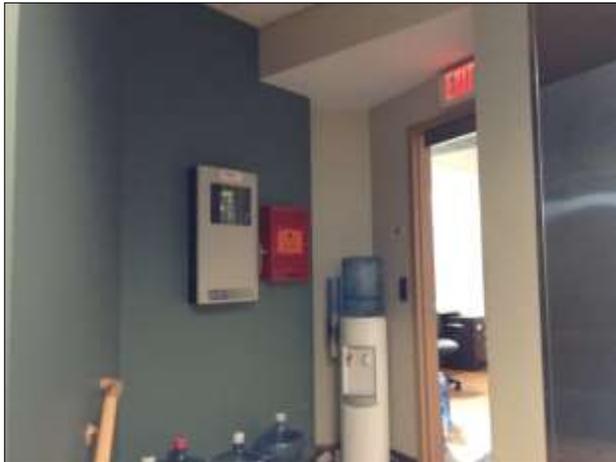
LS 3 – Exit area

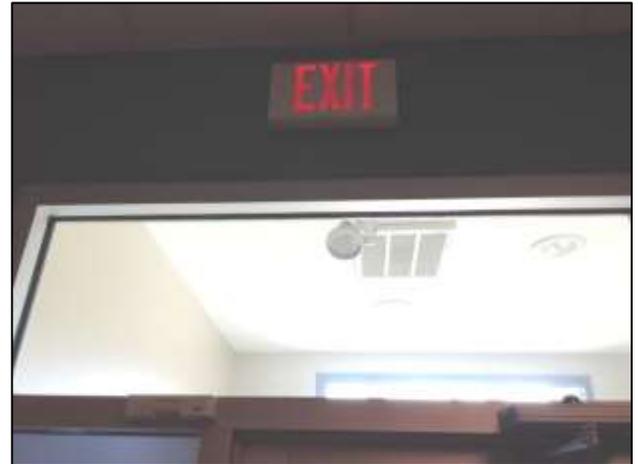
LS 4 – Emergency light / sign fixture

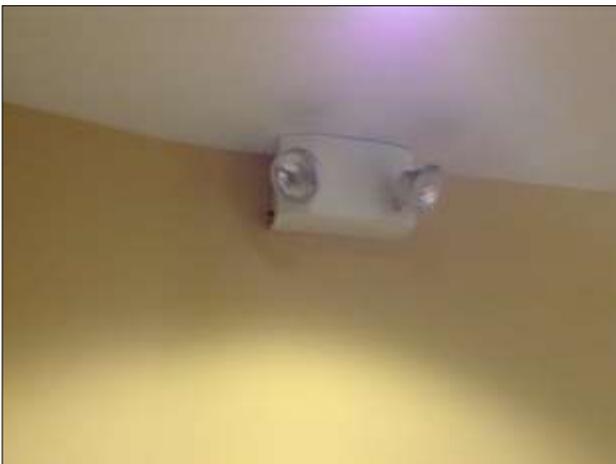
LS 5 – Emergency light fixture

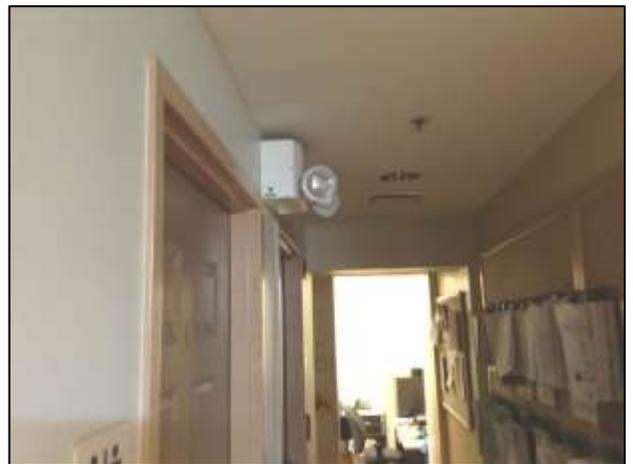
LS 6 – Emergency light fixture

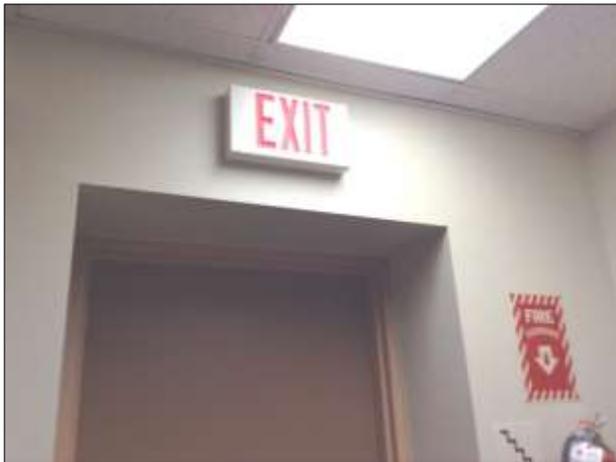
LS 7 – Emergency light / sign fixture

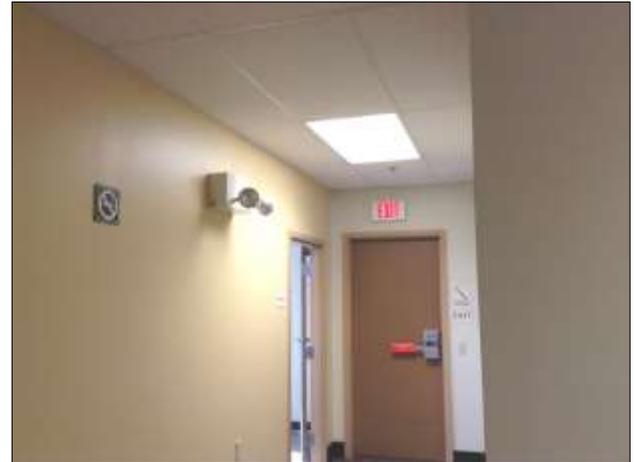
LS 8 – Exit area

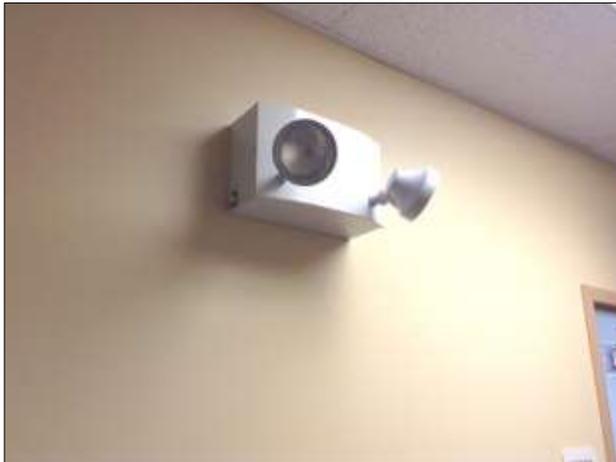
LS 9 – Emergency light

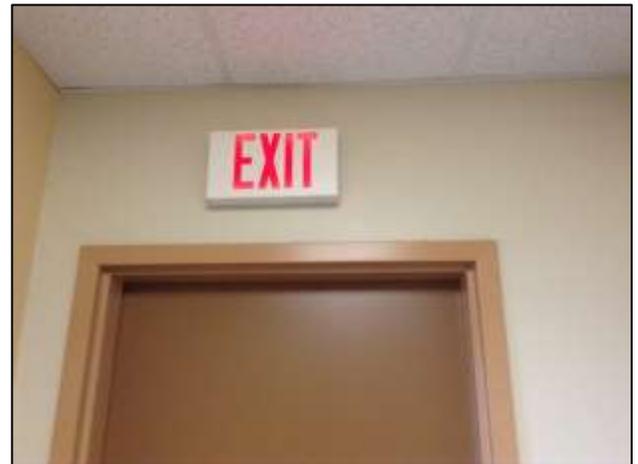
LS 10 – Emergency light / sign fixture

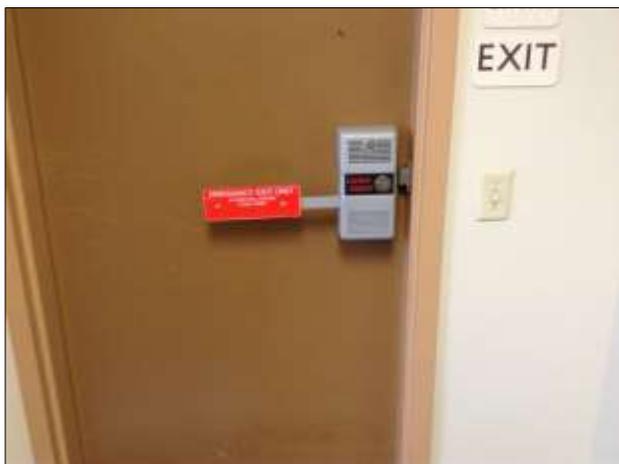
LS 11 – Emergency exit door hardware

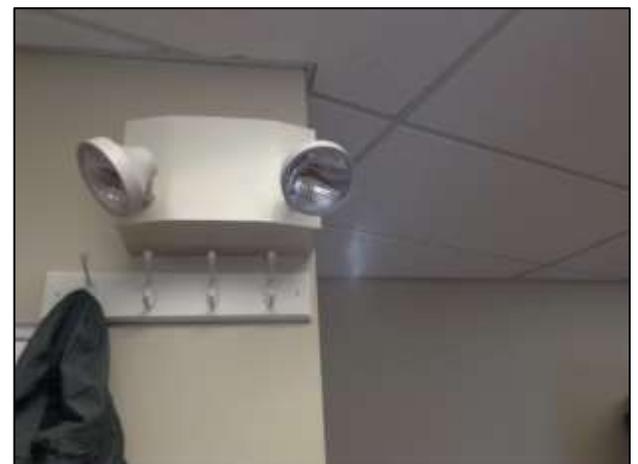
LS 12 – Emergency light

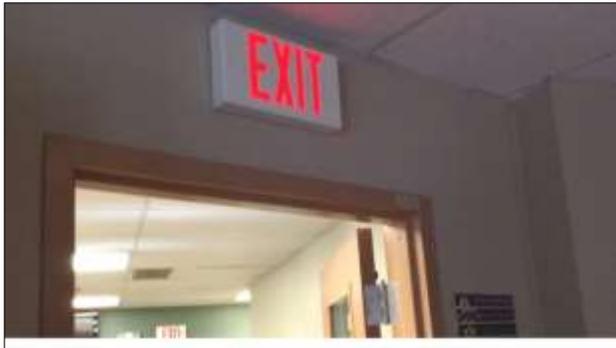
LS 13 – Emergency light / sign fixture

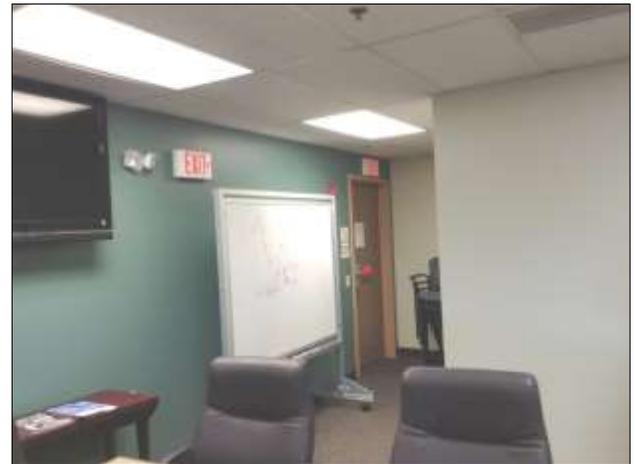
LS 14 – Emergency exit: 2nd floor

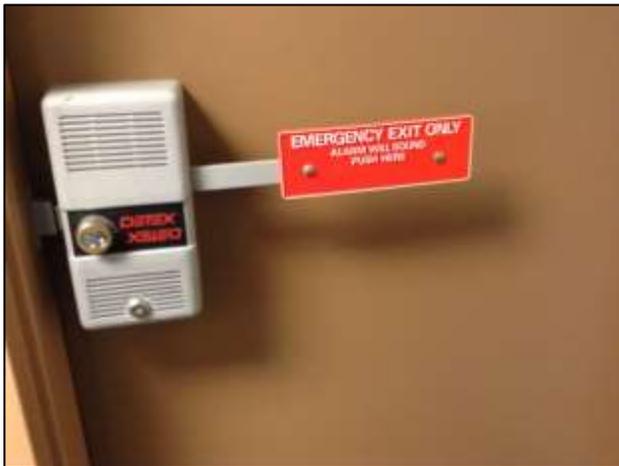
LS 15 – Emergency exit door hardware

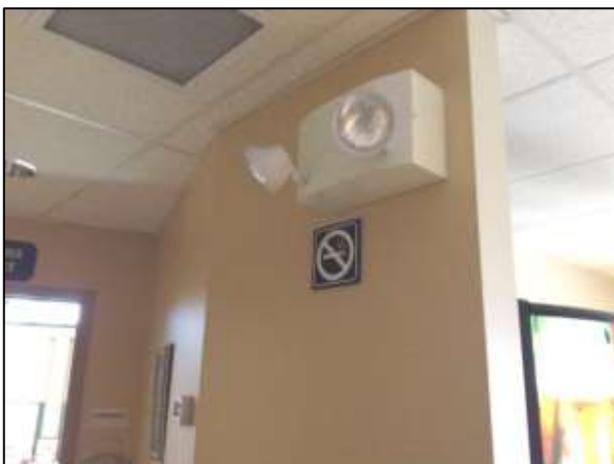
LS 17 – Basement emergency existing sign/light (typical)
