CITY OF
PITTSBURGH
FACILITY ANALYSIS REPORT

Pittsburgh Police Zone 5 (B402)
1401 Washington Blvd
Pittsburgh, Pennsylvania 15206

June 25, 2010

Executive Summary

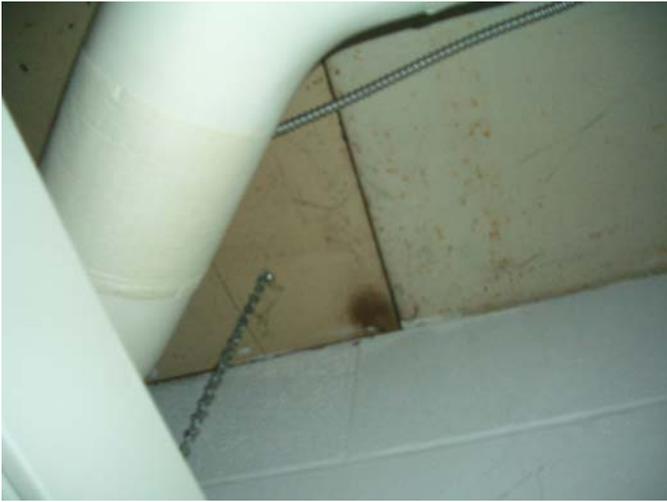
R-1 Underside of Roof deck

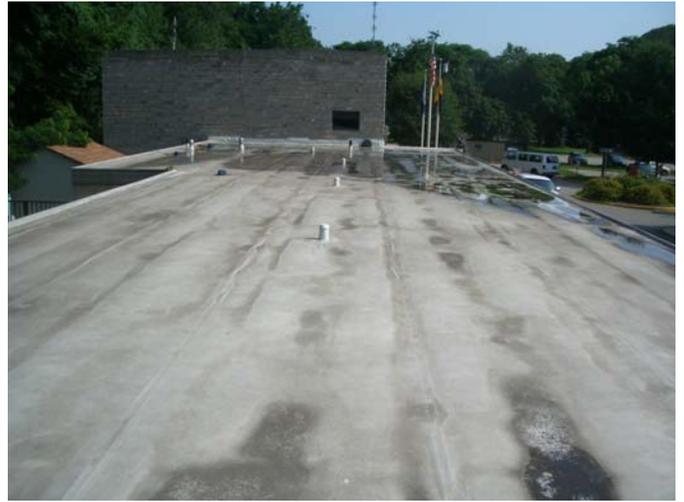
R-4 Garage roof looking north, dirty surface

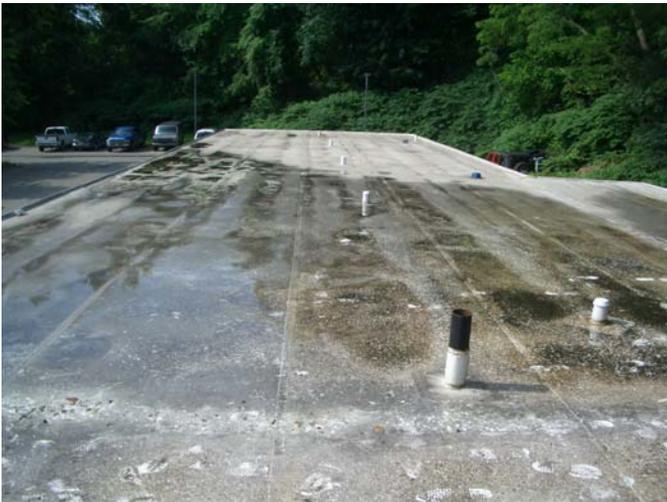
R-2 Garage roof looking south, dirty surface, pond

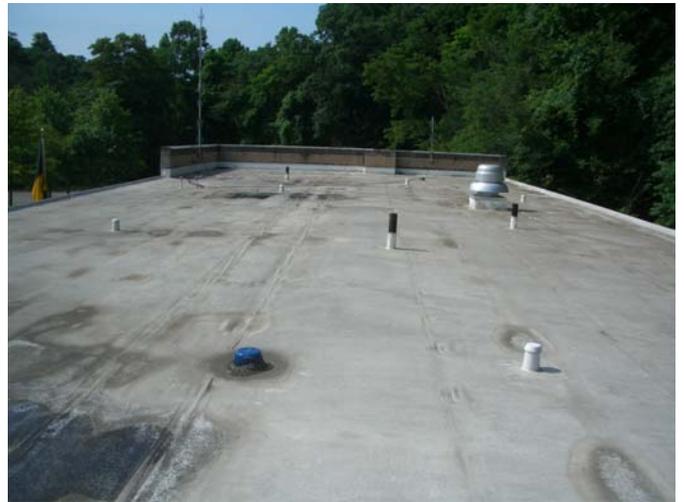
R-5 Second floor Office area looking south

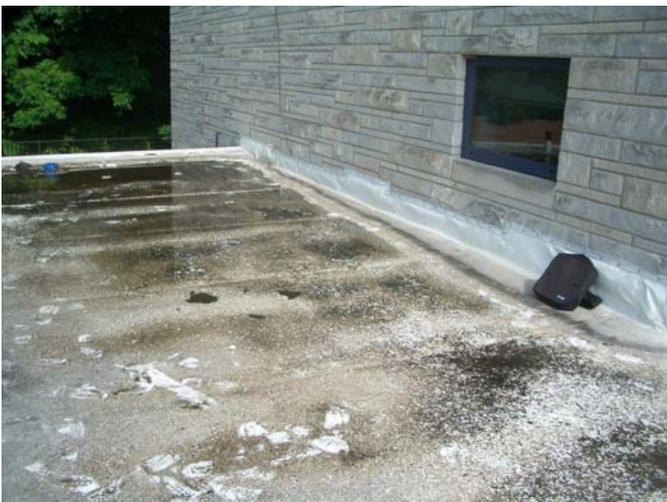
R-3 Garage roof tie in to two story office area, dirty surface, pond

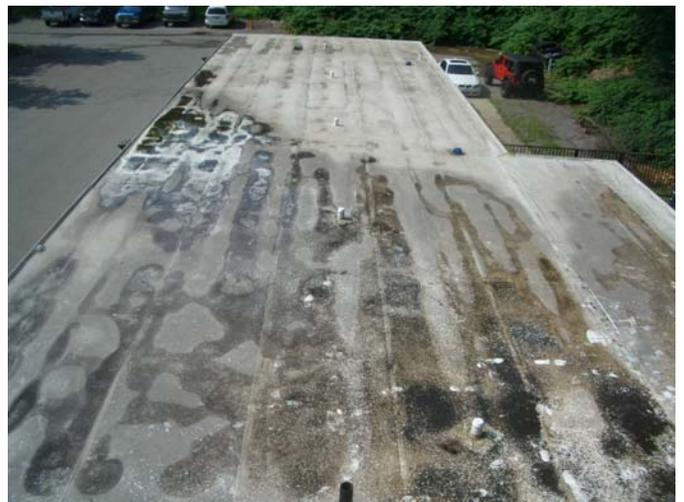
R-6 Garage Roof looking south, dirty surface and pond

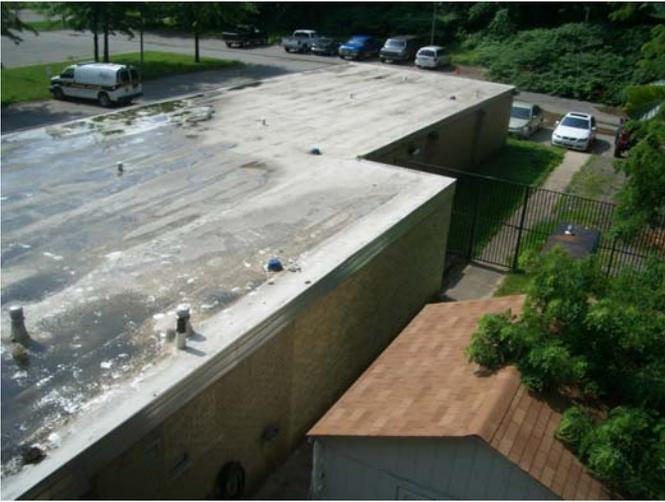
R-7 Garage roof, west side, looking south

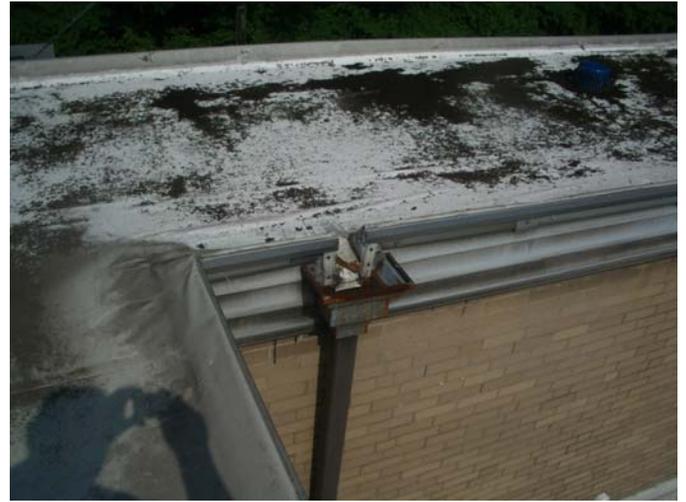
R-10 Scupper at NW corner of office area

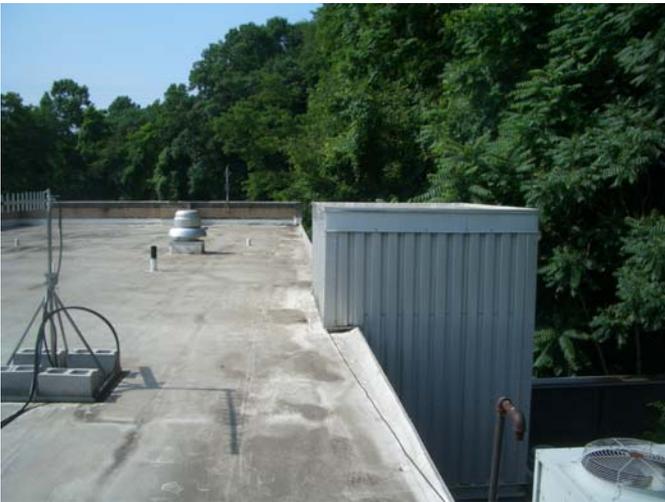
R-8 Second floor roof, looking south, elevator addition on west side

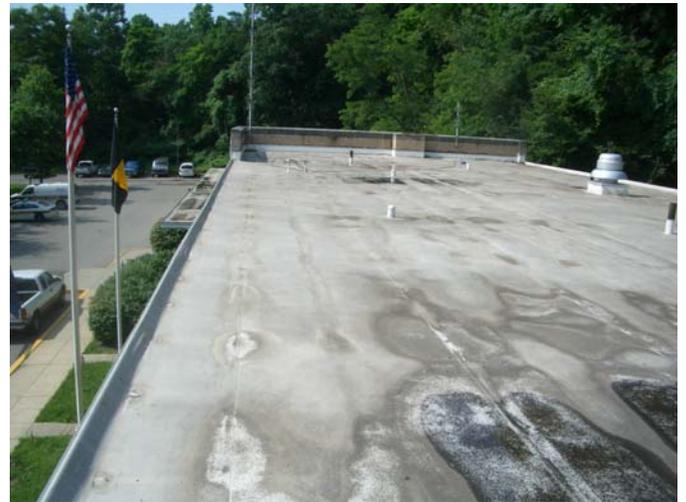
The drainage system is in good condition. The drains appear to be operating properly but some are blocked with debris causing ponding water on the roof surface.

R-11 Office roof looking south, pond and dirty surface

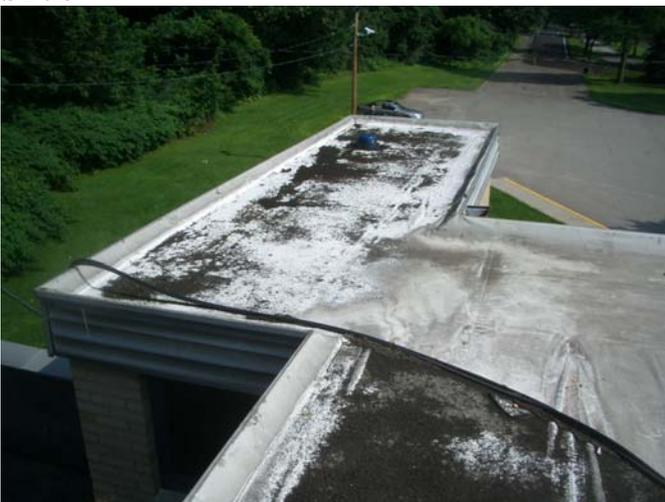
R-9 NW corner of second floor office area

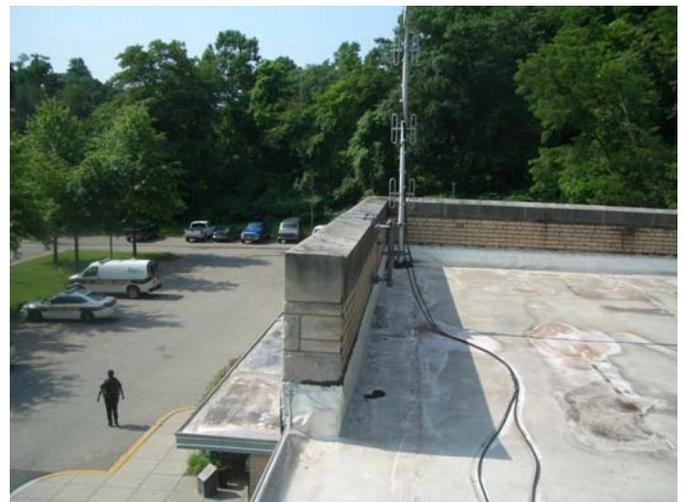
R-12 SE corner of office area, parapet wall

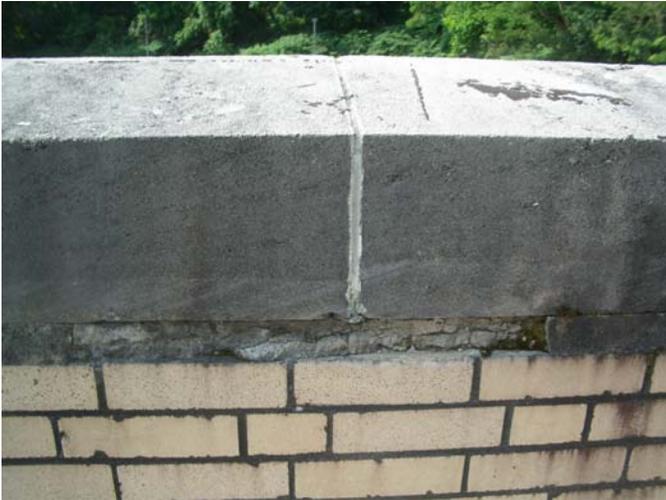
1.2 Condition: The building walls appear to be in fair condition. One area of cracked mortar joints was observed on the south end of the second floor office wall.

R-14 Mortar deteriorated on isolated area of parapet wall on office area

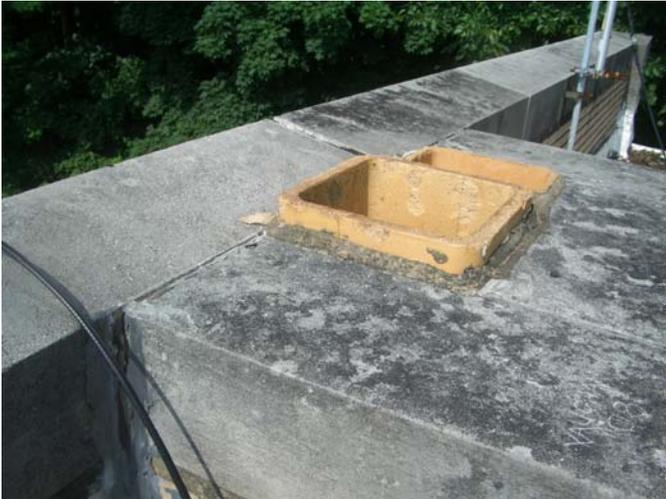
R-15 Chimney on office area

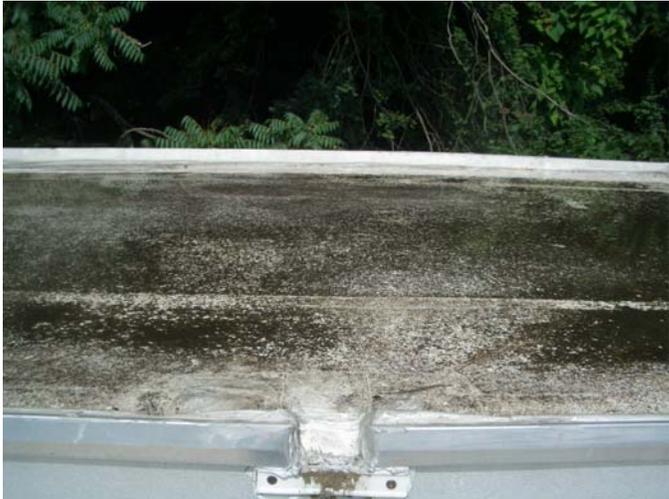
R-18 Elevator roof, ponding water and scupper

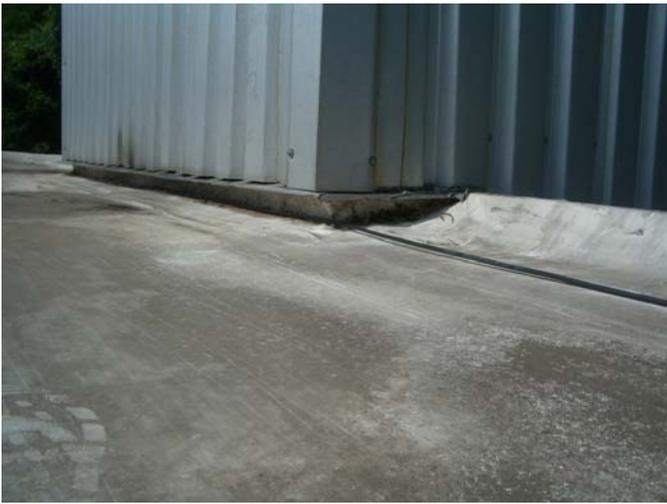
R-19 Base of Elevator roof on office area

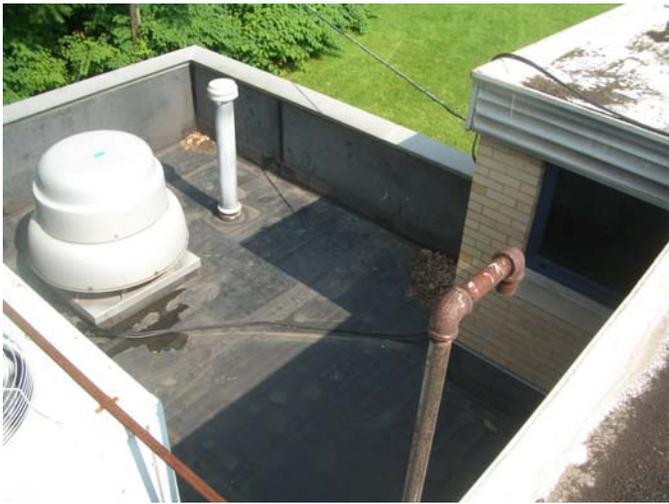
R-22 Mechanical roof, NW corner

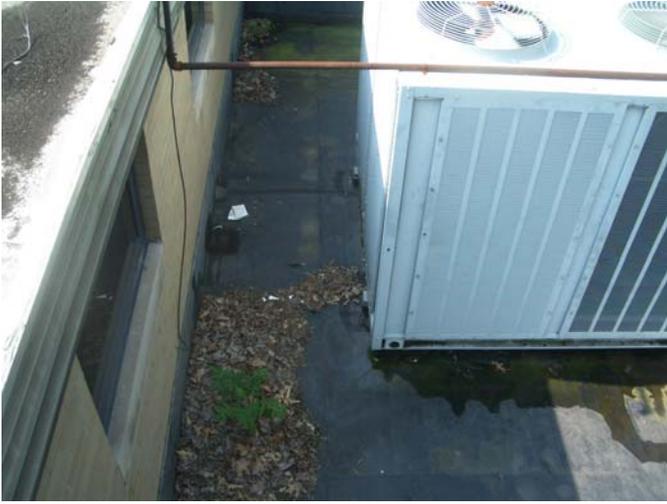
R-20 Mechanical roof, debris, east wall

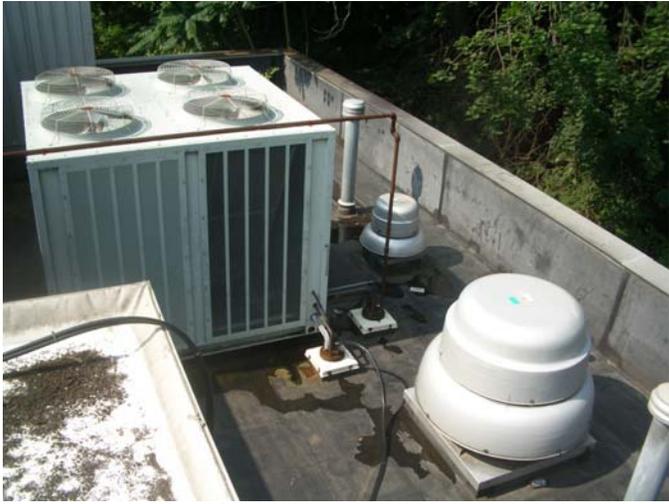
R-23 Mechanical roof, west wall

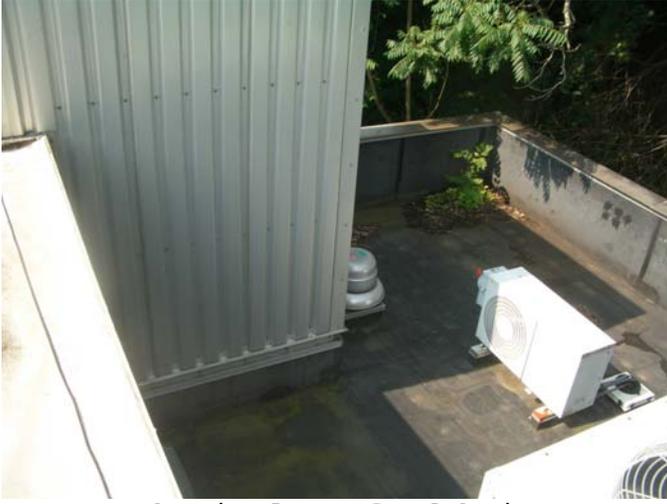
R-21 Mechanical roof, debris, SW corner

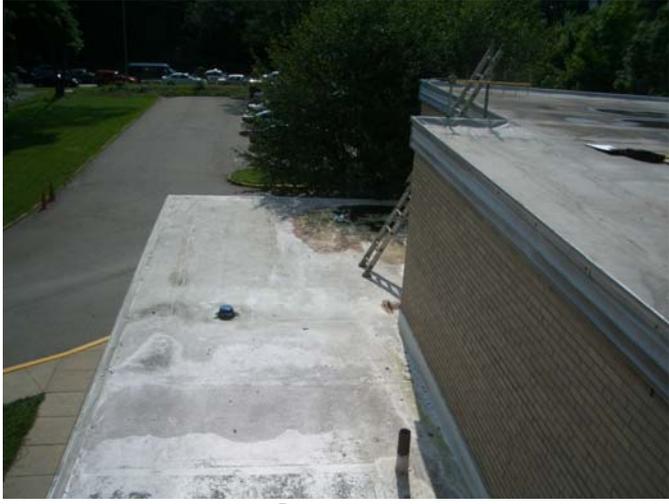
R-24 Entry Roof, SE corner

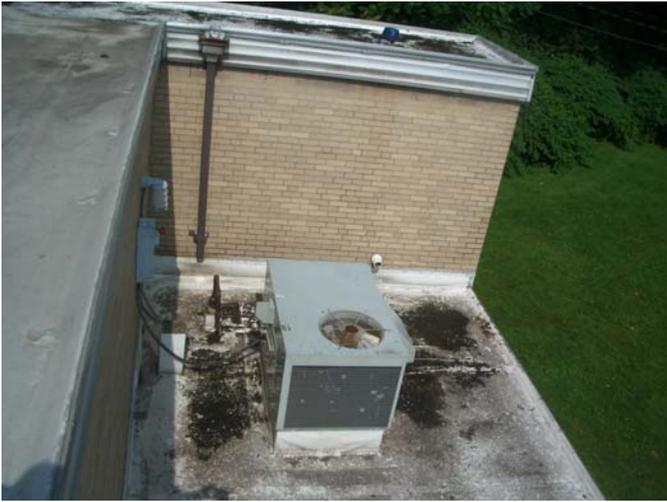
R-25 Entry roof, west end, debris

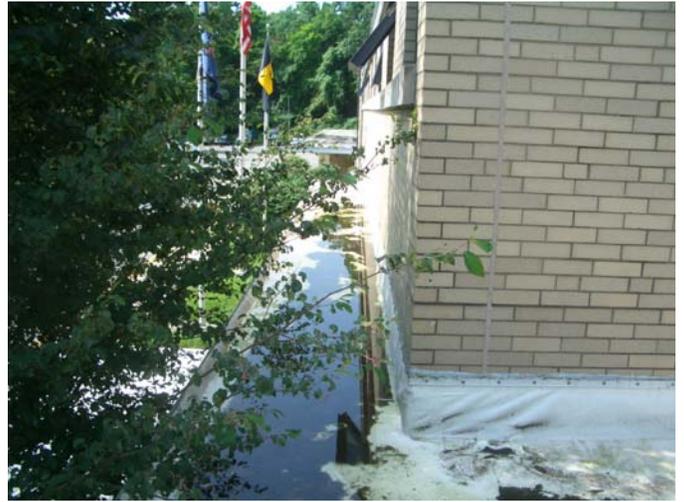
R-28 NE corner of entry area, pond

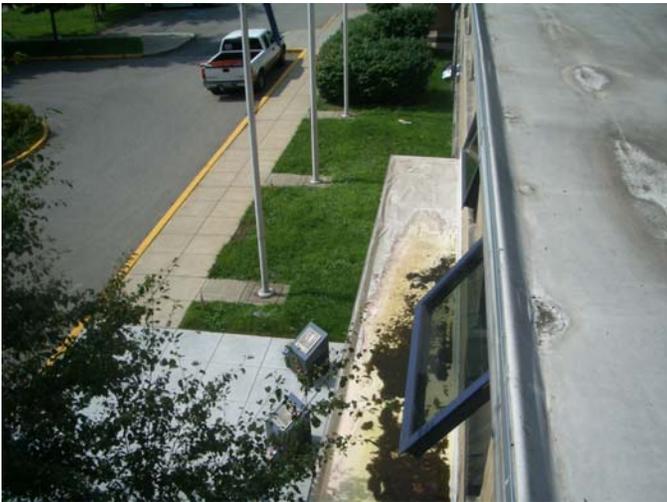
R-26 Entry roof east area, debris

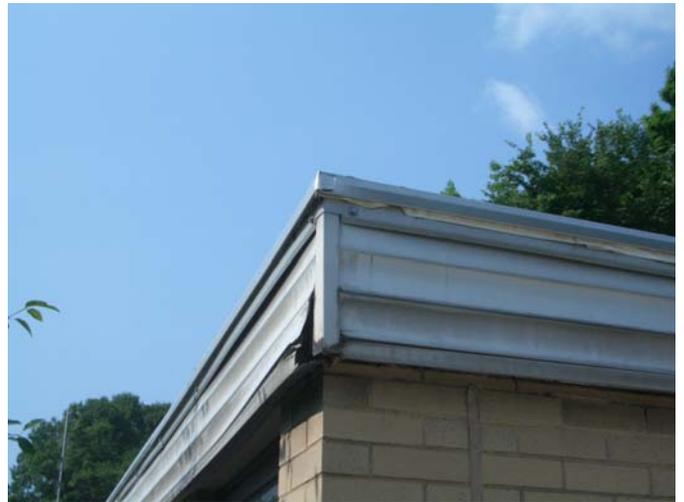
R-29 Open corner in fascia on NE corner of office area

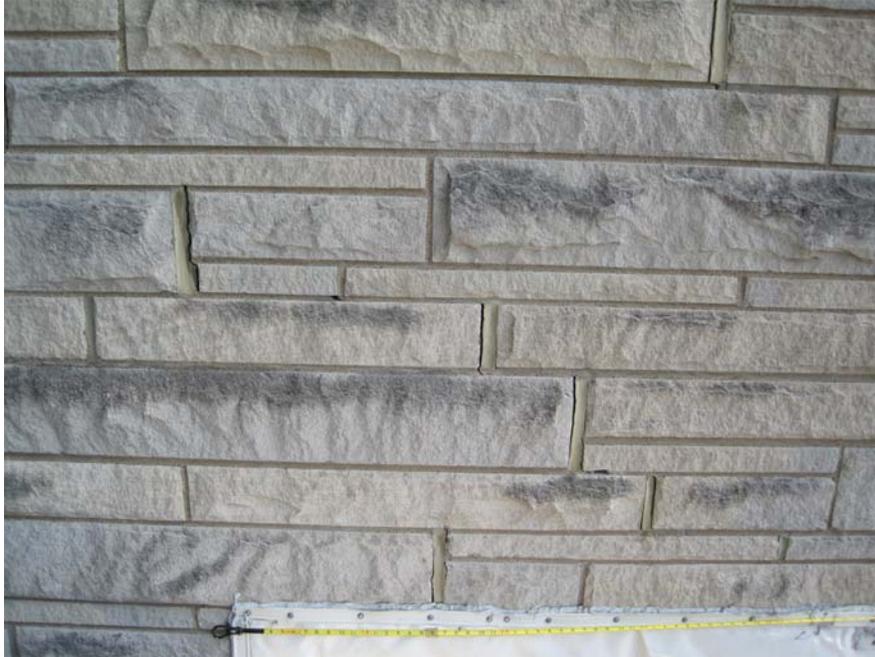
Photo S1

- 1) Repoint step crack through mortar joint on south facing stone exterior. Approx 40 LF (1yr) **(Photo S1)**
- 2) Replace sand stone base at south west corner of building. Approx 2 SF (1yr) **(Photo S2)**
- 3) Clean and paint exterior steel lintels and steel at garage bays. Garage interior not accessible. (1yr) **(Photo S3)**
