CITY OF
PITTSBURGH
FACILITY ANALYSIS REPORT

Public Safety Training
1435 Washington Blvd.
Pittsburgh, Pennsylvania 15206

Public Safety Training (B107)

Executive Summary

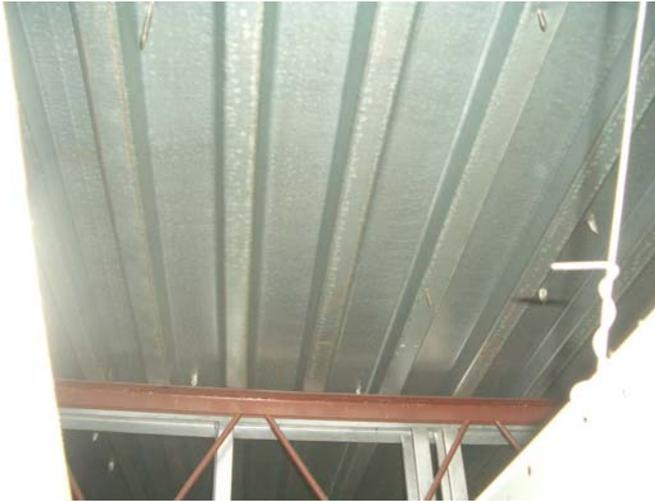
R-1 Underside of new classroom roof, metal deck with open web bar joists

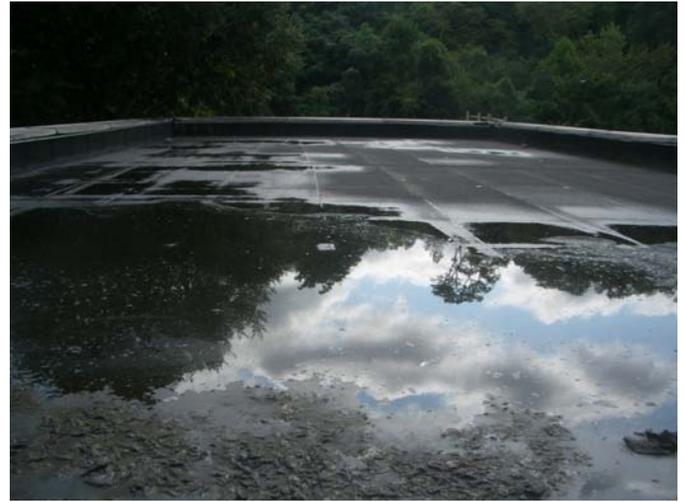
R-4 Truck bay roof looking east, ponding water

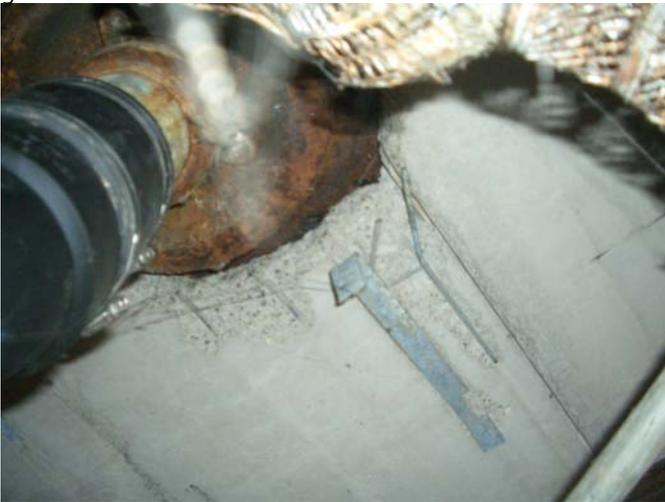
R-2 Underside of main roof, gyp plank at roof drain

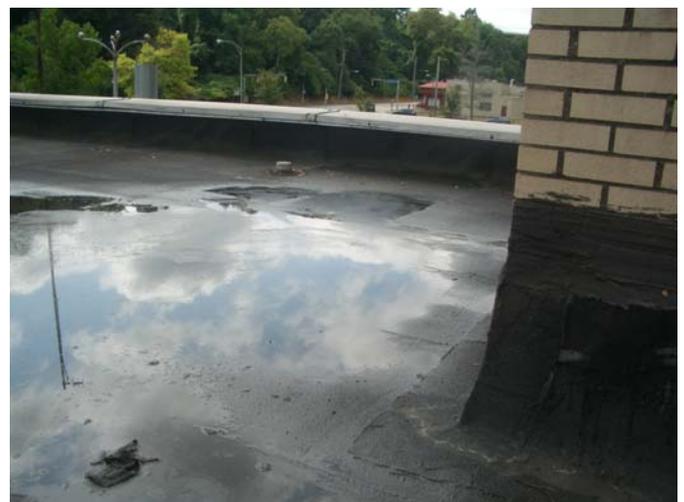
R-6 Truck bay roof looking south, ponding water

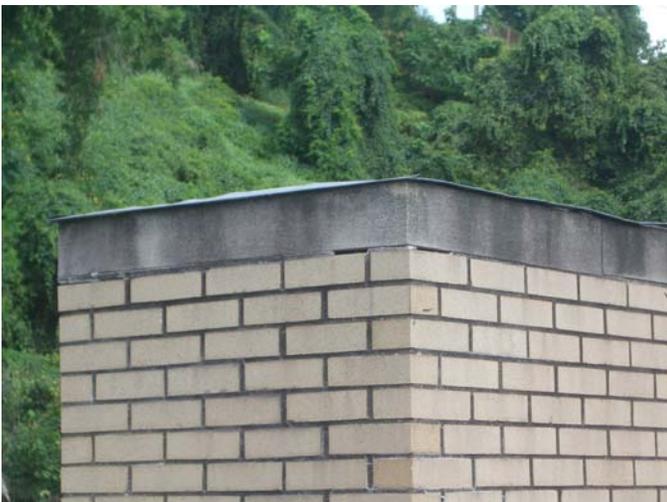
1.2 Condition: The building walls appear to be in fair condition. Some cracked mortar joints were observed in the chimney at the truck bay.

R-8 Chimney at truck bay, open mortar joints at cap

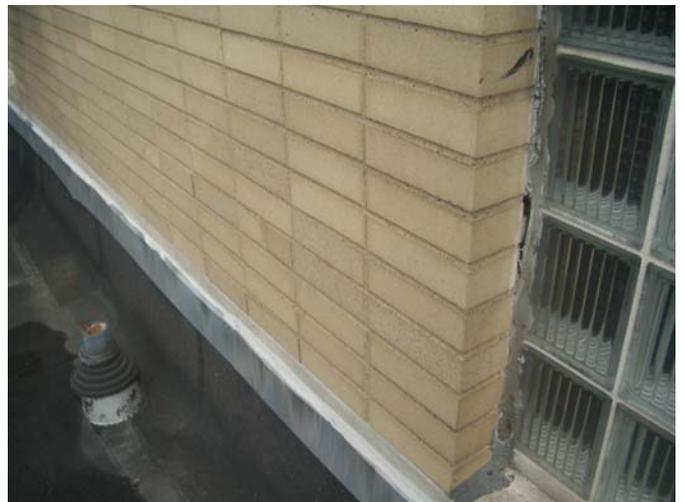
R-11 Truck bay wall, counter flashing, open caulking at window

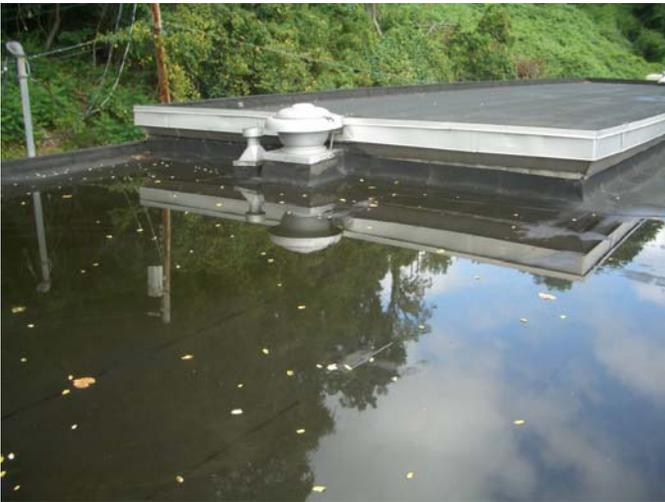
R-14 Main roof, ponding water at SW corner

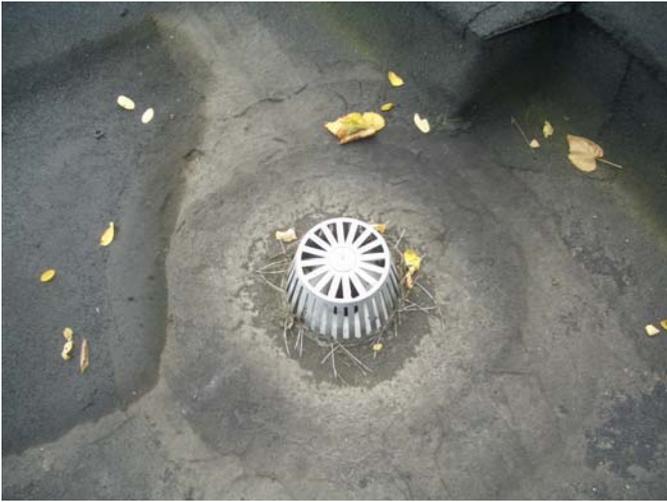
8.2 Condition: Debris observed at some drains. The drainage system appears to be operating properly.

R-19 Main roof, debris at roof drain, typical

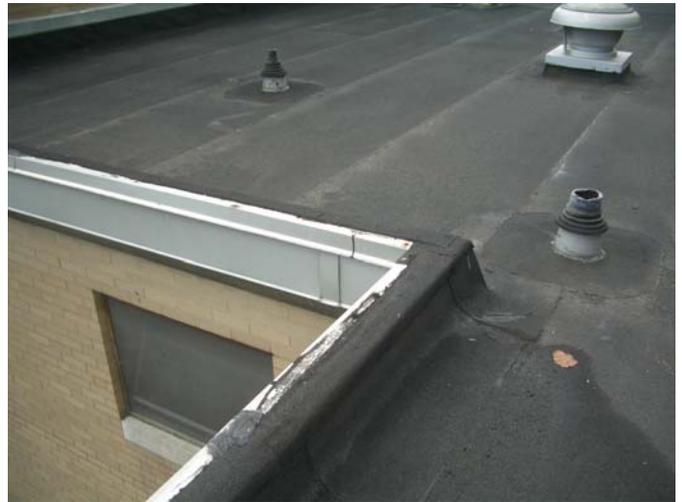
R-23 Main roof, east wall at entry, Flashing terminated on top of coping

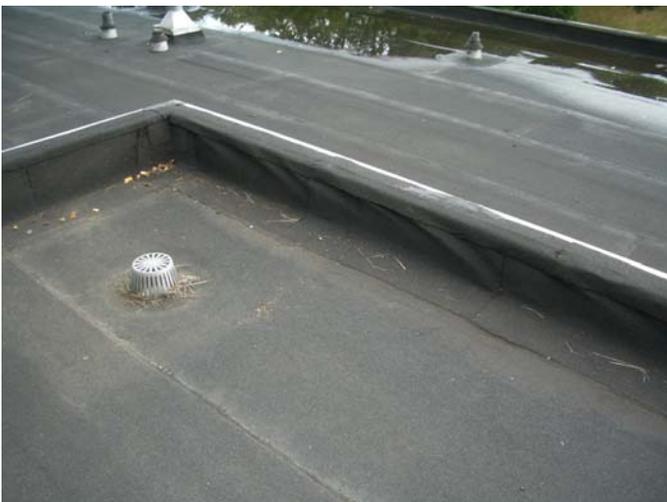
5.2 Condition: The flashing systems are in fair condition. In some areas the flashing is loose from the walls. The flashing is buckled at a few corners.

R-21 Main roof, buckled flashing, typical

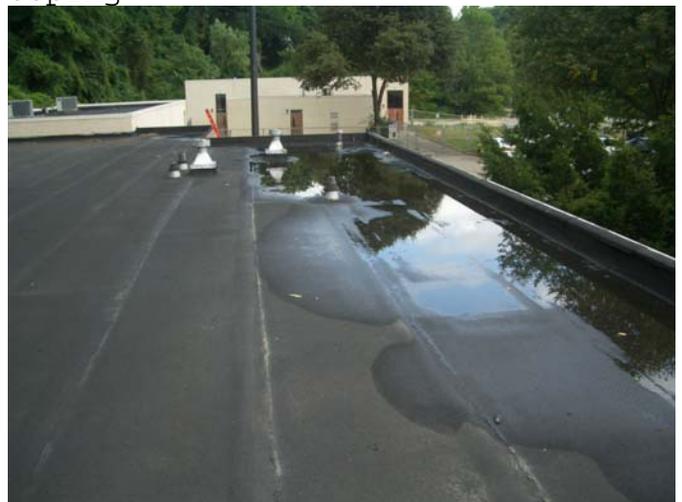
R-24 Main roof, NE corner, ponding water

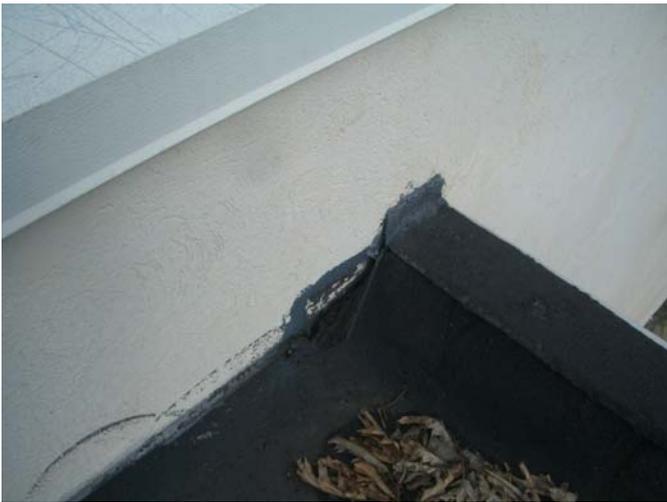
R-25 Main roof, north wall at tie in to classroom, open flashing in corner

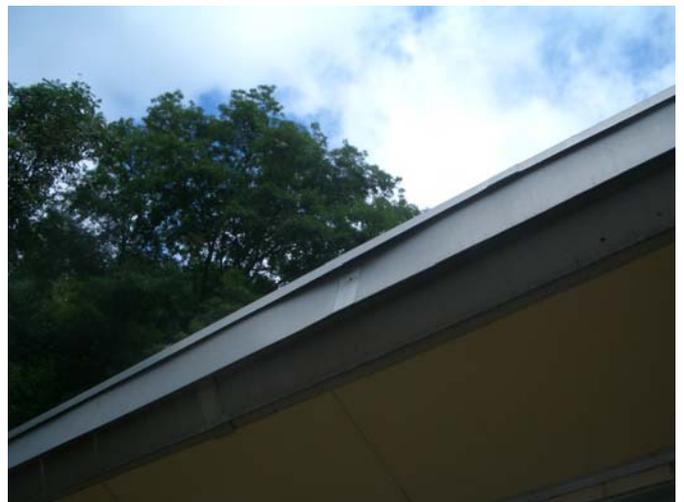
W-6 Coping, fascia and soffit on south wall, typical

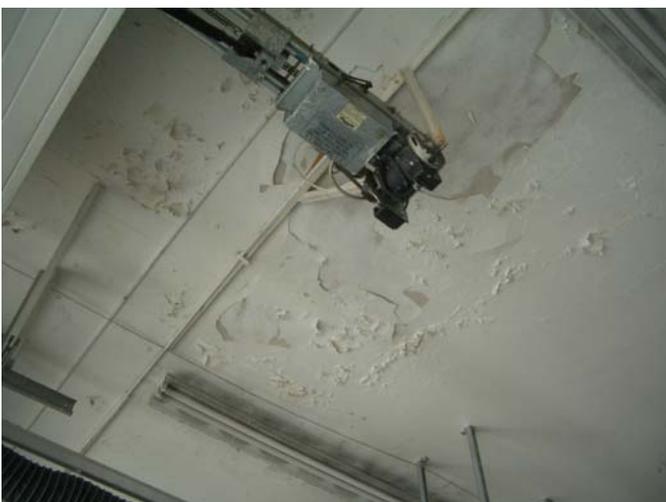
W-9 Peeling paint in truck bay ceiling
