CITY OF
PITTSBURGH
FACILITY ANALYSIS REPORT

Public Works 1st Division
300 Kilbuck Street
Pittsburgh, Pennsylvania 15214

Public Works 1st Division (B018)

300 Kilbuck Street
Pittsburgh, PA 15214

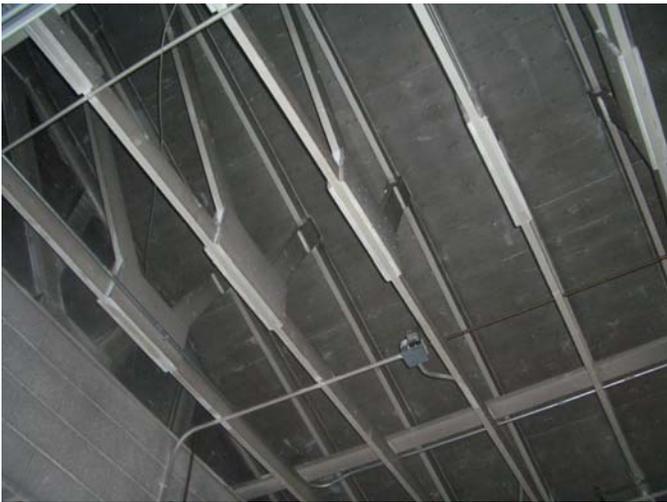
R-1 Underside of main roof garage area, wood deck & trusses

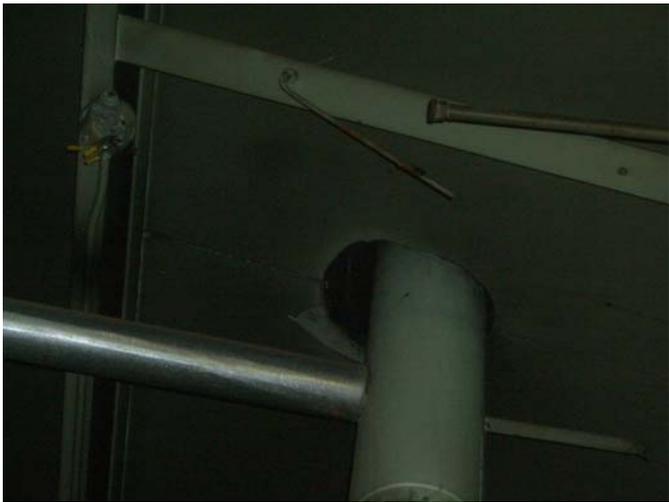
R-4 Underside of main roof, gyp plank and flue penetration

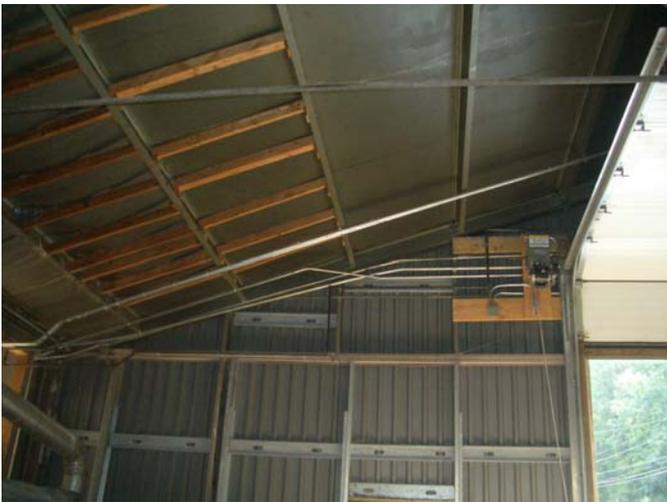
R-2 Underside of main roof, gyp plank and supports for cricket installation

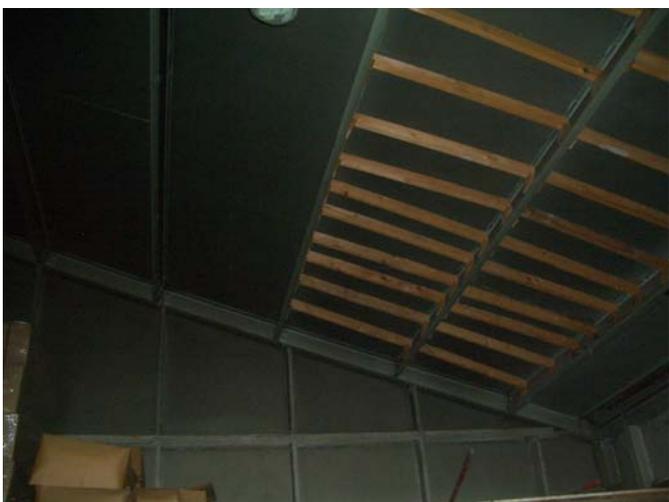
R-5 Underside of main roof, gyp plank and purlins

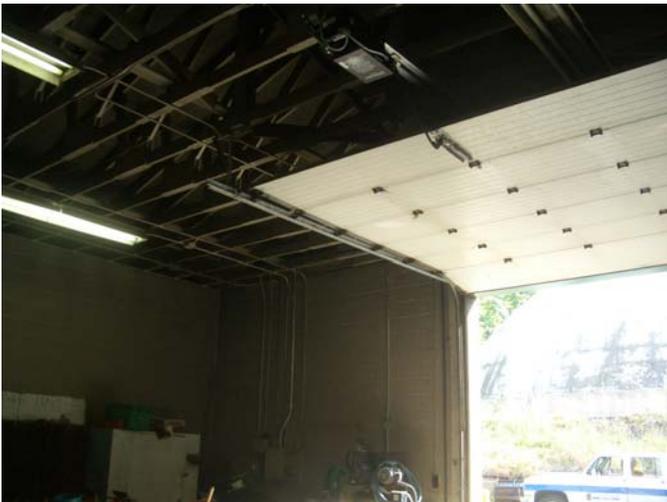
R-3 Underside of main roof, garage entry

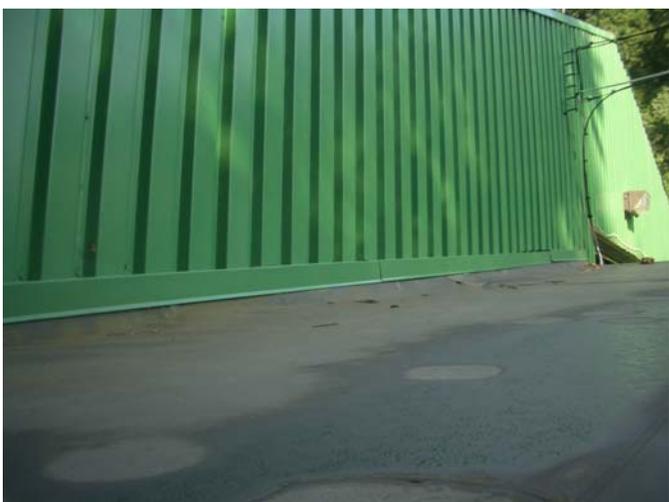
R-6 EPDM on shed roof of office area

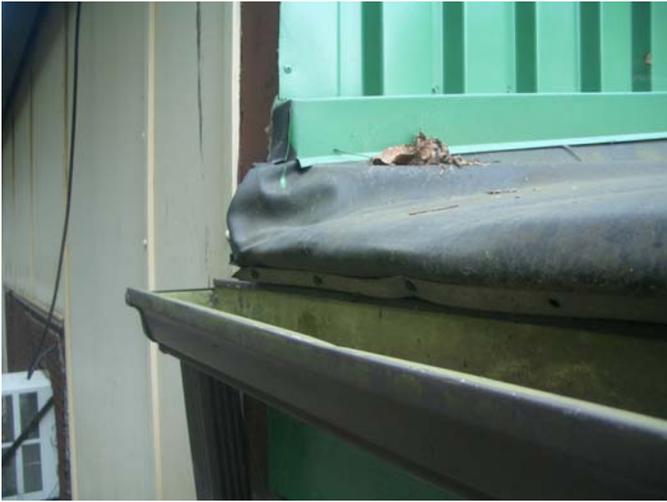
R-7 EPDM termination on shed roof of office area

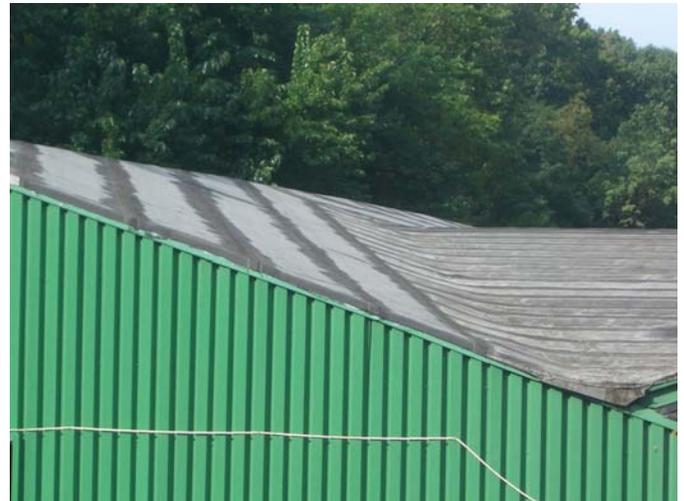
R-11 APP membrane and cricket installation between garage and office area valley

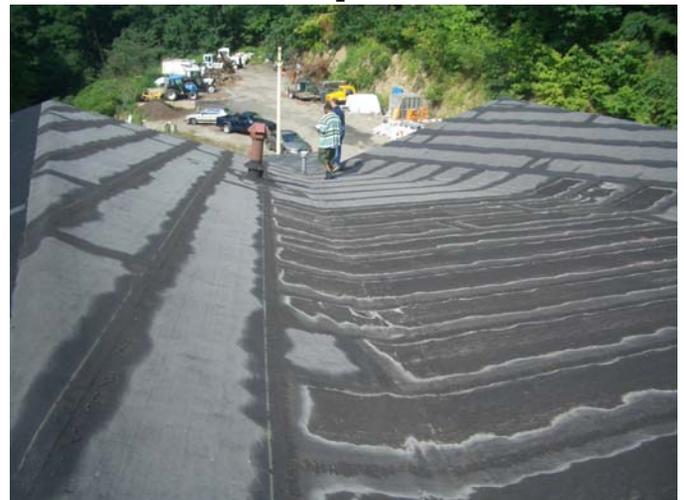
R-12 APP membrane installation looking south

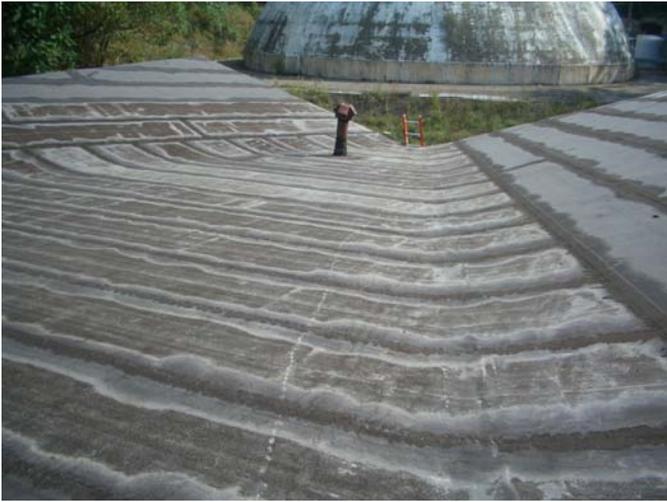
R-13 APP membrane installation looking north

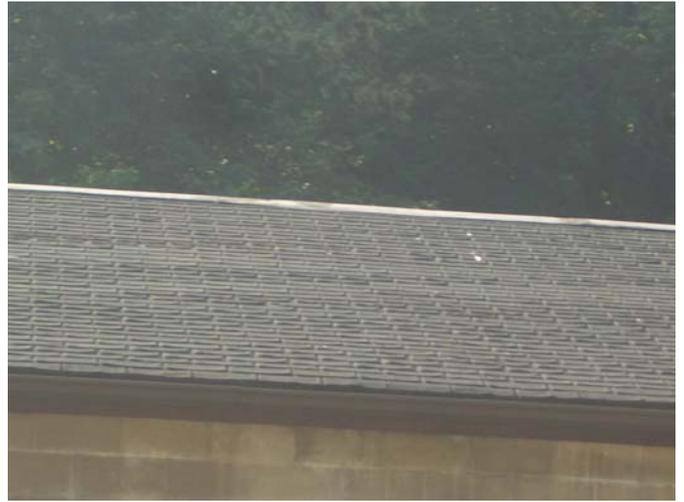
R-16 Shingle roof on garage area

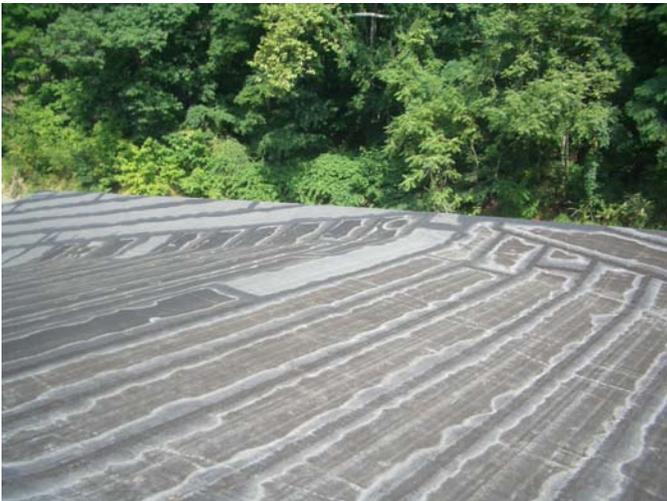
R-14 APP membrane installation looking west across ridge of cricket

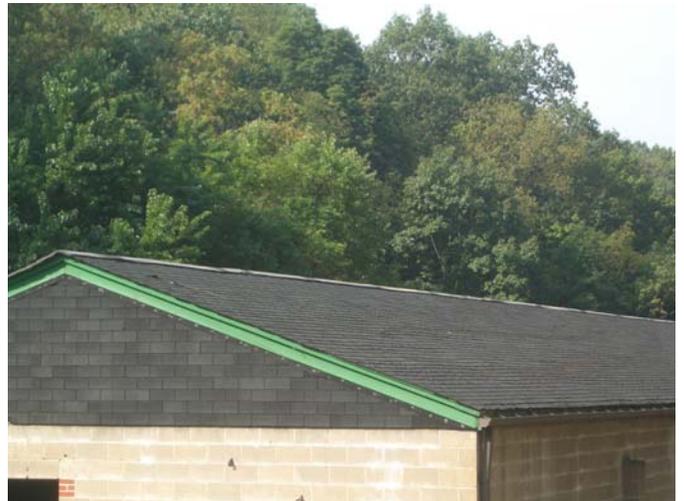
R-17 Shingle roof on garage and north end gable

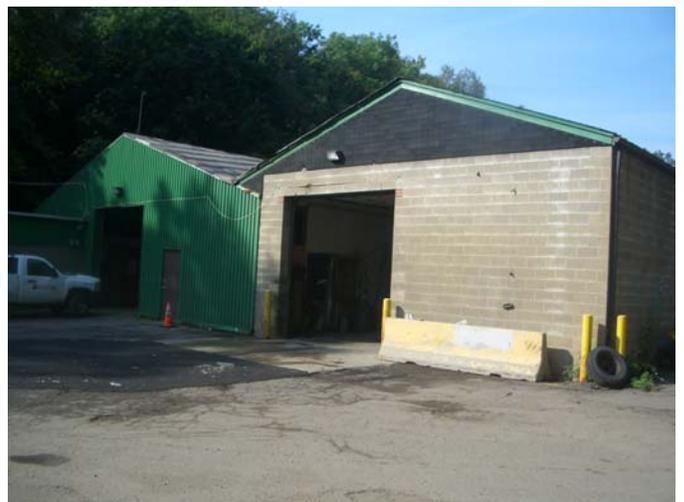
R-21 Shingles on north slope of Barn

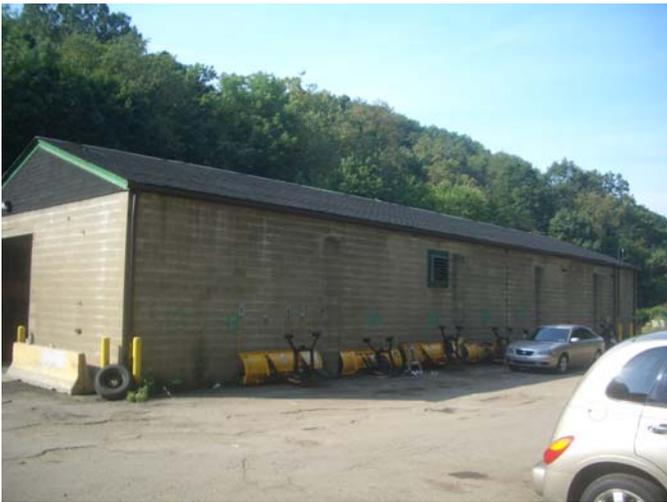
W-1 North end of main building

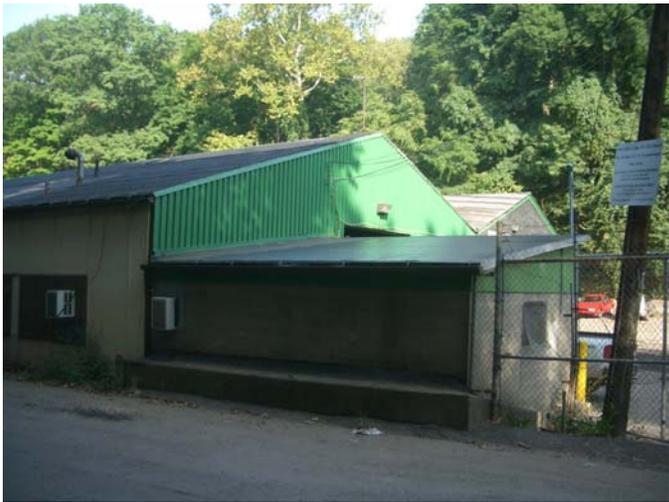
W-2 west wall of main building

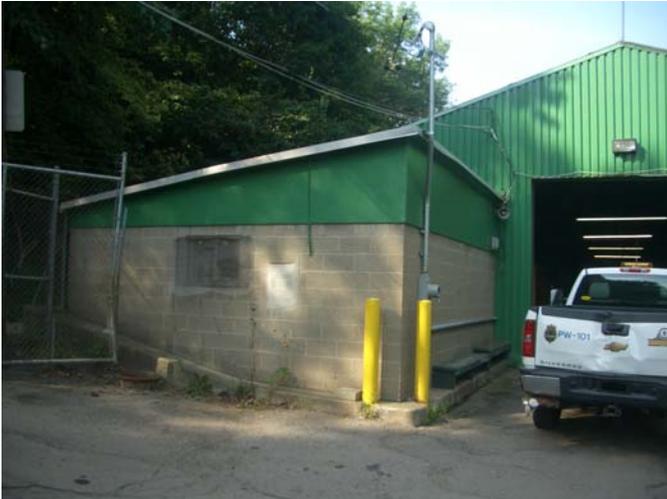
W-5 NE corner office and office/storage east wall

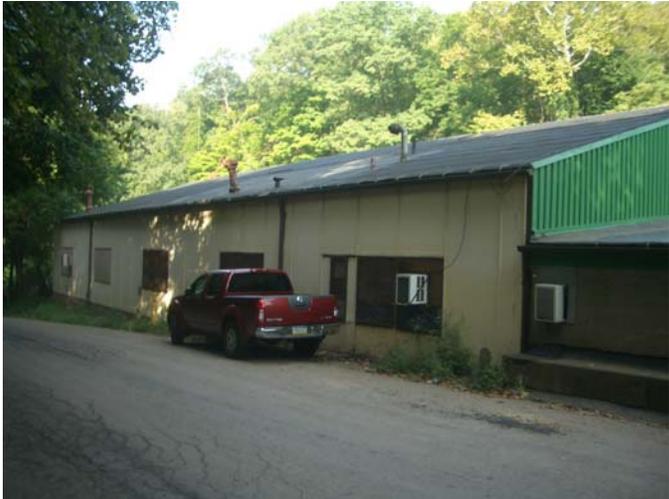
W-3 NE corner of main building and office area

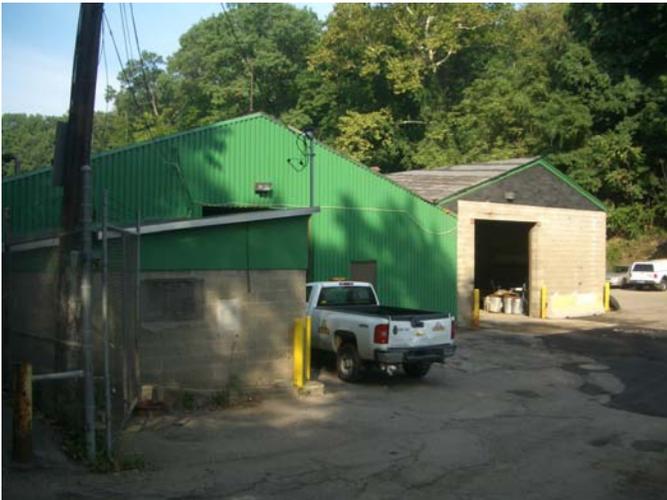
W-6 East wall of office/storage

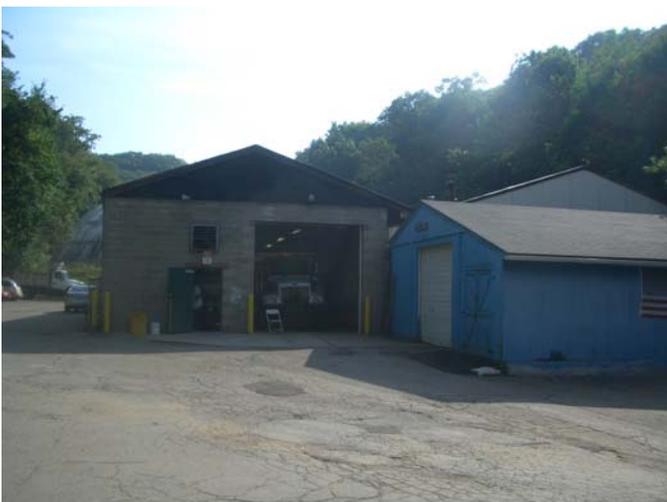
W-12 South end of garage at entry, cracked mortar joint above door

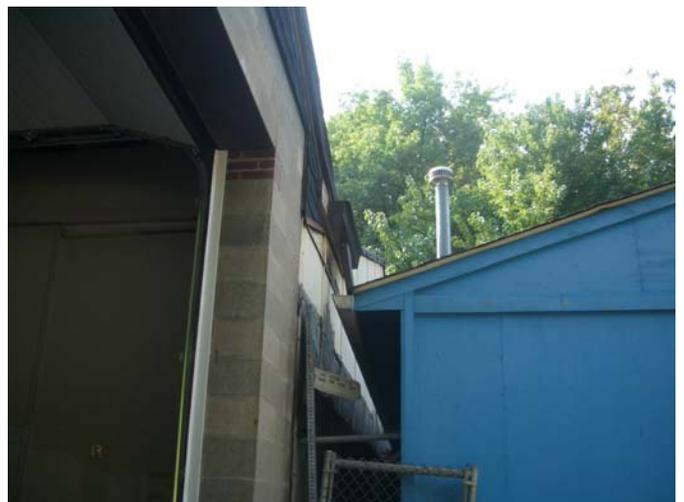
W-10 South end of main building and south wall of Barn

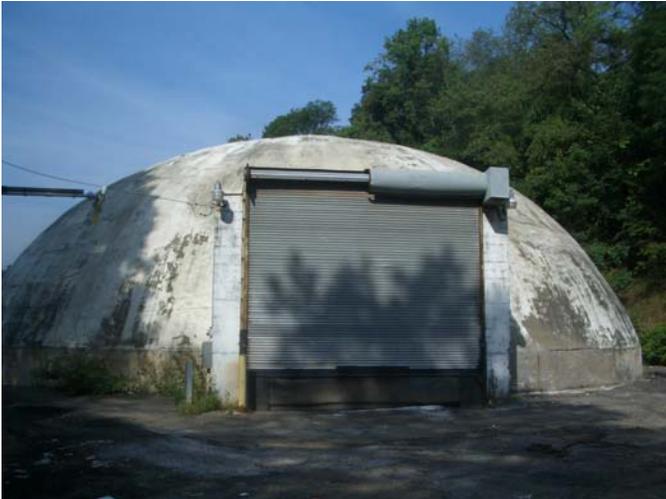
Other 4 - Salt storage building, deteriorating coating and plants growing in cracks
