CITY OF  
**PITTSBURGH**  
FACILITY ANALYSIS REPORT

**Public Works 4<sup>th</sup> Division**  
414 Bausmann Street  
Pittsburgh, Pennsylvania 15210

**Public Works 4th Division (B018)**  
414 Bausman Street  
Pittsburgh, PA 15210

**Executive Summary**

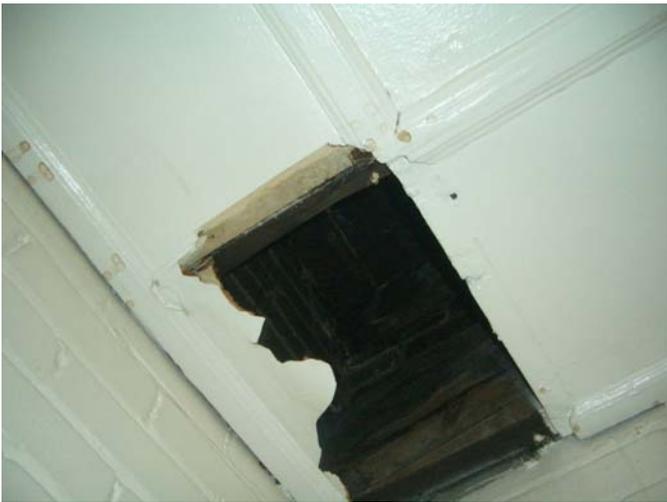
R-1 Underside of main roof

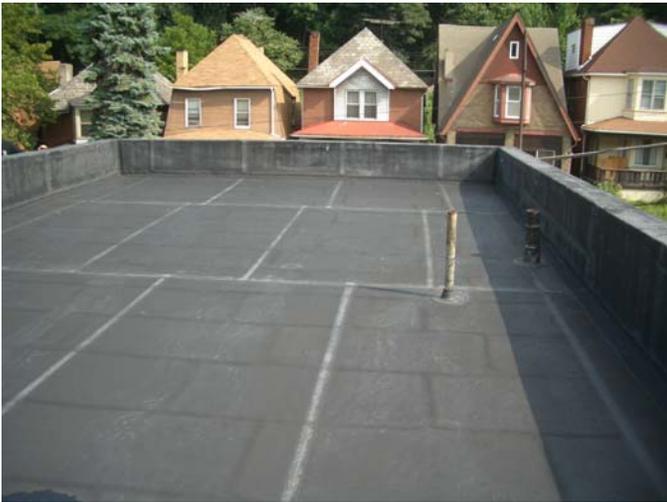
R-3 Penthouse roof looking north

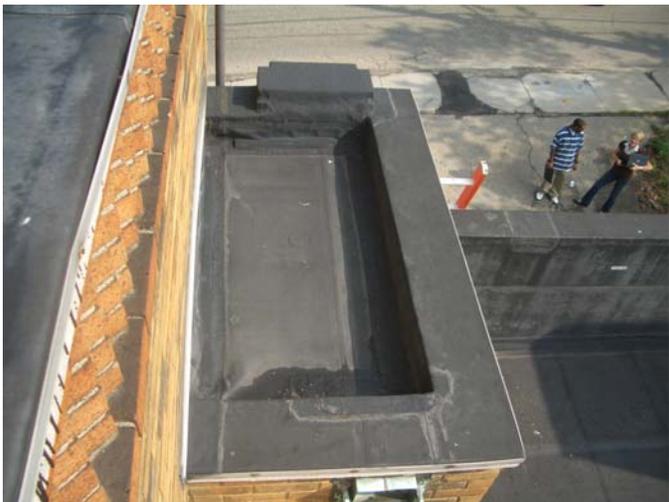
R-6 Small roof on northeast side of penthouse

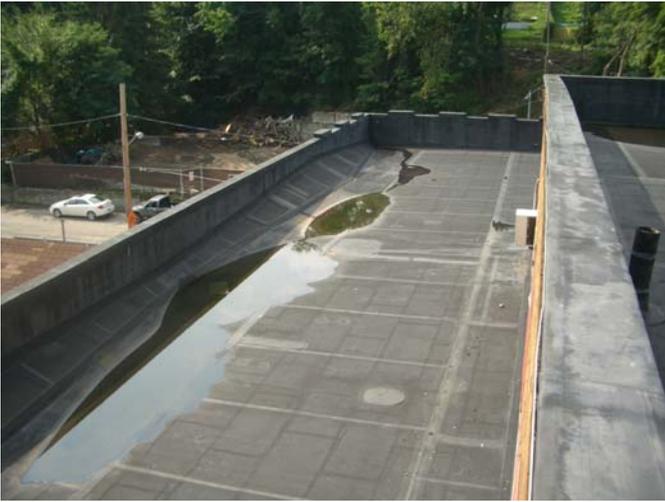
R-7 East side of Main roof looking south, flashing over top of parapet

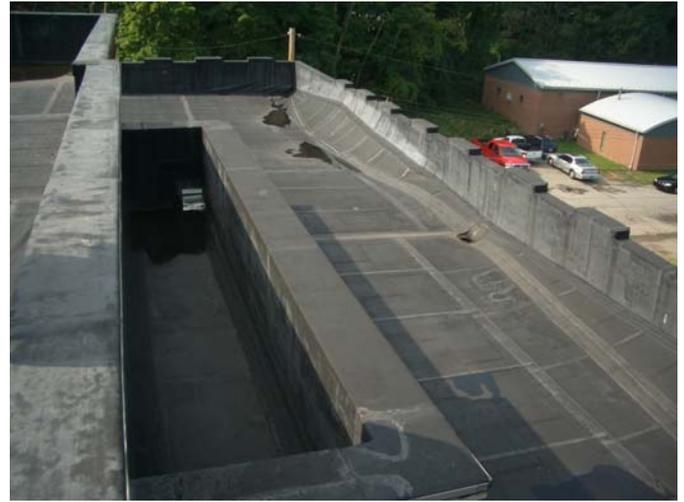
R-10 West side of Main roof looking south

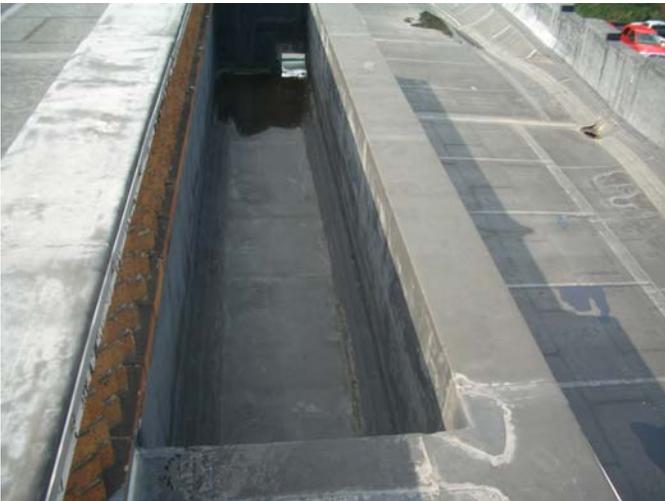
R-8 Small roof on west side of penthouse, bar termination of flashing over top of wall

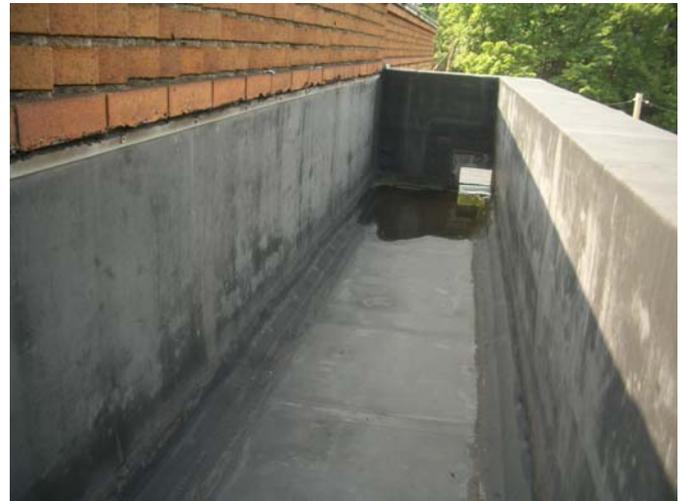
R-11 Small roof on west side of penthouse with bar termination

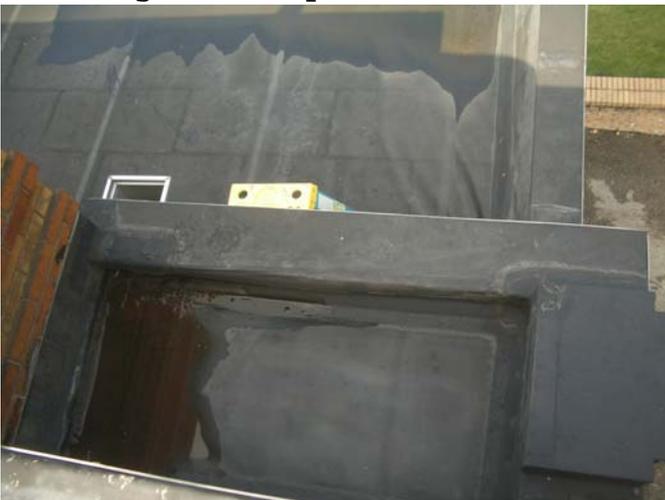
R-9 Small roof on NW side of penthouse

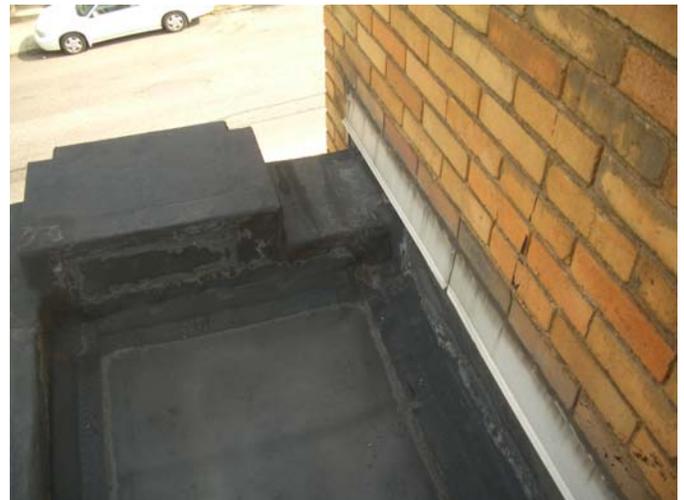
R-12 Small roof on NW side of penthouse with counter flashing termination

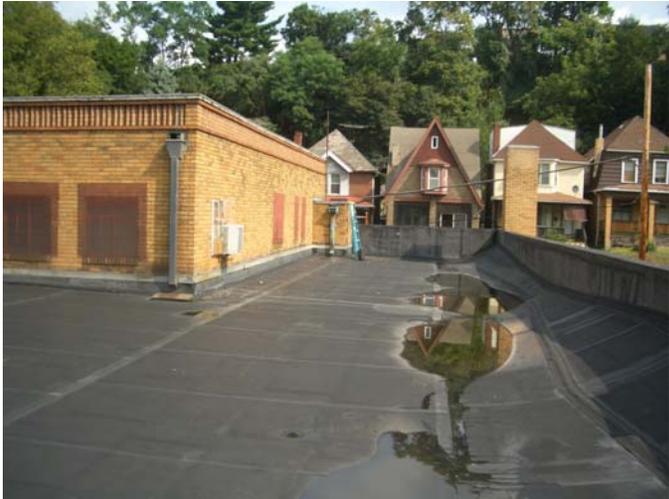
R-17 East side of main roof looking north

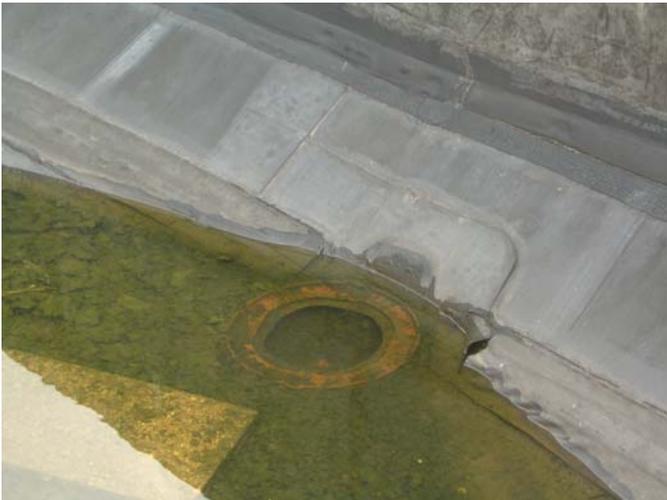
8.2 Condition: One roof drain is clogged and ponds water on the east side of the main building. The gutter drainage system on the garage is in poor condition. Most gutters section on the north side are missing and some sections are damaged on the south side. The downspouts are missing.

R-15 Clogged roof drain on east side

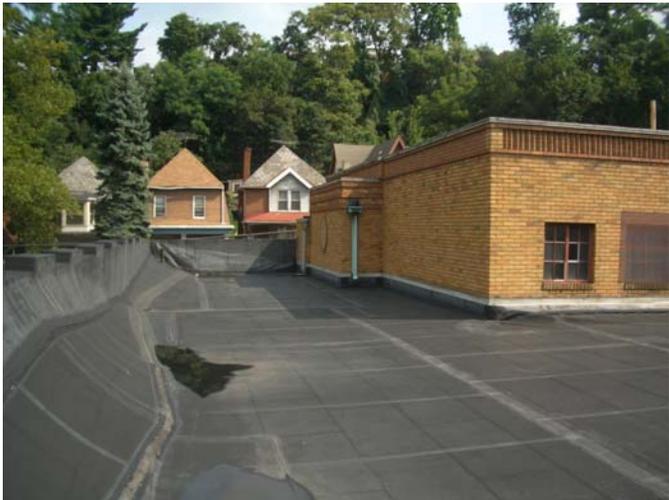
R-18 West side of main roof looking north

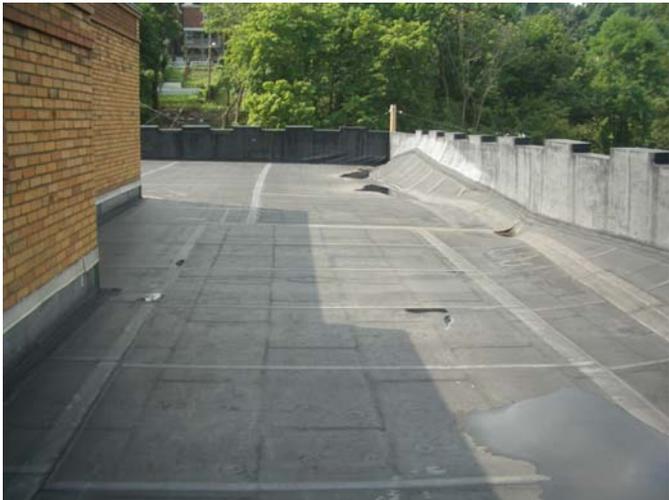
R-24 West side of main roof looking south

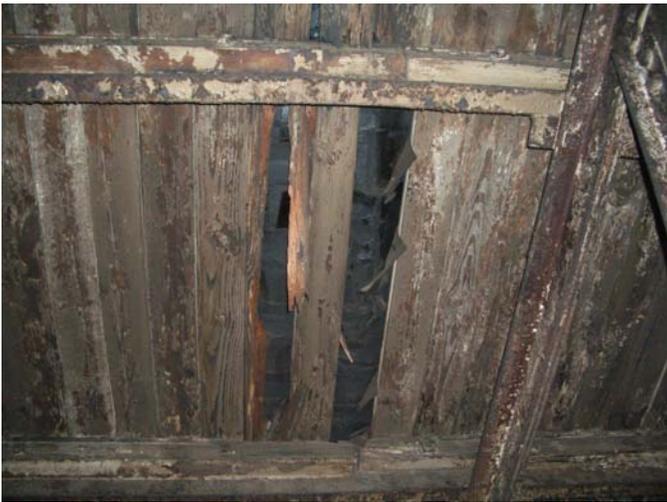
The roof decking appears to be in poor condition. The garage deck is deteriorated to a state that it is unsafe to walk on.

R-25 Underside of Garage roof, rotted sheathing

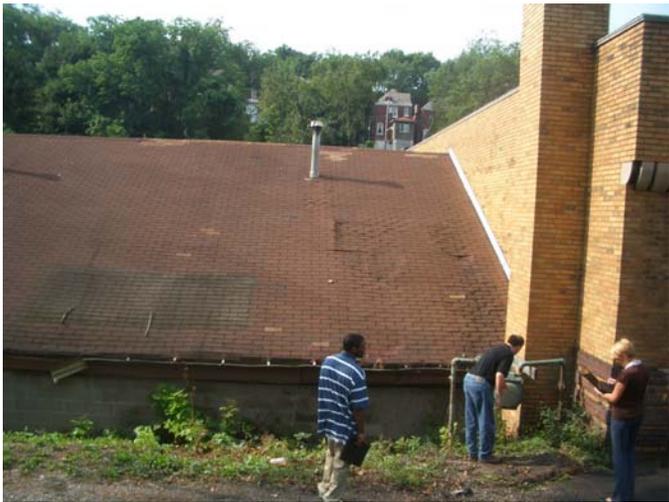
R-28 North slope of garage roof

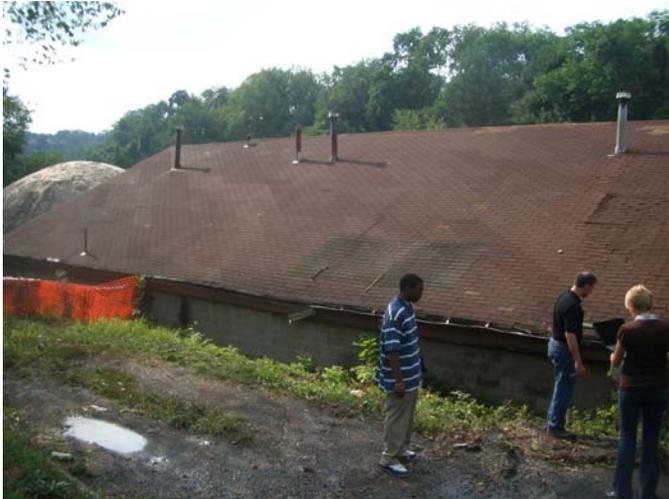
R-29 North slope of garage roof

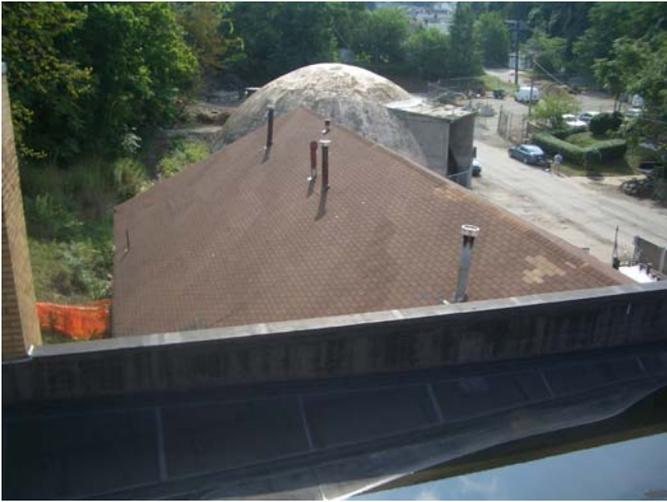
R-31 North slope of garage roof

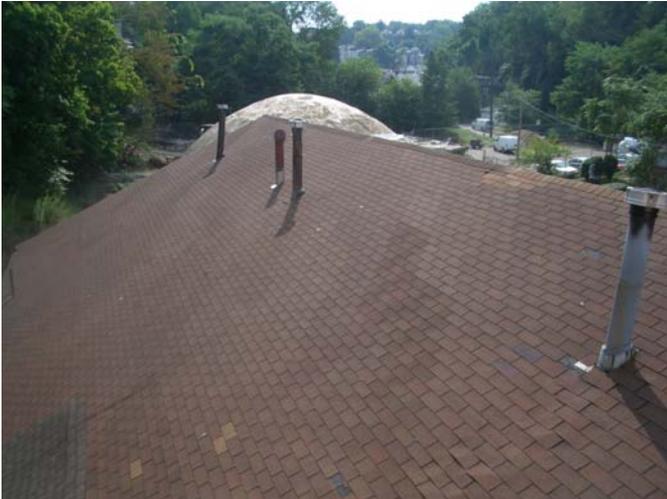
R-32 Penetrations on north slope of garage roof

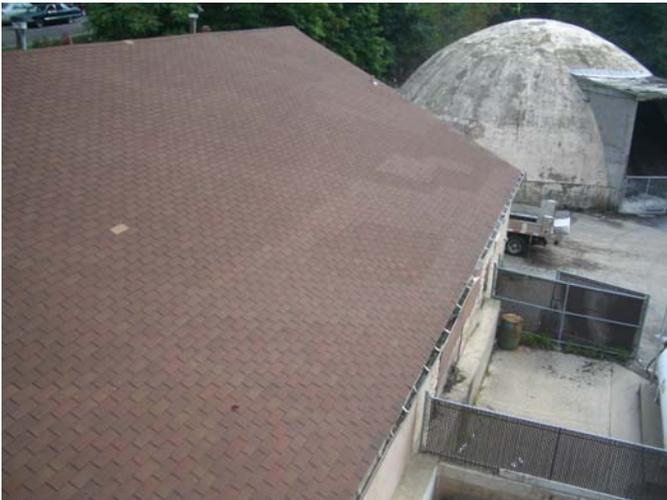
R-33 South slope of garage roof

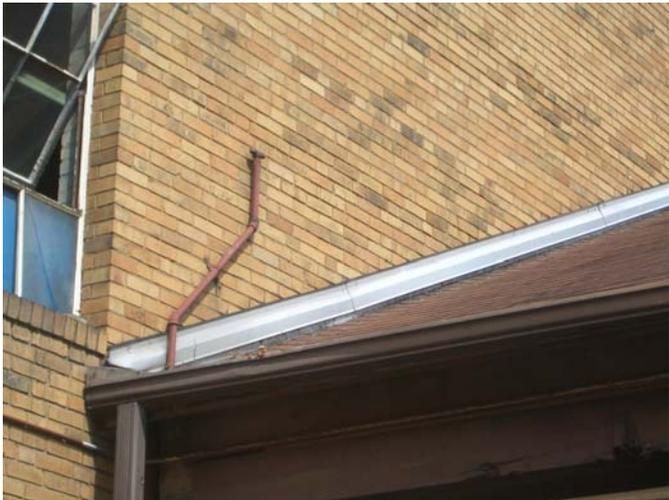
R-36 Flashing of garage to main building, Channel flash not step flash

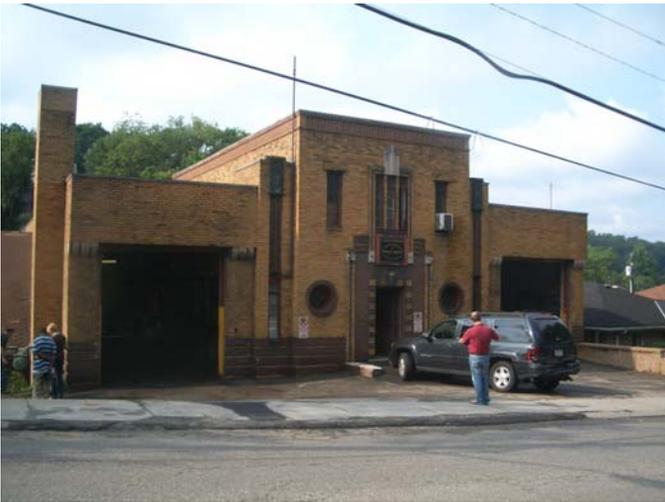
W-1 Front of building

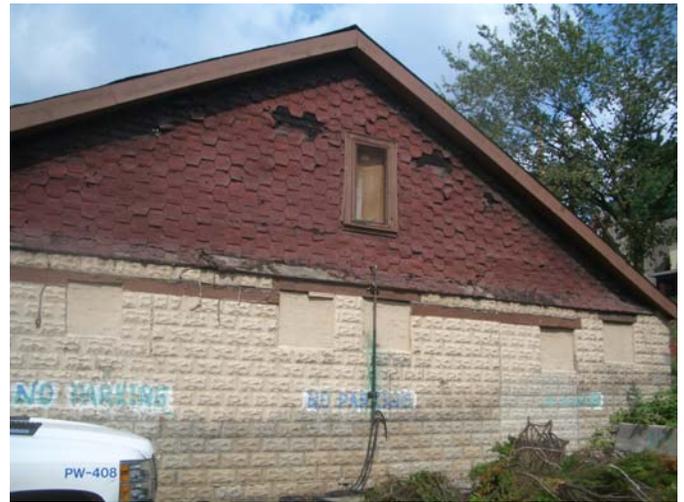
W-4 East end of garage

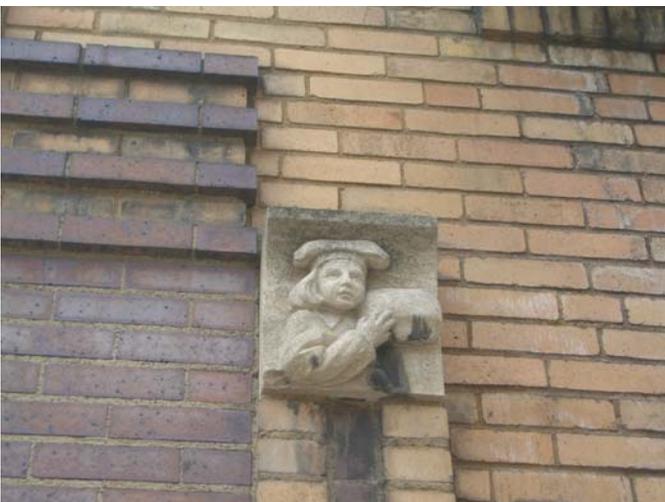
W-2 Carved limestone show baker indicating the original bakery use of building

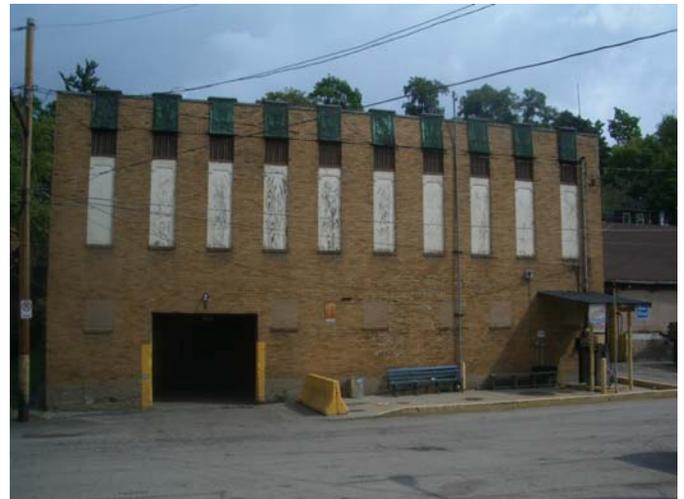
W-6 Rear (south) of building

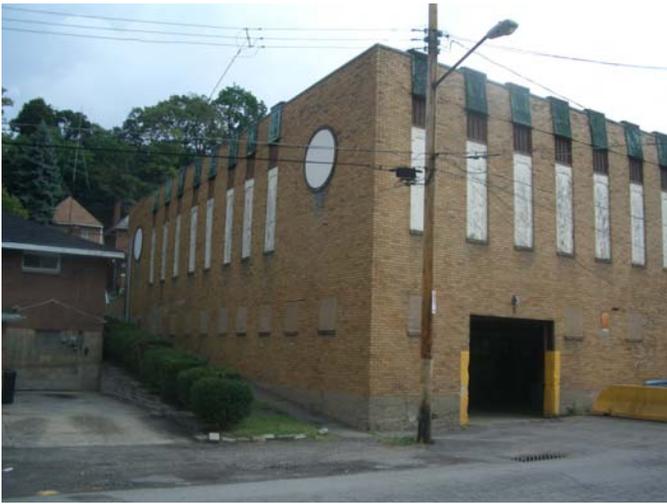
W-7 Rear and west wall of building

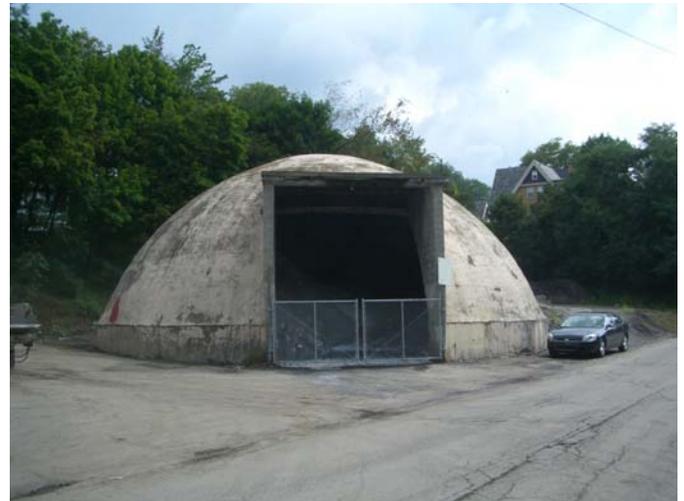
Other - Salt containment building

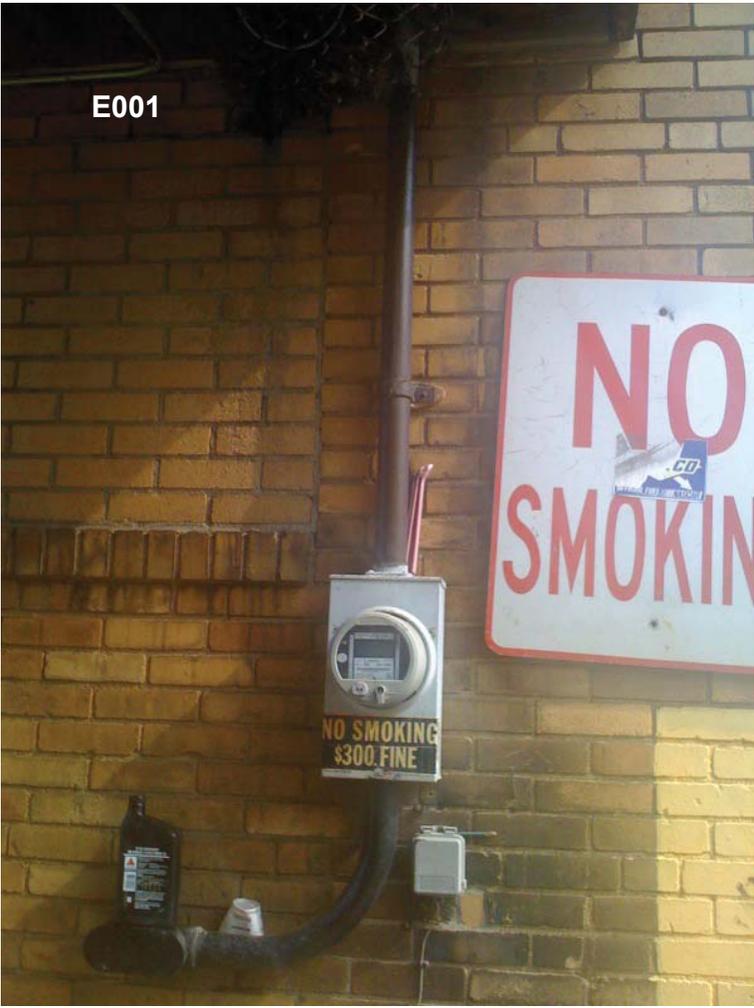
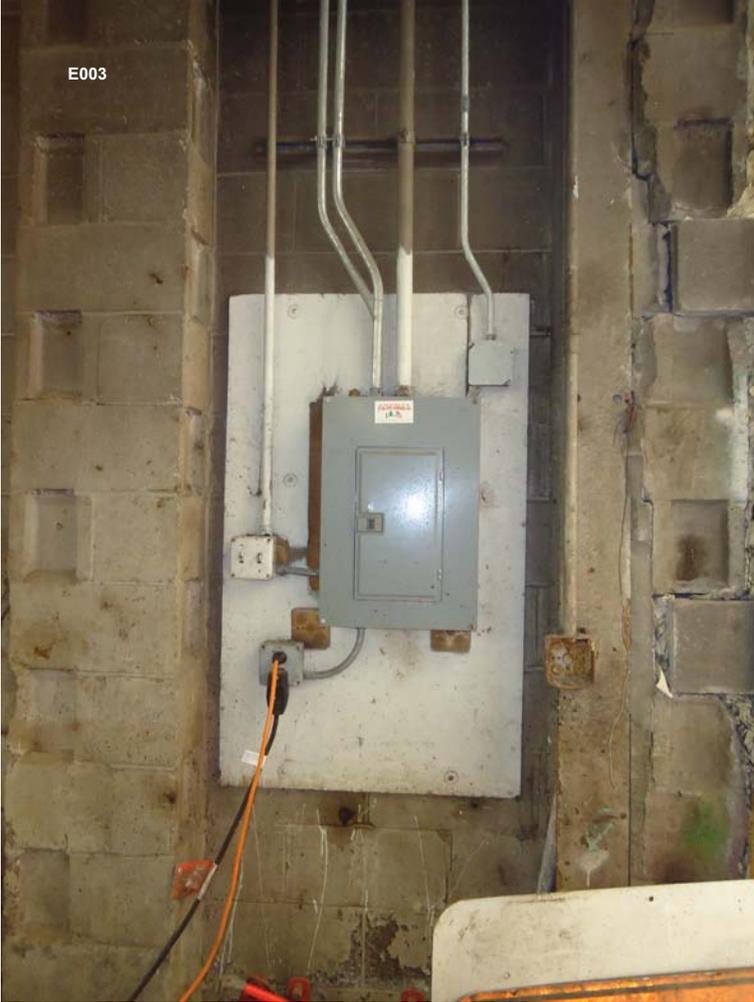
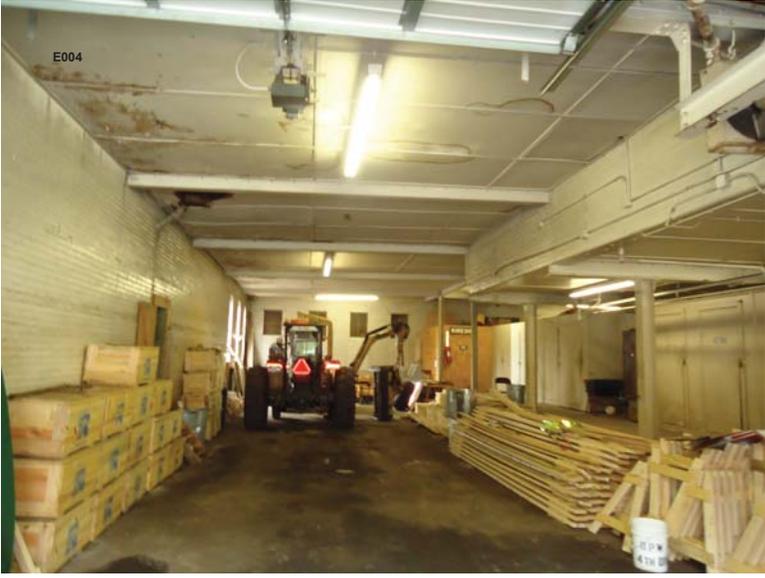
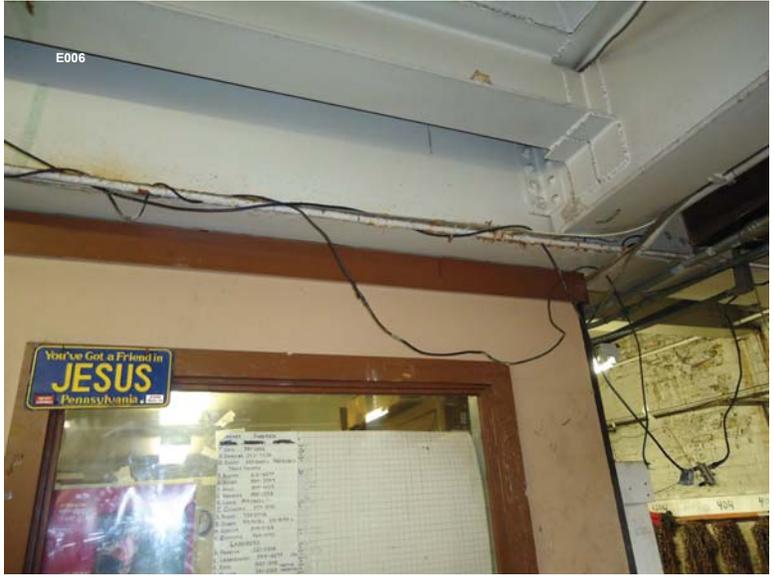
See photos labeled FP for Fire Protection.

Many Fire and Life Safety Hazards, Standards and Code violations observed throughout the facility.  
 Bring this facility up to local and national codes and standards as soon as possible.
