CITY OF
PITTSBURGH
FACILITY ANALYSIS REPORT

Schenley Park Skating Rink (B 064)

501 Overlook Drive
Pittsburgh, Pennsylvania 15217

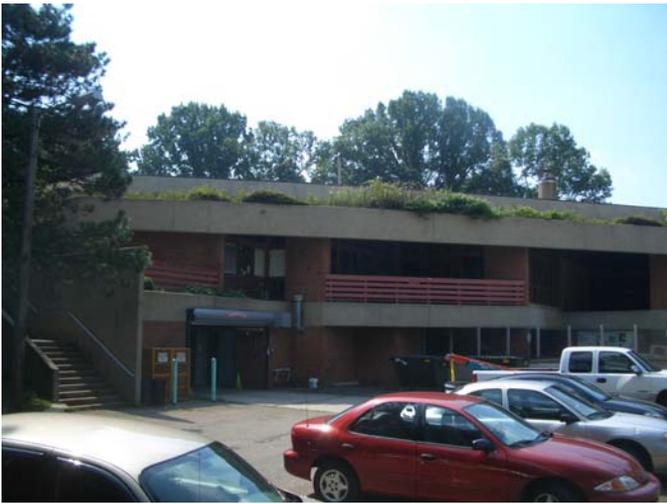
R-1 Front entry to Support Building, showing planter at top

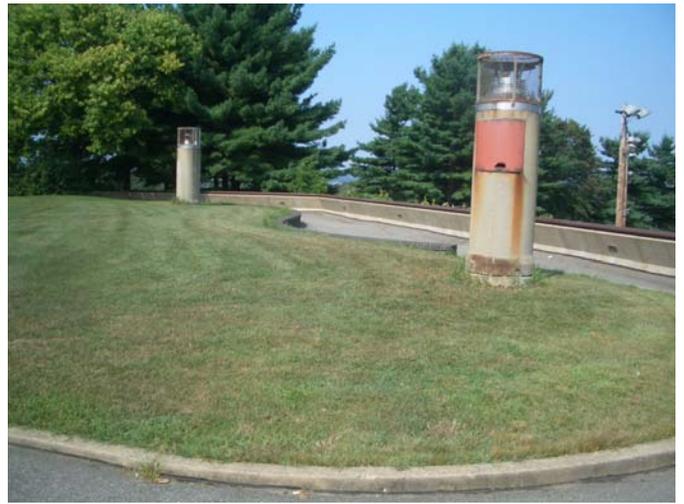
7.2 Condition: The Concrete Flue penetrations are in fair condition. Some joints are cracked and some metal cover plates are rusted.

The roof top flue penetrations are in poor condition. Leaks are located near two flue pipes.

R-4 Concrete flue pipes on Support Building

Remove the overburden around the concrete flue pipes, inspect and repair the pipes and membrane seals. Estimated cost: 3 flues = \$15,000 (plus cost of landscaping repair).

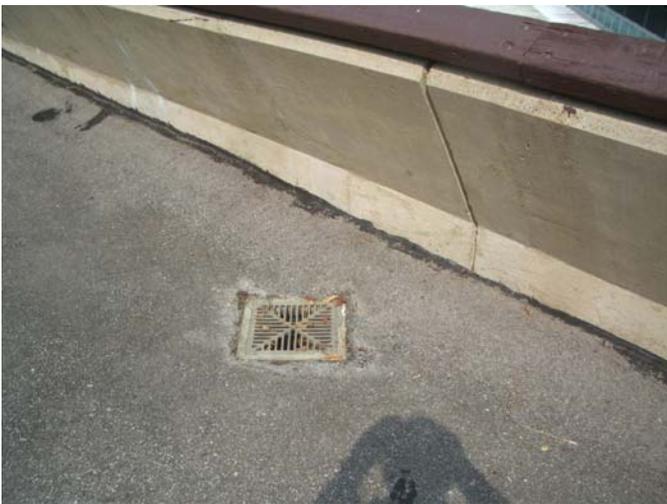
The drainage system is in fair condition. The drains appear to be operating properly. Leaks are located near two drains.

R-2 Drain behind parapet wall at Support Building

Remove the overburden around the two suspected leaking roof drains, inspect and repair the drains, piping and membrane seals. Estimated cost: 4 drains (2 roof, 2 planter) = \$20,000 (plus cost of asphalt paving repair and landscaping). Recommend all drains be videographed for defects.

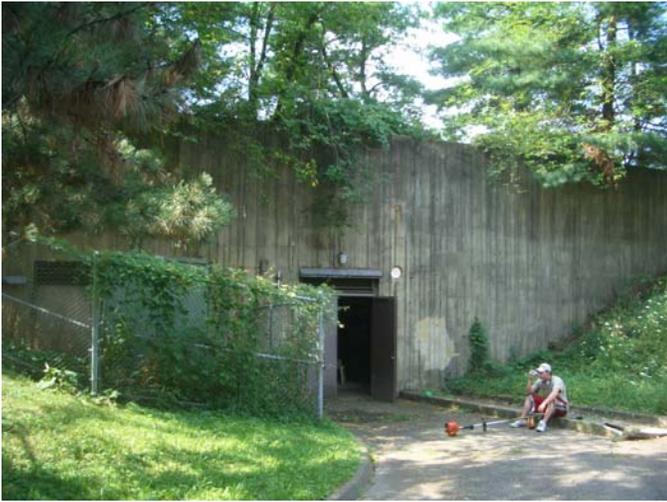
R-13 Entry wall of Mechanical Building

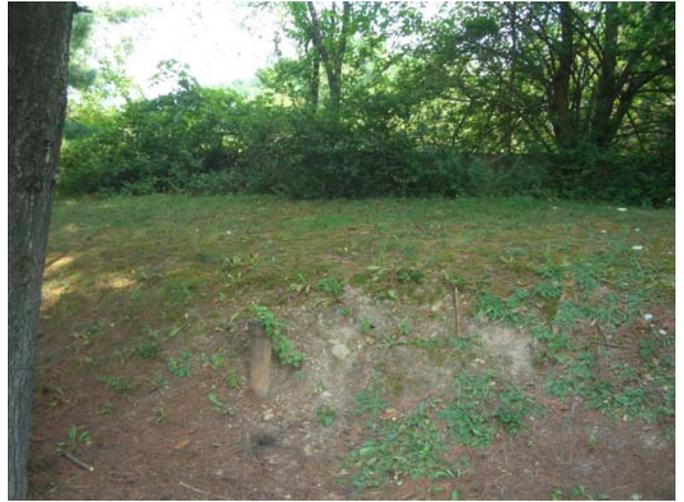
R-16 Vent pipe in overburden on top of Mechanical building

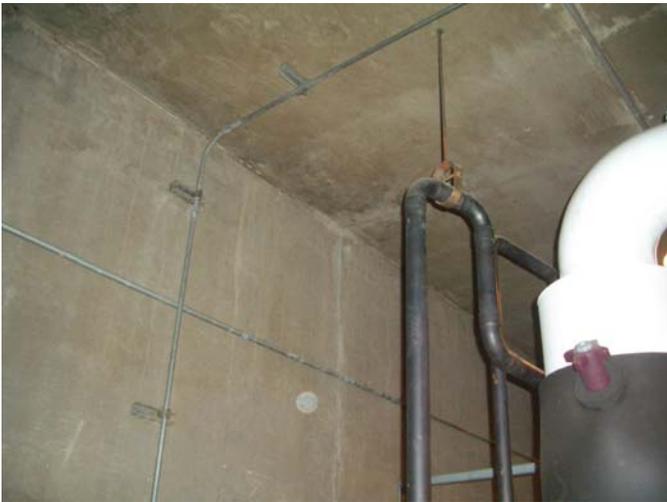
R-14 Wall and ceiling in Mechanical building

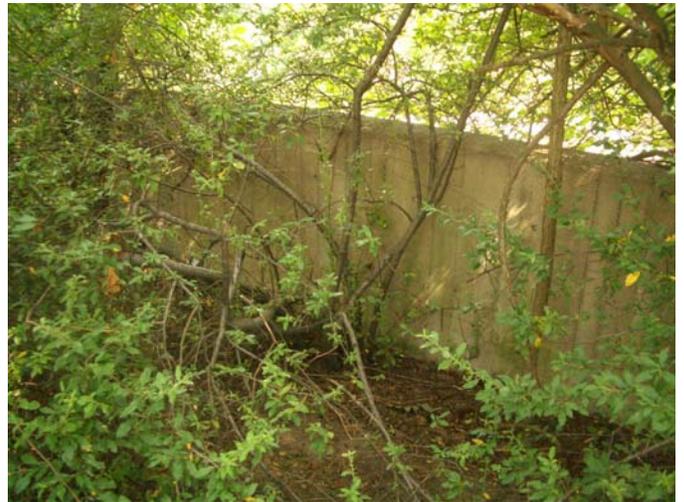
R-17 Back of wall at mechanical building

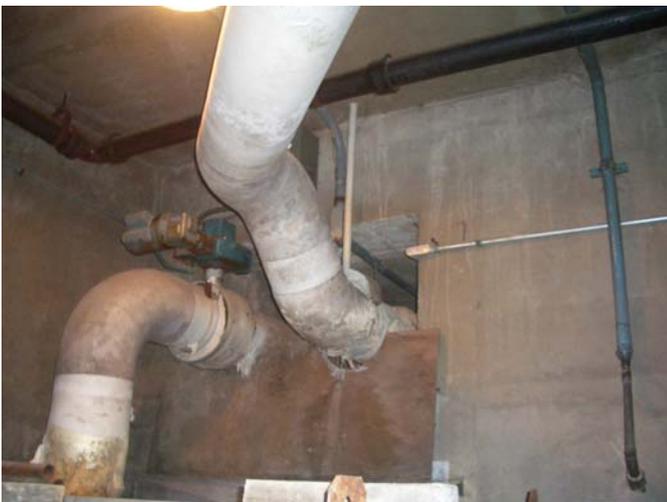
R-15 Tunnel to rink from Mechanical building

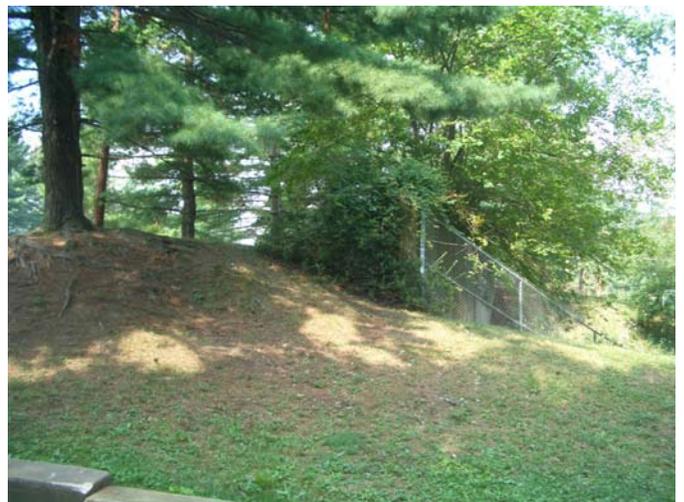
R-18 Overburden on Mechanical building
