CITY OF
PITTSBURGH
FACILITY ANALYSIS REPORT

South Side Market House
1200 Bingham St.
Pittsburgh, Pennsylvania 15203

South Side Market House

1200 Bingham Street
Pittsburgh, PA 15203

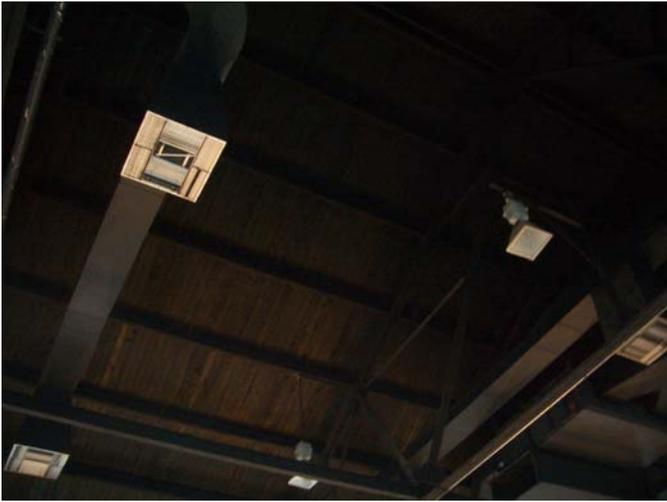
R-1 Underside of wood deck with steel trusses and purlins

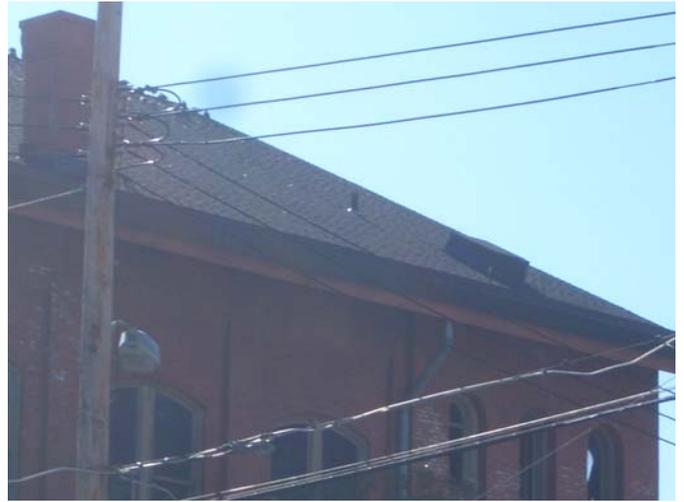
R-4 West side of gable showing hatch location

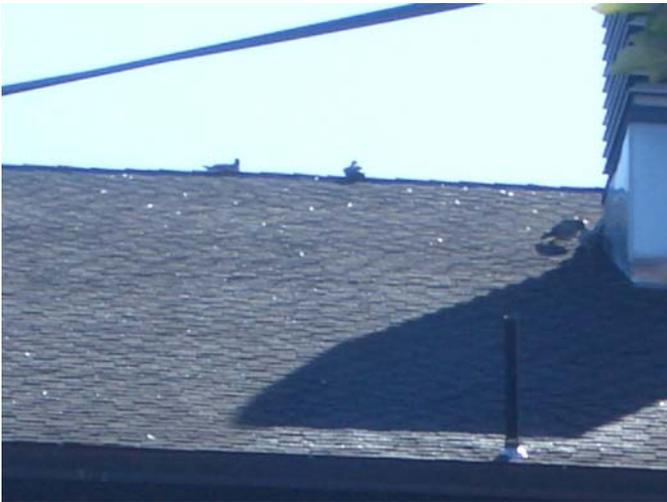
R-2 West side of roof

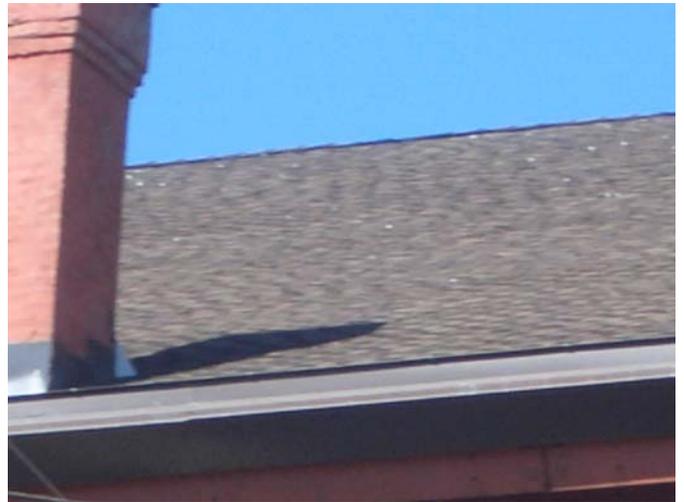
R-5 East side of roof

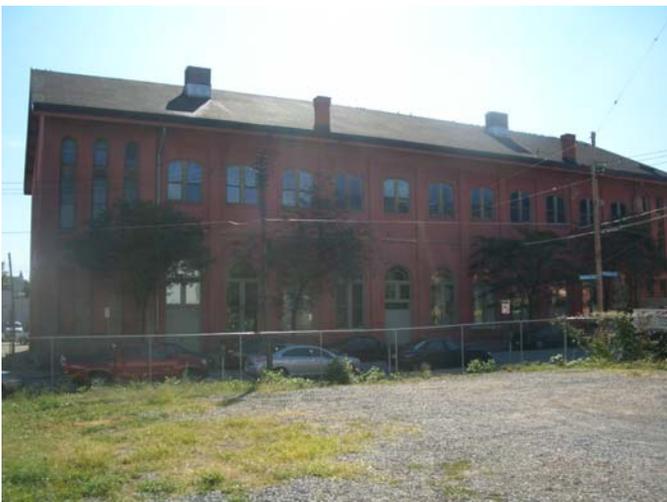
R-3 West side of gable roof

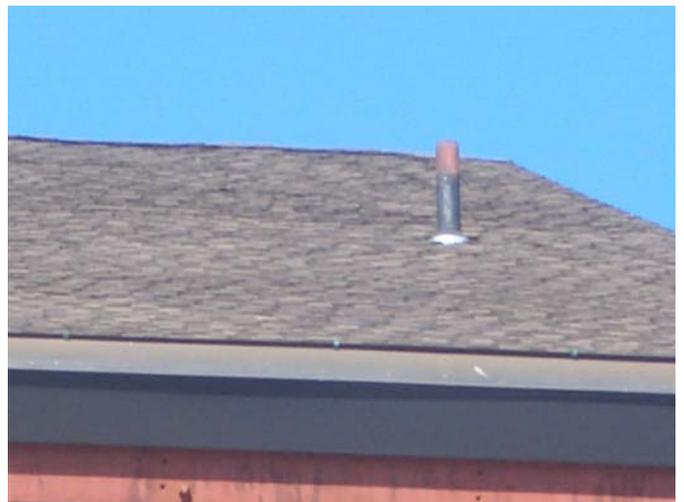
R-6 East side of roof

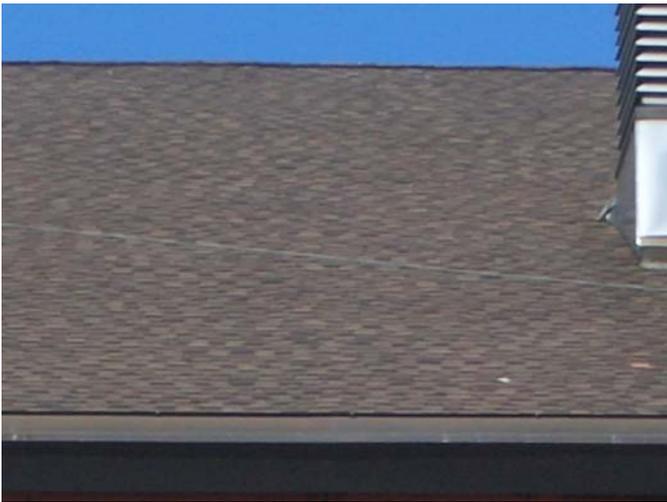
R-7 East side of roof

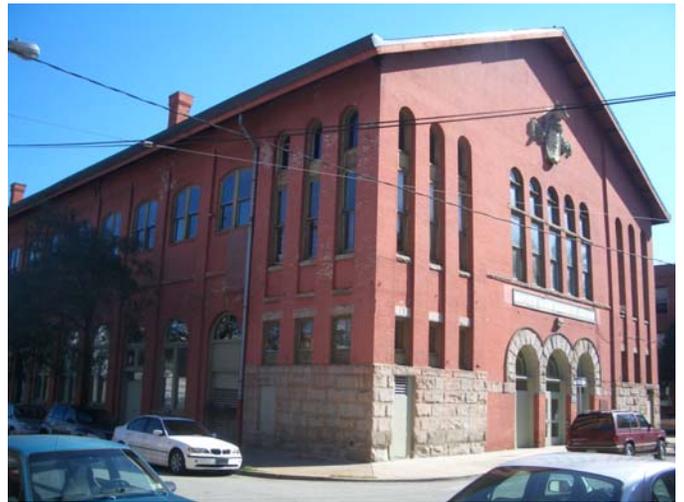
W-3 SW Corner of building

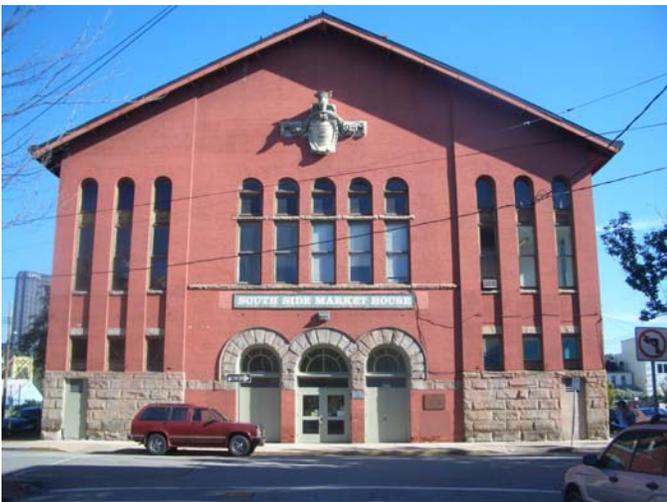
W-1 Front of Building (south side)

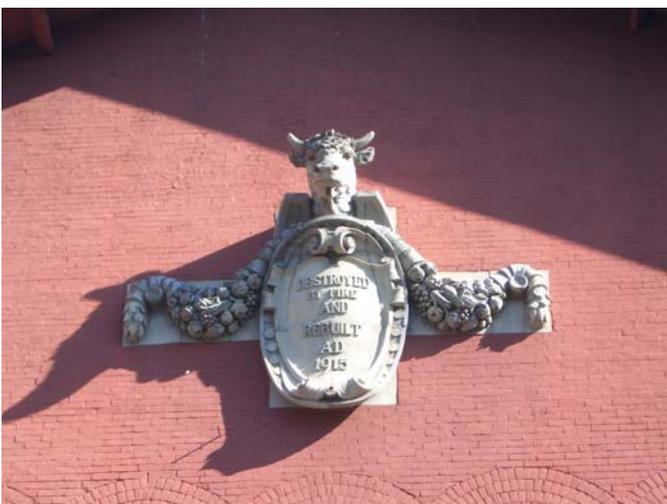
W-2 Medallion on front of uilding

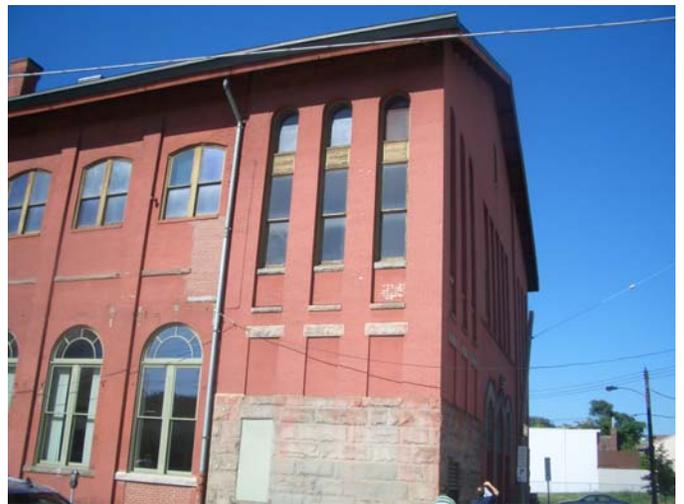
W-10 NE corner of building

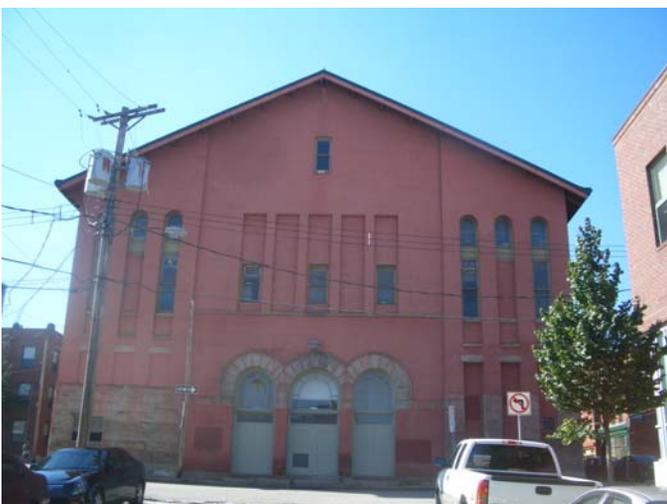
W-8 Rear wall (North side) of building

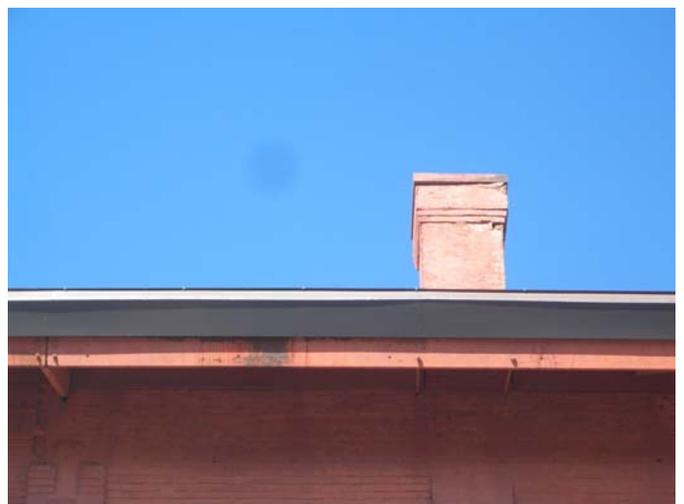
W-11 Fascia and box gutter on east eave

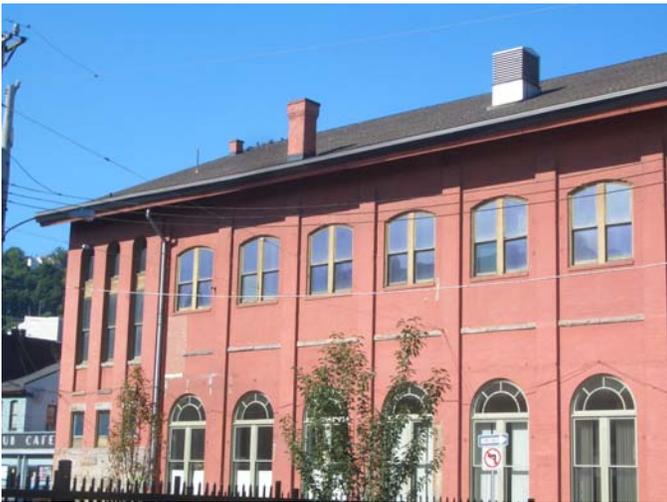
W-12 South end of east wall

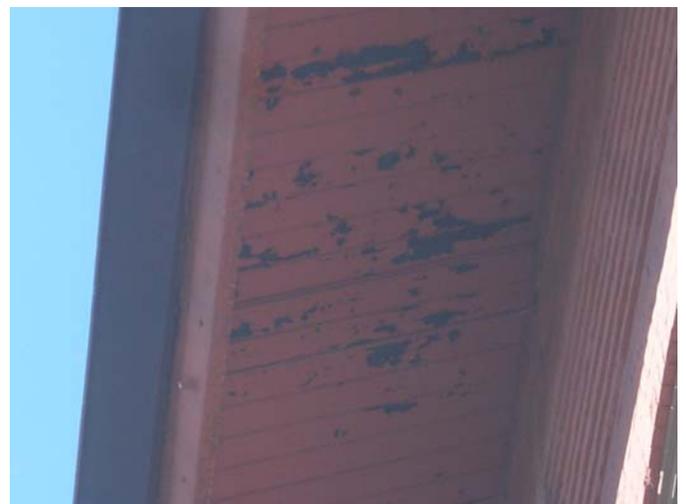
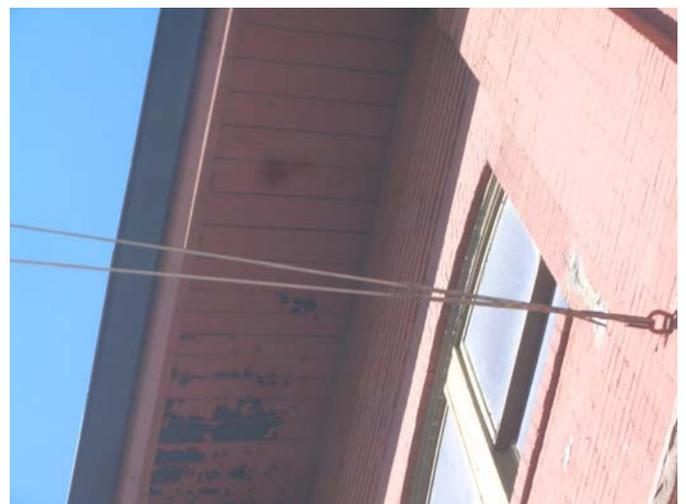
6.2 Condition: The wood soffit is in fair condition. Some paint is peeling and a few pieces are loose and broken.

W-16 Peeling paint on soffit, typical

W-17 Peeling paint on soffit, typical

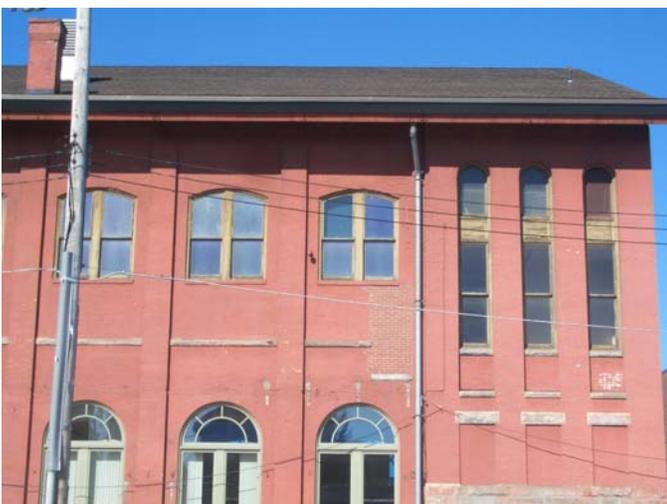
W-14 North end of east wall

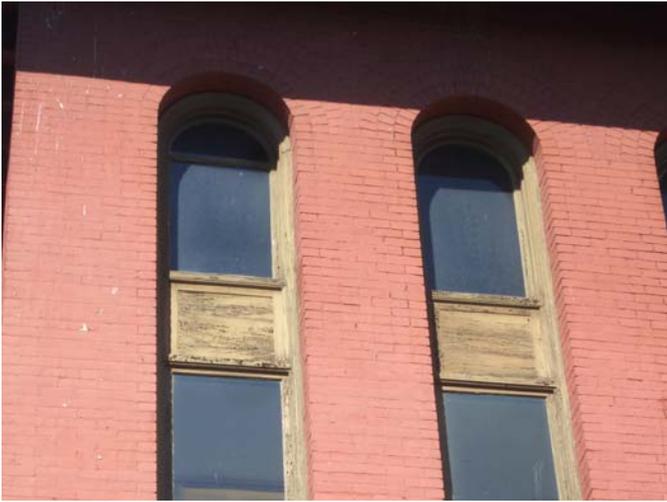
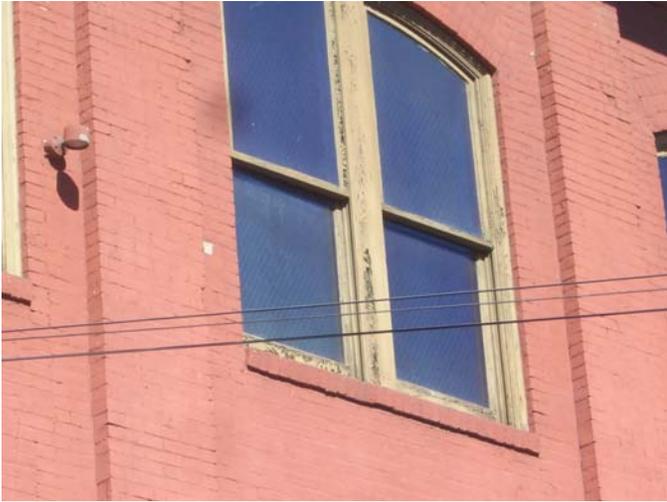
1.2 Condition: The building walls appear to be in fair condition. Some areas of cracked mortar joints were observe. Some paint is peeling and faded in some areas of the brick walls and windows.

W-18 Peeling paint on wood windows, typical

W-19 Peeling paint on wood windows, typical

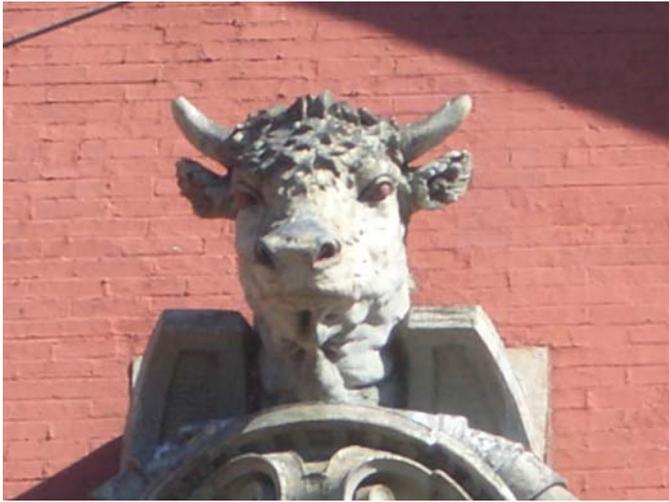
Bull on front of building

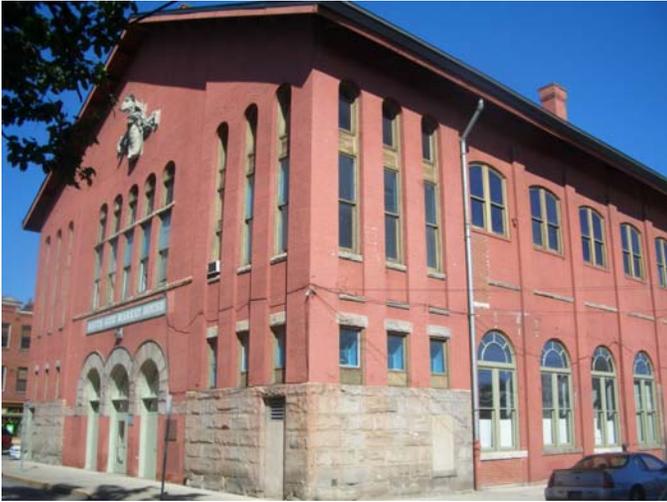
W-20 SE corner of building

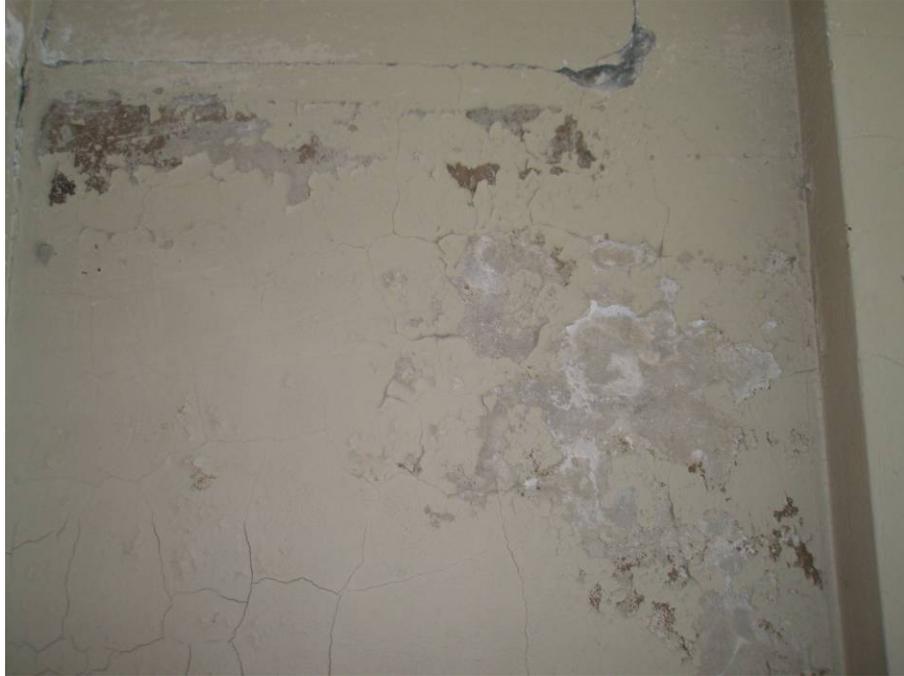
Photo S41

- 16.) There is heaving flooring in the 2nd floor locker rooms. Recommend replacing flooring and floor sheathing. (1 to 5 yrs) **(Photo S36)**
- 17.) In the northwest stairwell, there is significant cracking of plaster and paint peeling. Recommend grouting the cracks in the brick backup and repairing plaster and paint. (1 to 5 yrs) **(Photos S37 through S41)**

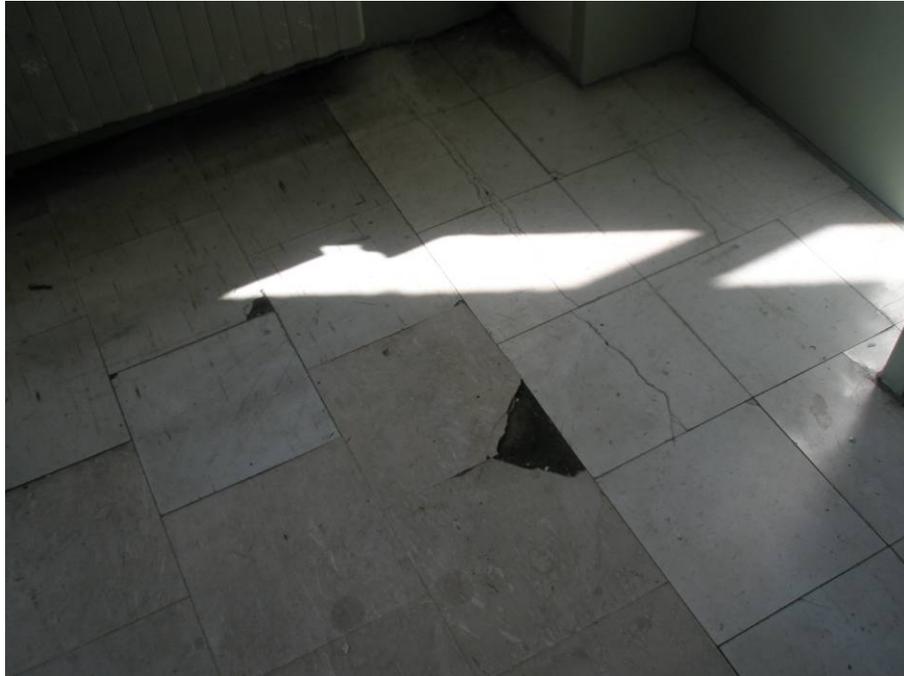
Photo S43

- 18.) There is damaged and heaving flooring at the 2nd floor south entry area to the gymnasium. Recommend replacing flooring and floor sheathing. (1 to 5 yrs) **(Photos S42 and S43)**
